# The case study of a brittle failure of a mountain bike frame composed by carbon fiber reinforced plastic

## Abstract

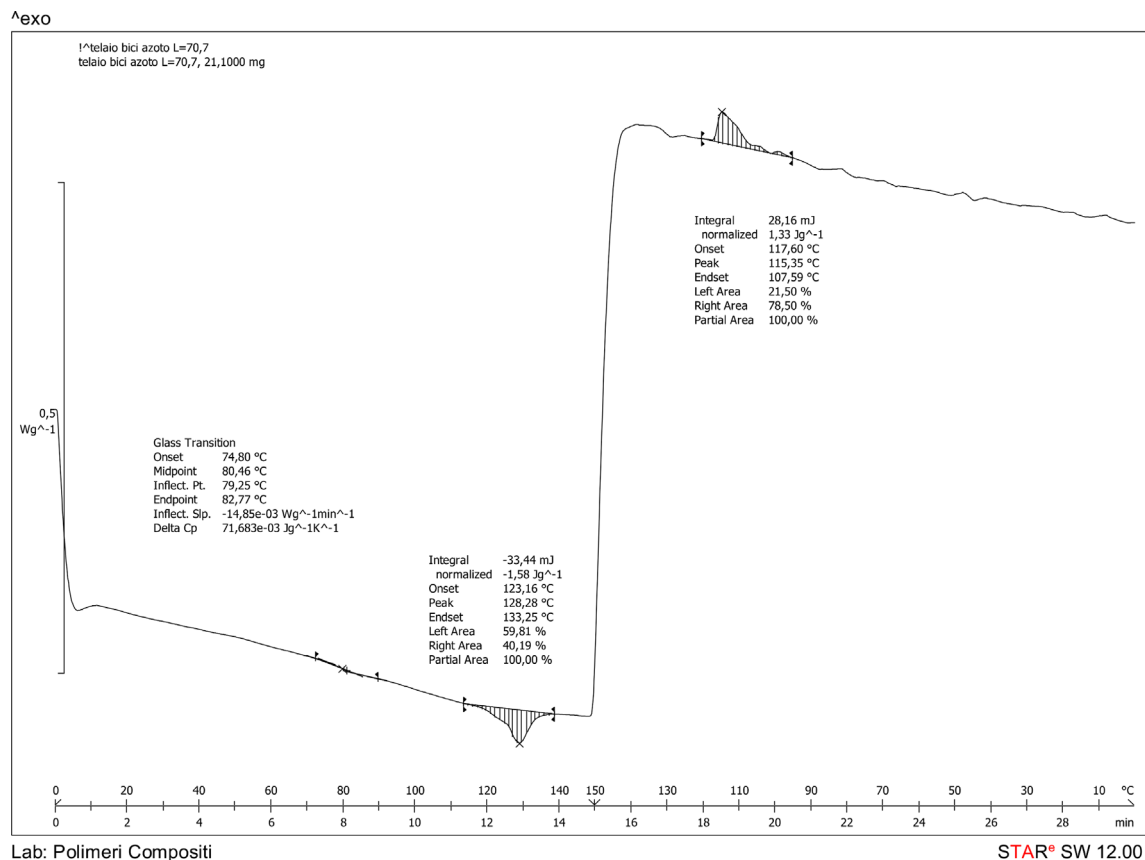
FIGURE 3 Differential scanning calorimetry thermograms of third heating cooling scans.

peak located at about 130°C can be attributed to a thermoplastic material (probably polyethylene). In fact, even by naked eyes inspection, some white fibers can be noticed. This additional phase will be discussed in the next sections. A third DSC scan followed by a cooling scan confirmed that the signal is related to a crystallization process of a thermoplastic polymer, Figure 3.

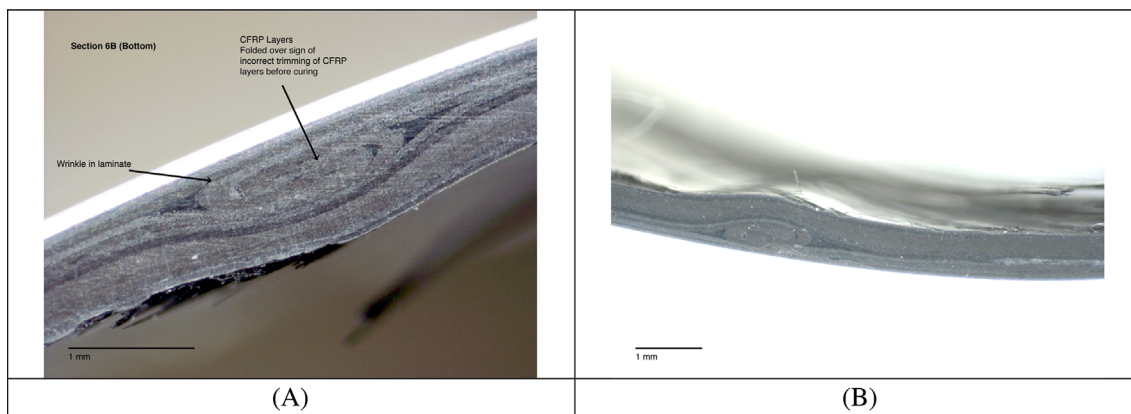
Numerous instances of severe wrinkling are discovered from the micrographic inspections. Figure 5 shows a large wrinkle in two of the sections from the top tube. The presence of large amounts of out-of-plane wrinkling (or fiber waviness) point to poor handling of the plys during the ply cutting and collation process. The oversized plys appear to have been mishandling during the collation process in the tool leading to the wrinkle defects. The wrinkle defects found in multiple locations on the bike frame fall under the category of severe wrinkling defects not acceptable for high performance composite applications where good dynamic, fatigue and static strength performances are desired.

The acceptable industry practices on fiber waviness typically tolerate low amounts of fiber wrinkling based on the waviness aspect ratio. A wrinkle aspect ratio (length divided by height) greater than 15 is considered acceptable. As the aspect ratio approaches infinity the ply is considered perfectly straight while an aspect ratio below 15 indicates severe impact on the composite design. The wrinkle in Figure 5A does not only have an aspect ratio of

approximately 8 but is also coupled with the load path being completely disrupted by the folding over for 2 plys. A similar defect from another section is also shown for comparison in Figure 5B. It is important to note that the wrinkle from 6B appears to have run all the way across the tube to the front of the frame when observed at 6F. Large wrinkles are also observed in the cross-sectional scans in samples 2, 3, 4, 5, and 6. In many cases the same wrinkle extends through the multiple sections examined. Given the morphology of wrinkles observed, the static strength and stiffness in the areas around the wrinkling zone are expected to be more than 50% lower than pristine or unwrinkled portions away from this region and the fatigue life reduced by more than 10.<sup>1–36</sup>

FIGURE 5 (A) Large wrinkle due to the carbon fiber reinforced plastic (CFRP) ply folding over during the ply collation process (Section 6B). (B) Large wrinkle in top tube in Sample 7F.

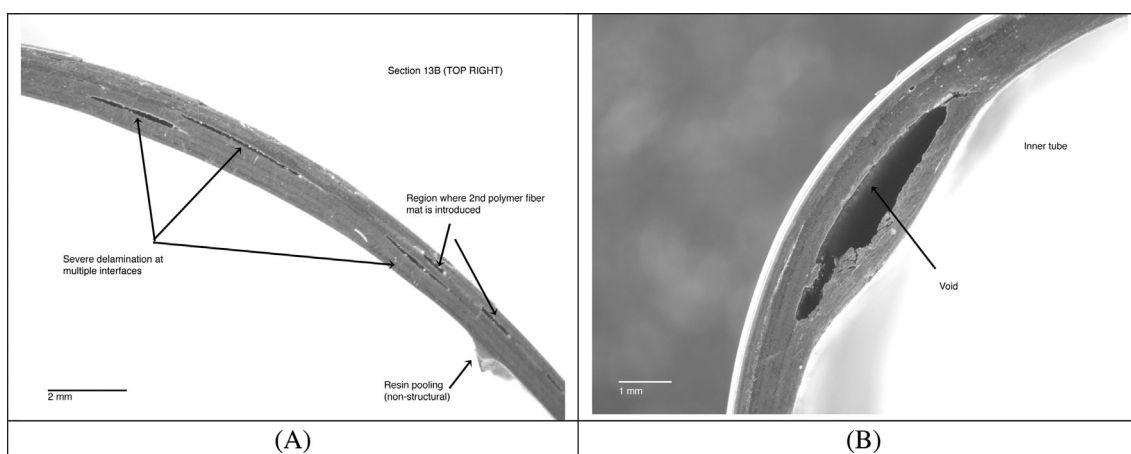
Every section of the frame examined contained multiple interfaces that are affected (Figure 6A). In one section near the fracture zone a large void is observed at the tube radii (Figure 6B). Curved parts are sensitive to the tooling, stacking sequence, part thickness and resin properties. Resin migration, disbonds, fiber waviness and porosity can all occur in the curved regions when improper processing takes place.<sup>48</sup> Other defects observed in the examined frame that are also associated with poor consolidation at the tube radii include blisters in the inner tube and non-uniform ply thicknesses or resin thinning.

Such macroscopic delaminations are even more critical than the previously observed wrinkles. The defects are so numerous, large and close that their interaction and further weakening is expected.

FIGURE 6 (A) Multiple delamination sites at various interfaces in Section 13B. (B) Large void due to improper consolidation in Section 7F.

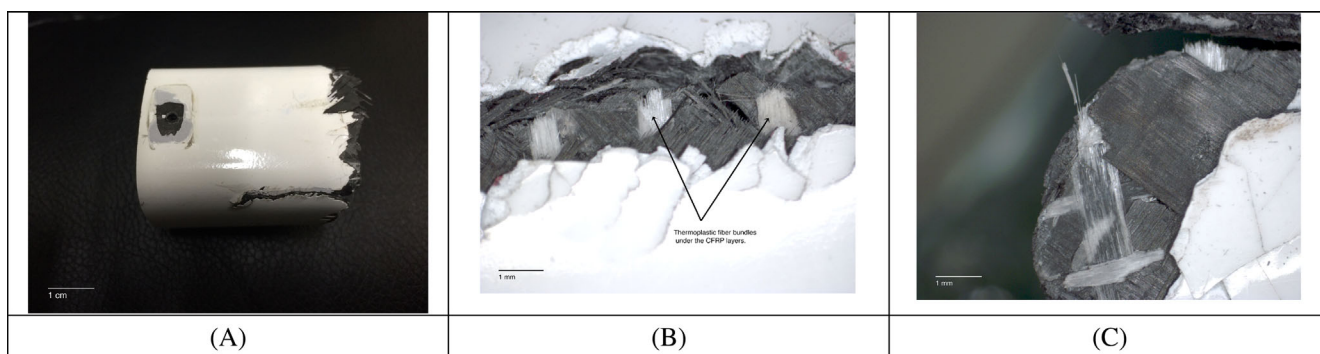
FIGURE 7 (A) Top tube fracture region (note this is the section adjacent to Sample 8 face b). See part (B) for close-up of fracture region. (B) Close-up of fracture zone in top tube showing thermoplastic fibers in failure region; note the thermoplastic fiber bundles are located within the carbon fiber reinforced plastic (CFRP) stack. (C) Close-up of region containing thermoplastic fiber mat.

appeared to be white colored filaments in the fracture zone (Figure 7A–C). The microstructural investigation confirms the presence of a 2nd material system directly present and impacting the structural performance of the

composite material beyond the carbon fiber and the polymeric resin. The filaments appear to be polymer fiber bundles and are in the form of a fiber mat that is present along the sides of the tubes (both top and down tubes).

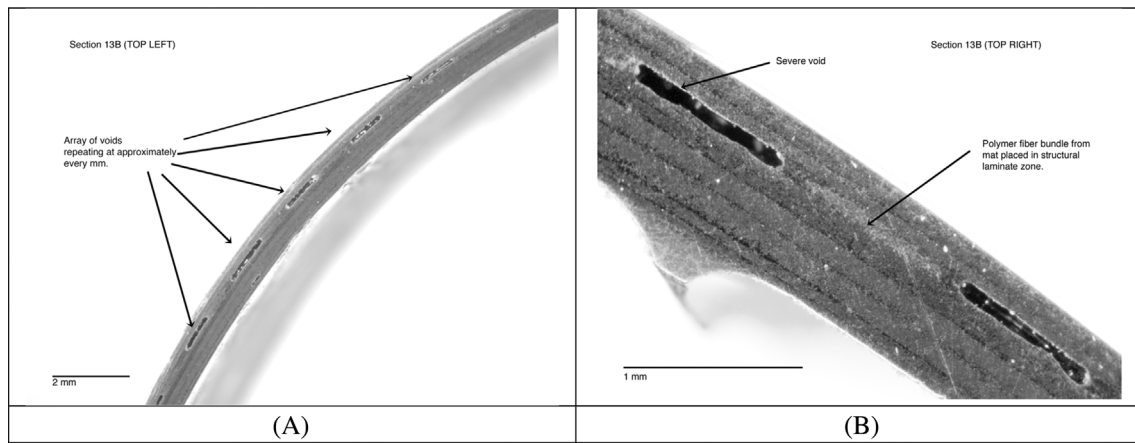
**FIGURE 8** (A) Large voids corresponding to the gaps in the polymer fiber mat. (B) Close-up showing large voids occurring after several layers from the outer surface in the region corresponding to the thermoplastic fiber mat.

The thermoplastic fiber mat is problematic for several reasons. The mat is located a few CFRP plies from the outer surface of the composite. Thus the mat is sandwiched between structural layers and thus cannot be considered a non-structural part such as the paint or primer layer. In addition, the mat used has large gaps (greater than 1 mm), which coupled with improper compaction during cure (e.g., low pressure areas) results in large voids forming within these regions (as seen in Figure 8A,B). Note the ordered location of voids in this layer corresponding to the gaps in the mat layer. The defects are so numerous and close to each other that their interaction is expected to further weaken this frame.

In the top tube, it is observed that this thermoplastic fiber mat extends from the lower radius to the top radius regions, with the top and bottom surfaces not appearing to contain this mat layer. It is possible that this thermoplastic mat layer may have been added to reinforce this section or improve the processing although without having additional design details this remains only a speculation. It is curious that the tension failure observed in the top tube as a crack running along the top tube main axis (on both sides of the tube) occurs in this region. The curved radius region is a highly stressed region in composite tubular parts. The fracture surface does not show carbon fibers present in the laminate that are perpendicular to the crack. It is not realistic to assume that the thermoplastic mat added around the curves is enough to reinforce this area significantly due to their low volume fraction (due to large spacing). This is also coupled with the fact that the mat seriously compromises the strength and stiffness of the composite laminate in this area by allowing for severe void nucleation sites.

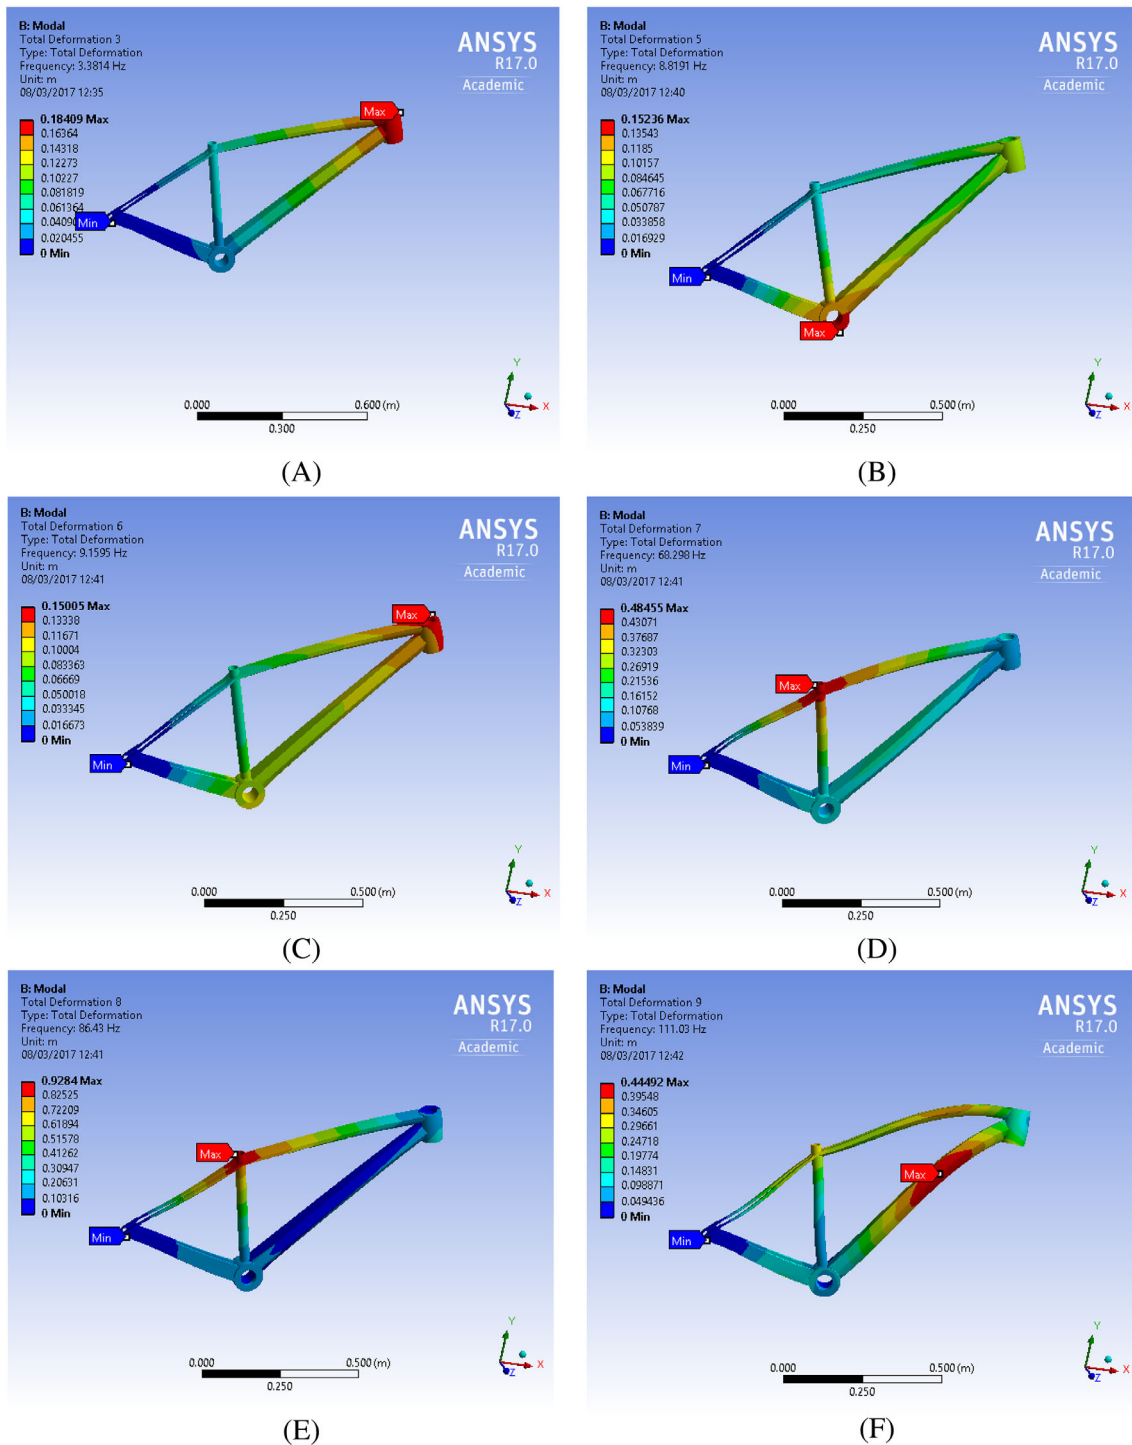
FIGURE 11 (A) Mode 1. (B) Mode 2. (C) Mode 3. (D) Mode 4. (E) Mode 5. (F) Mode 6.

fork is  $A = 2.18 \times 10^{-3} \text{ m}^2$  thus as  $K_f = K/A$  (Table 8). Figure 10B and Table 9 report the adopted mesh. The computed natural frequencies are reported in Table 10 and, due to the driver position/man mass real distribution and measured low elastic modulus, are observed quite low, from 3 up to 111 Hz for the first 6 modes, Figure 11A–F. Note that mode 4 has a frequency around 68 Hz and is thus compatible with a resonance imposed by the wavy nature of the grass and cycling velocity (previously computed as 69 Hz); also note that the related mode shape (Figure 11D) has the maximal relative displacement in the region of the observed fracture. We cannot thus exclude that the observed severe defects were further weakened by interaction with a dynamic resonance.
