# Engineering Failure Analysis

## General durability criteria for exposed timber structures based on the analysis and inspection of bridges and observation towers

<https://doi.org/10.1016/j.engfailanal.2026.110986>

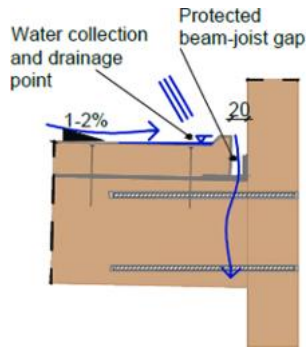
n°	Bridge	Description	Detail	Photo
D9	Montreux_2005	Detail of the main beam-joist joint. Good condition at the gap between deck and main beam due to the presence of joist protection

<p>Water collection and drainage point</p> <p>Protected beam-joist gap</p> <p>1-2%</p> <p>20</p>

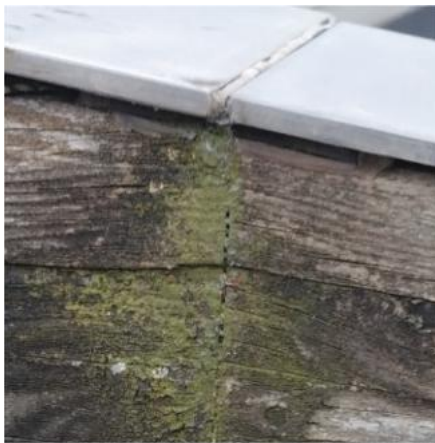
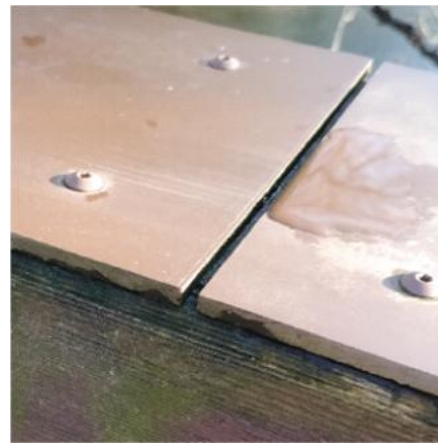
Fig. 2. Details of the metal plate joints in the Corcelles\_2008 (a) and Boudry\_1998 (b) bridges, showing the gaps between plates and the lower support elements that lead to water stagnation.

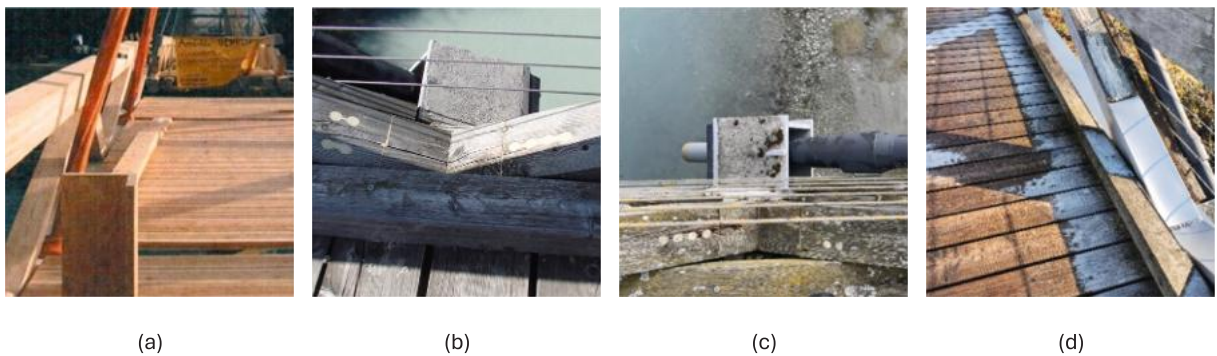
Fig. 4. Illarsaz\_2004 bridge: detail of the truss-deck joint – (a) right after construction (photo from 2005); (b) first signs of decay (photo from 2008); (c) widespread decay (photo from 2021); (d) after retrofit (photo from 2024).

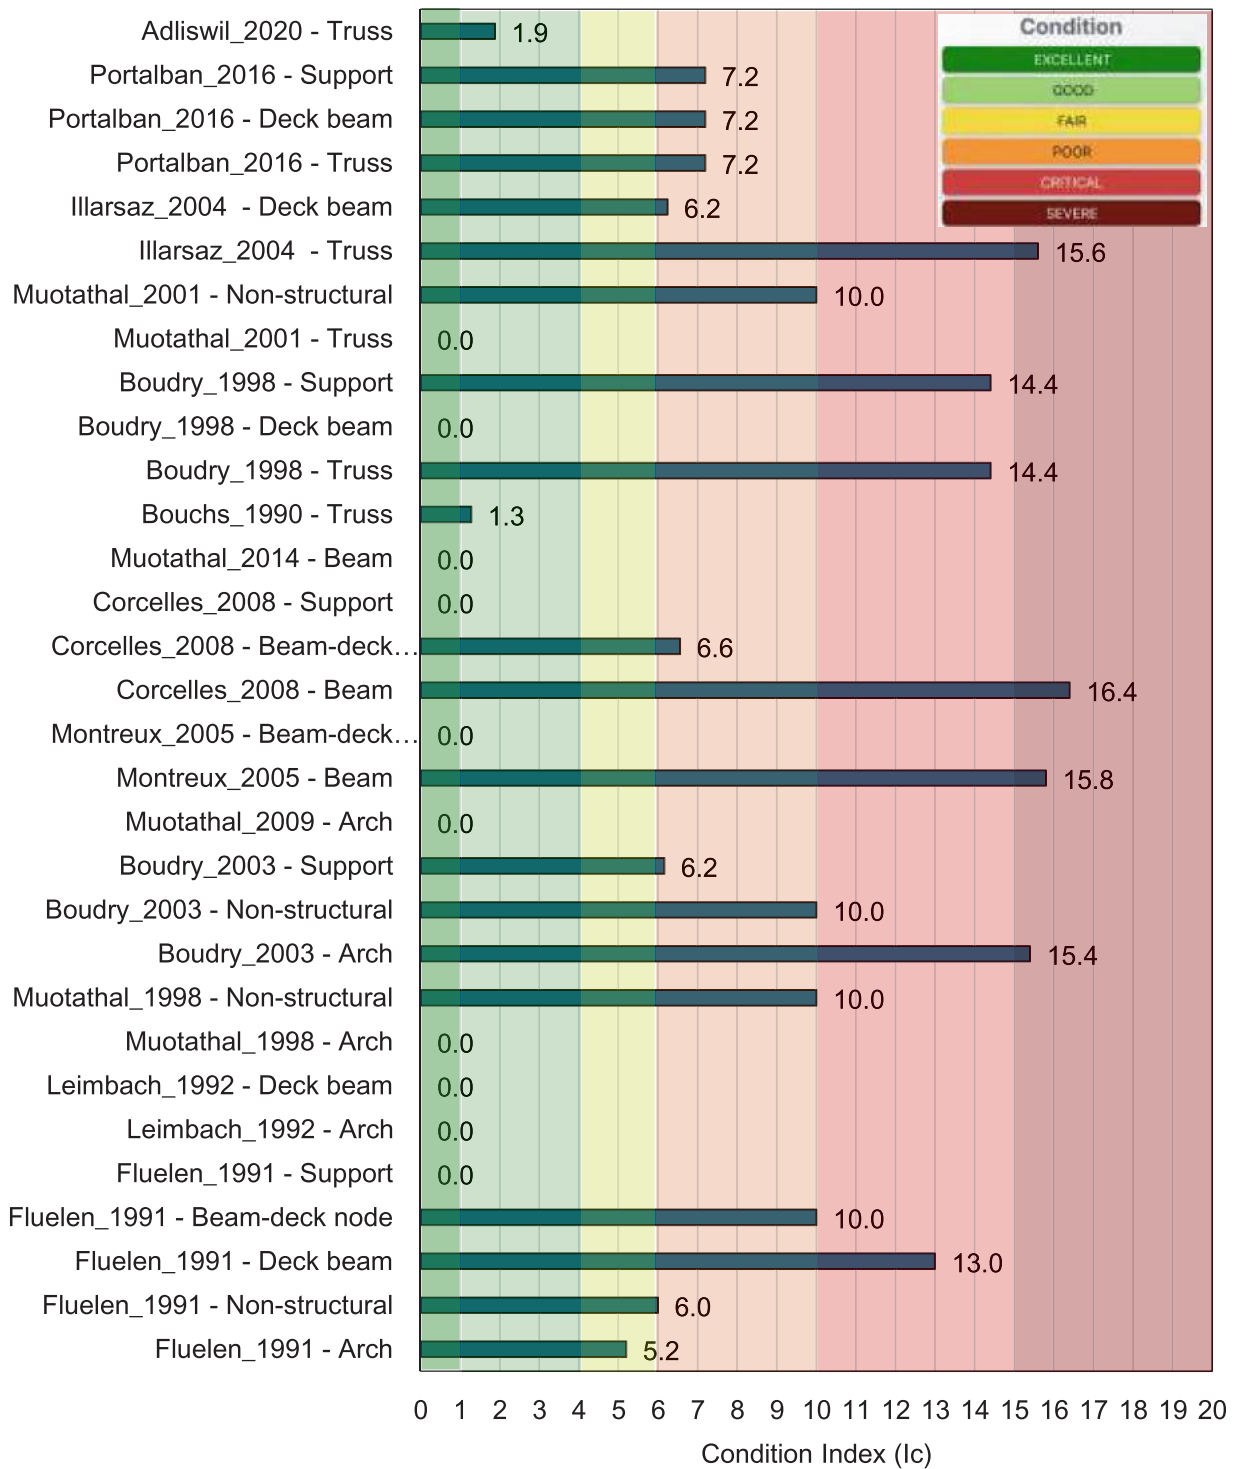
Fig. 6. Condition Index  $I_c$  of the Inspected Timber Bridges.

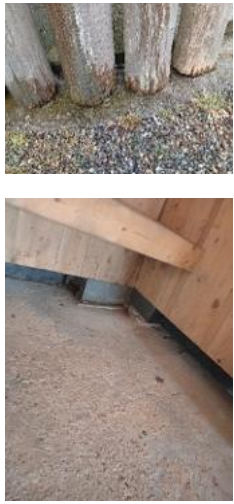
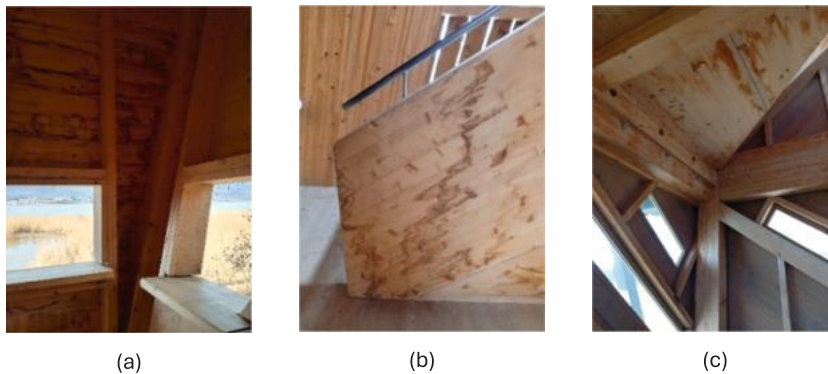
(D18, Table 6). It is worth mentioning that Seedorf\_2012 (No. 16, Table 1) is located in close proximity to the Fluelen\_1991 bridge (No. 1, Table 1), in an area characterized by a favourable microclimate, as previously described in 4.2, which may have had a positive impact on the good condition of the tower logs. In Lausanne\_2003 (No. 15, Table 1), the tower height required stacked log segments and the log-to-log joint, after almost 25 years, still shows very good performance ( $I_c = 0$ ) thanks to partial protective measures and adequate spacing between elements (D19, Table 6). By contrast, CLT and frame wall systems tend to exhibit high internal moisture levels, most likely due to insufficient ventilation, resulting in staining and surface decay (average  $I_c \approx 7$ ), as shown in Fig. 7.

Fig. 7. Moisture stains on timber – Towers of (a) Cheseaux\_2018, (b) Goldau\_2016 and (c) Bullet\_2018.

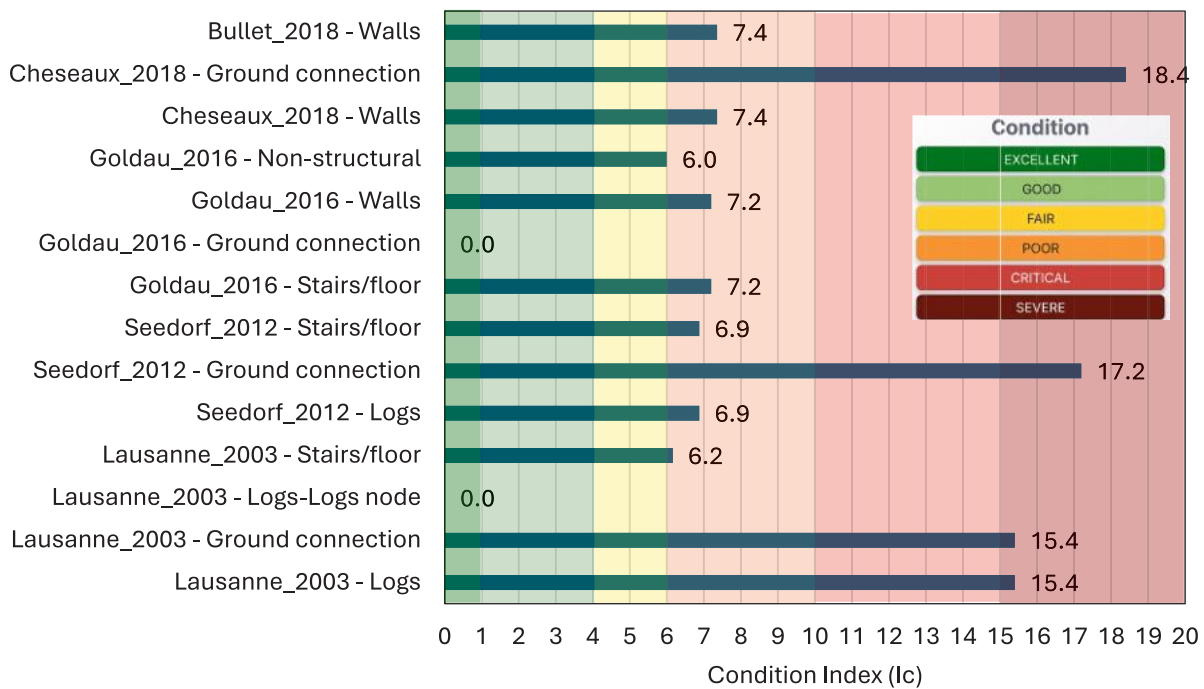
Fig. 8. Condition Index  $I_c$  of Inspected Timber Towers.
