Giongo I, Rizzi E, Riccadonna D and Piazza M  
On-site testing of masonry shear walls strengthened with timber panels.  
*Proceedings of the Institution of Civil Engineers – Structures and Buildings*,  
<https://doi.org/10.1680/jstbu.19.00179>

Paper 1900179

# On-site testing of masonry shear walls strengthened with timber panels

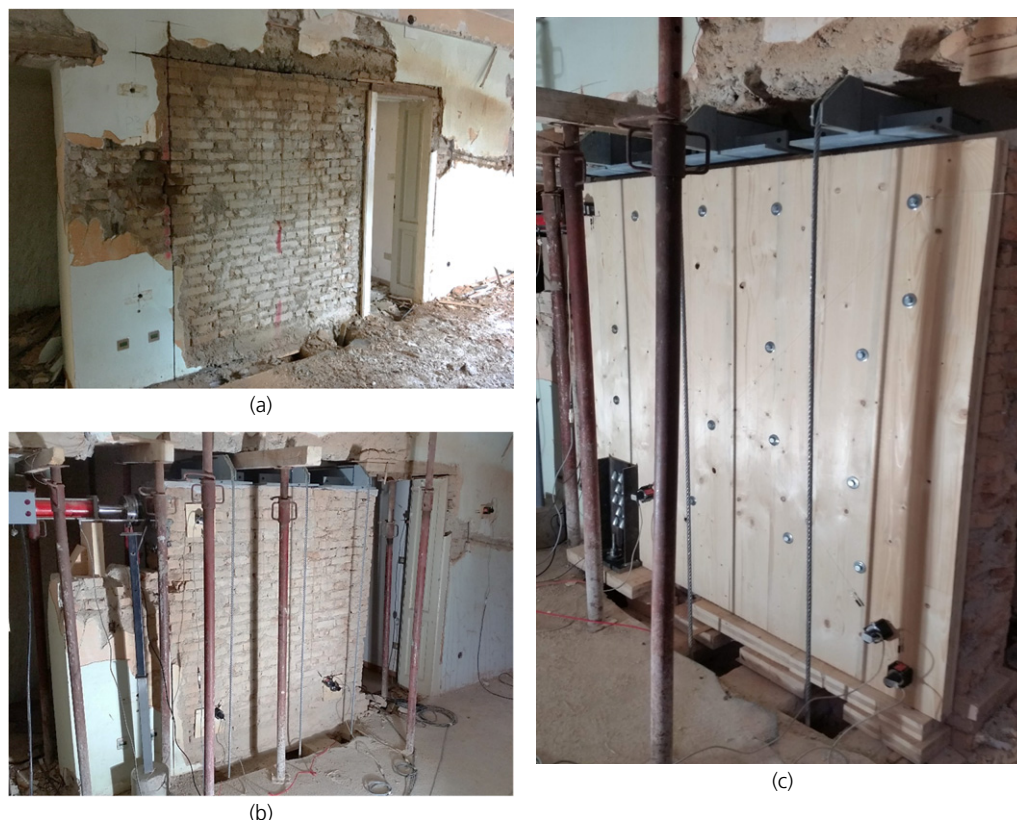
**Figure 3.** Specimen preparation: (a) specimen after removal of plaster and creation of through cuts; (b) specimen AsB-1 prior to testing; (c) specimen R-1 prior to testing

cracks that originated from the testing of the specimens in the as-built condition. As the masonry wall surface was hidden by the CLT panel, care was taken to drill the holes in correspondence with the bricks so as not to install fasteners into the mortar bed joints and consequently reduce their effectiveness. Holes were cleared from dust and debris prior to the fastener insertion with an impact screwdriver. The CLT panels were installed so that the grain direction of the external board layers was oriented vertically (Figure 3(c)).

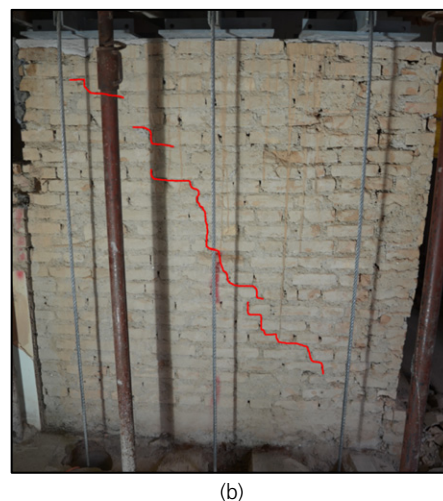
**Figure 6.** Specimen 1 as-built (AsB-1): (a) load–displacement curves; (b) crack pattern at peak loading

Subsequent to the application of vertical stress up to 0.22 MPa, specimen 1 was first tested in the as-built unreinforced condition (AsB-1). Horizontal loading was applied in semi-cycles following a stepwise procedure of 5 kN load increments up to 30 kN, after which the step size was increased to 10 kN until the maximum load ( $F_{max}=69.3$  kN) was reached. The failure mechanism was identified by the formation of a stair-stepped diagonal crack involving both mortar bed-joints

and bricks, as illustrated in Figure 6(b). No visible cracking was observed prior to the maximum load, with the sole exception of a horizontal crack located in the mortar bed-joint at the specimen base on the wall's tension side. This horizontal crack, associated with the wall rocking response, was only visible at the cycle peaks and had a length ranging from a few centimetres to  $\approx 20$  cm at the last loading cycle. Figure 6(a) shows the load–displacement curves obtained from AsB-1 test plotted with reference to the displacements measured by the DISP\_R and DISP\_L transducers (shown in Figure 5).

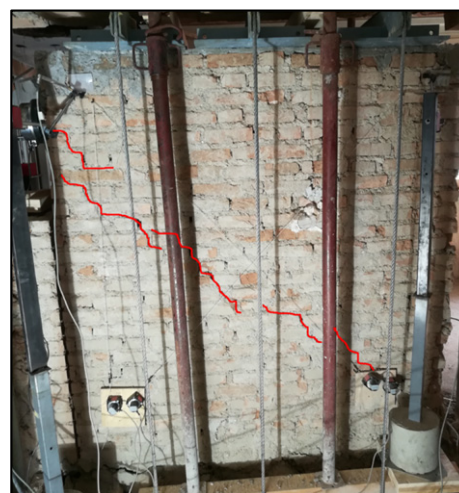
**Figure 10.** Specimen 2 as-built (AsB-2): (a) load–displacement curves; (b) crack pattern at peak loading

of the diagonal shear failure mechanism (for a shear load of approximately 70 kN, consistent with test AsB-1), pushing the specimen up to a net displacement of 50 mm at the top (Figure 10). Similarly to test AsB-1, the failure mechanism of AsB-2 was marked by the formation of a stair-stepped diagonal crack along the compressed wall diagonal, as highlighted by the crack pattern shown in Figure 10(b).

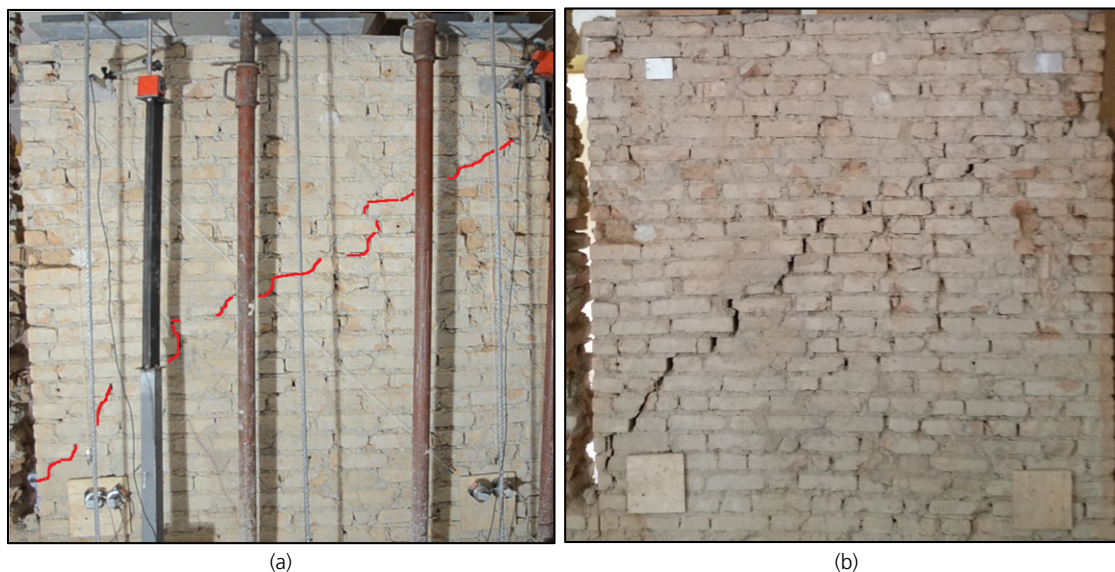
**Figure 14.** Damage to specimen R-3: (a) diagonal shear crack formation at peak loading; (b) crack pattern at the end of testing

the effectiveness of the strengthening solution in a scenario without pre-existing damage. A total of 25 type B fasteners ( $\approx$ eight fasteners per square metre of wall surface area) were used to connect the CLT panel to the masonry wall. The fasteners were arranged in five rows with 300 mm spacing in both vertical and horizontal directions and at a 300 mm distance from the panel edges. Figure 13 shows the loading cycles and the envelope curves plotted with respect to the displacements of the timber panel and the masonry wall. After reaching the maximum load capacity of the system at a lateral force of 106 kN, with the formation of a clear shear failure mechanism (Figure 14), additional load cycles were performed under displacement control by increasing the displacement amplitude (measured with reference to the masonry side of the specimen) by 10 mm at each cycle. As is visible in Figure 13, specimen

R-3 exhibited a softening behaviour with a 10% capacity loss after two cycle sets under displacement control (maximum wall displacement of 80.3 mm). Similar to the tests on specimen 2, it was not possible to reach the ultimate capacity of specimen 3 due to safety concerns. However, the observed experimental drift capacity was equal to  $DR = 4.5\%$  (at peak loading  $DR = 3.3\%$ ), denoting a remarkable deformation capacity of the strengthened system. The portion of drift capacity associated with the shear deformation ( $DR_{\text{shear}}$ ) was calculated from the readings of the instruments located at the specimen diagonals and corresponded to  $DR_{\text{shear}} = 3.1\%$  (at peak loading  $DR_{\text{shear}} = 1.6\%$ ). Morandi *et al.* (2018) report details of the
