Experimental fire response of seismic elastomeric bearings

Massimiliano Lucon¹, Paolo Baragatti¹, Luca Possidente², Nicola Tondini^{2*}

Abstract

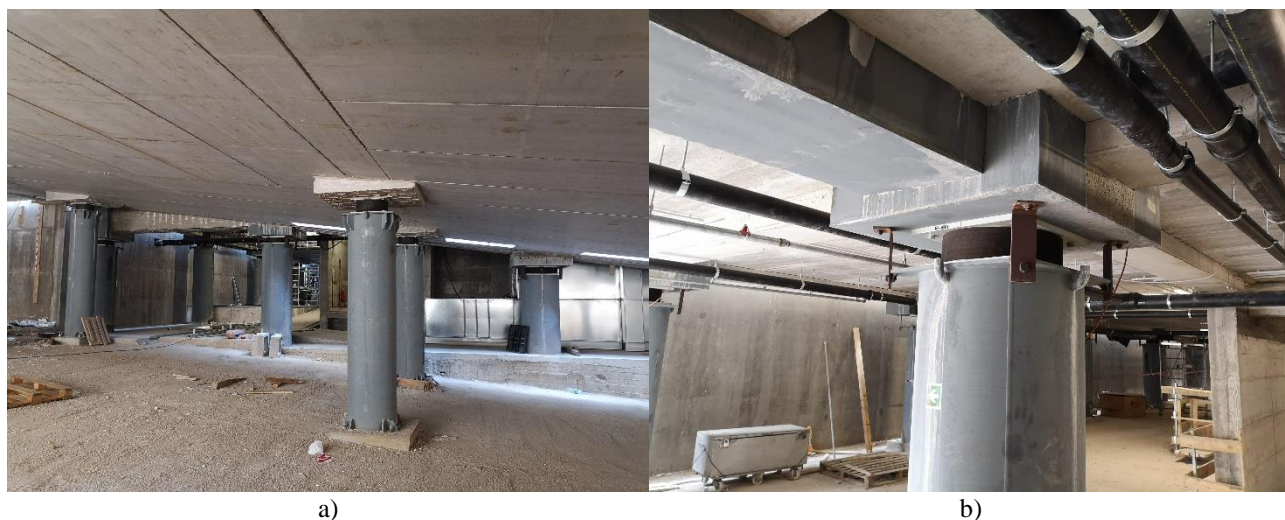
Figure 1. Isolators installed at the top of the columns located at the 1st underground floor.

and an underground car park are being built. The buildings are 5 storeys high or less and have different occupancy, i.e. an office building, a conference hall, a company canteen, a wellness centre and a warehouse space. Except for the conference hall, the buildings are connected at the level of the 4th and 5th floor. The car park covers more than 3000 square meters and has an inter-storey height of 2.9 meters. Seismic isolators are installed at the top of the concrete-filled columns of the car park to mitigate the effects of seismic actions, as shown in Figure 1.

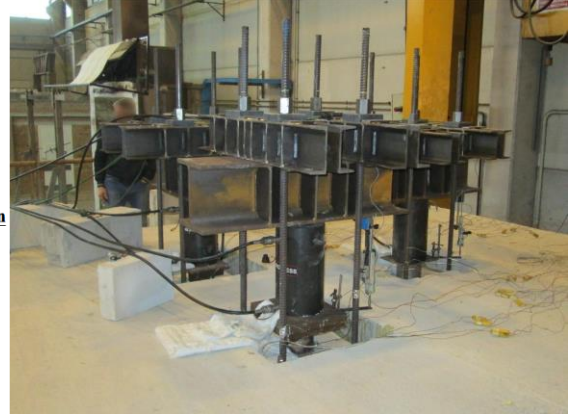
Figure 2. Test setup. Dimensions in cm.

The test setup is depicted in Figure 2.

Each specimen was made of a circular concrete-filled steel column 1692 mm high, with diameter equal to 609 mm and the isolators mounted on the top. The specimens were installed inside a furnace and the height of the column was such that the top surface of the bearings and the inner surface of the furnace were aligned. Four steel bars SAS 670/800, with diameter of 28 mm and a length of 3300 mm, were embedded in the columns. These bars, together with steel plates at the ends of the columns,

allowed for fixing the specimens to a concrete basement 150-mm thick at the bottom of the furnace and to the load redistribution beam outside of the furnace, as shown in Figure 2. Indeed, the column-isolator systems were realised by simply placing the isolators on the top of the columns and letting the SAS 670/800 steel bars pass through four holes drilled in the corners of the top and the bottom plates of the isolators, as illustrated in Figure 3. The loading system consisted of UPN 160 and HE 260 B beams and a hydraulic jack. A load of 900 kN was applied, which was the highest load acting on the SI-S 400/100 bearings in the fire situation, i.e. 60% of the maximum vertical design load of the bearings. The load was controlled and applied directly on the upper plate of the isolators, on which the applied stress was less than 10 MPa. A pressure gauge allowed for measuring and control the load intensity to keep it constant during the test.

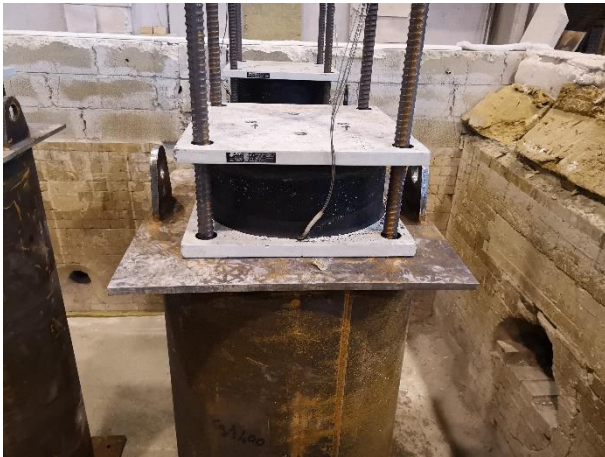
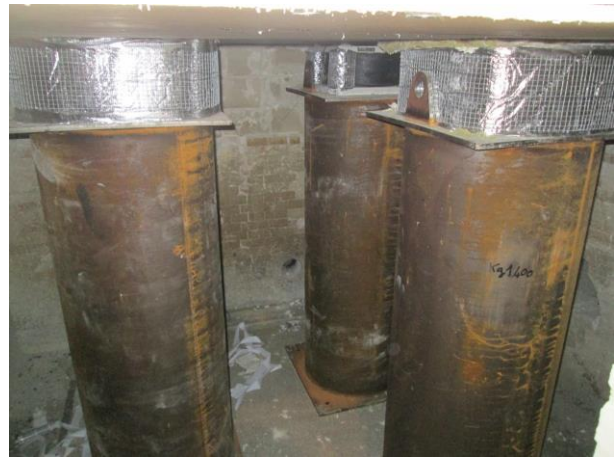
Figure 3. Installation of the isolators on the top of the composite columns.

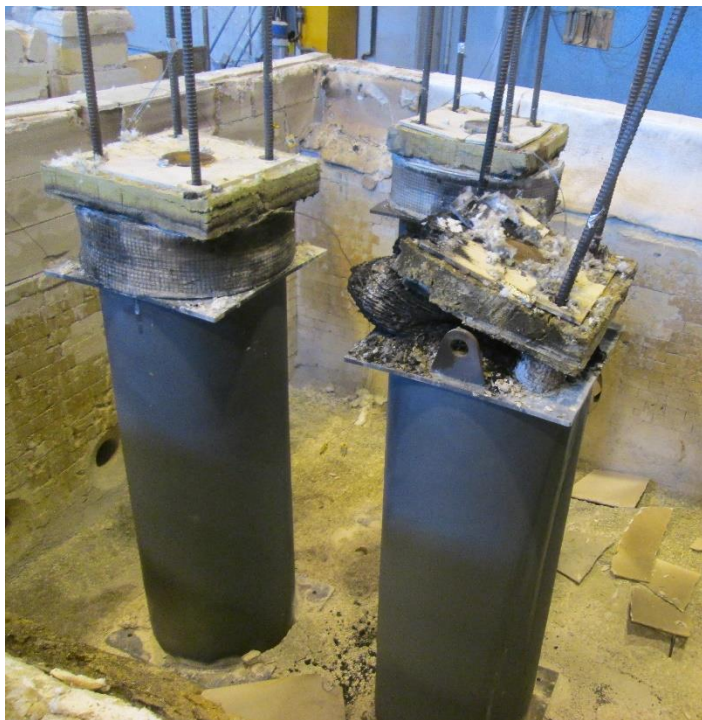
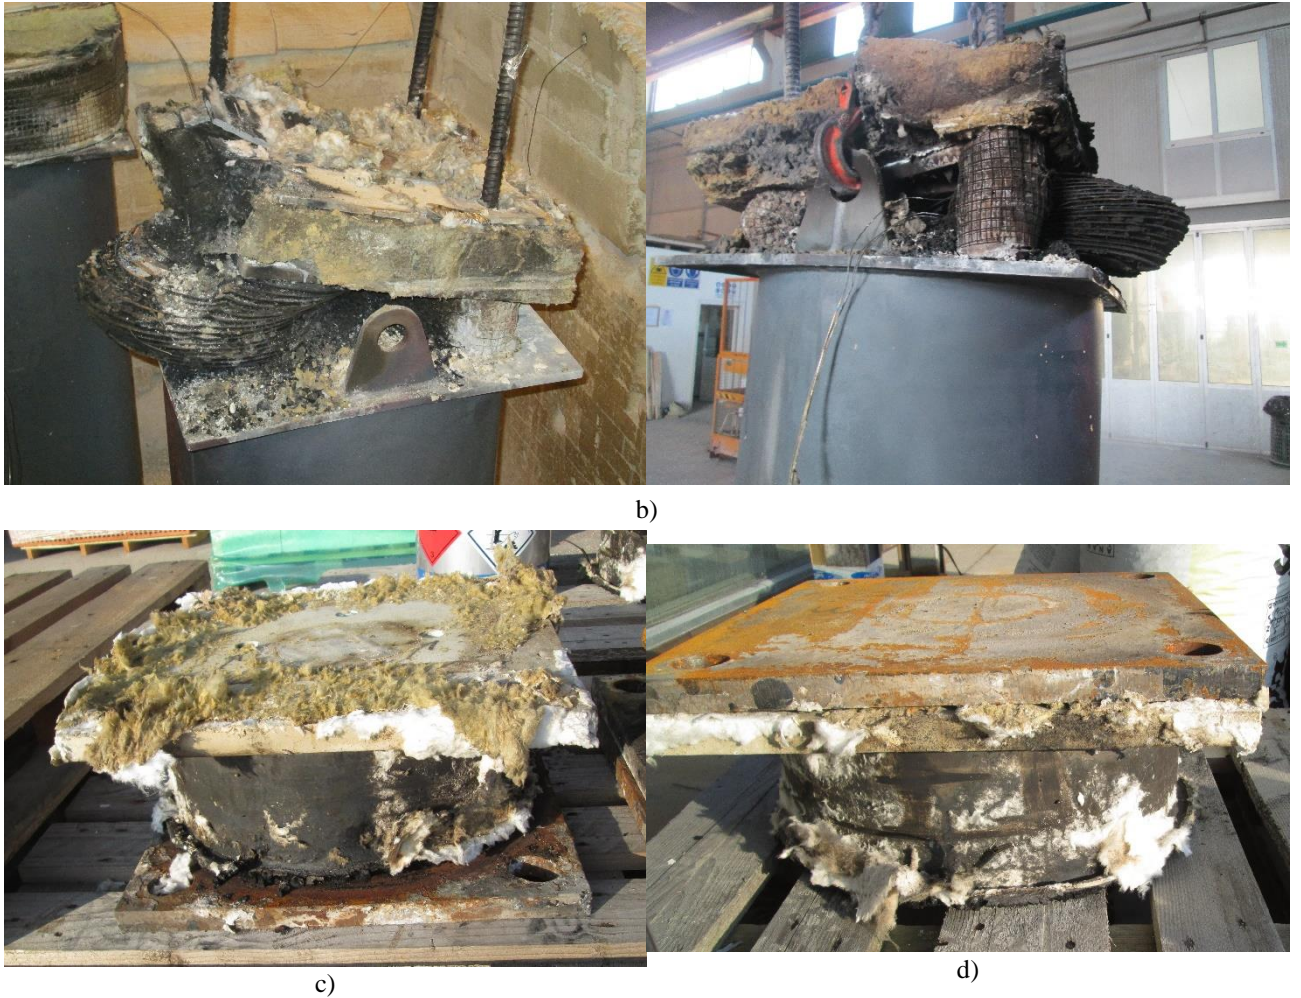
Figure 5. Conditions of the isolators after the fire test: a) Isolator A; b) Isolator B; c) Isolator C.

for 92 min, time at which the furnace was stopped because flames came out from the hole of Isolator A that made the continuation of the test difficult. Thus, even if the performance could be higher, the fire resistance requirement of 90 min was met for both Isolator B and C. Figure 5 shows the conditions of the isolators after the fire test. It is possible to observe in Figure 5a and b that Isolator A underwent significant damage and loss of stability with the steel shim plates clearly visible and the rubber highly degraded falling apart. The bars used to apply the load were also damaged and bent with one that even broke. Conversely, in Figure 5c and d Isolators B and C are not visibly damaged with the rubber still in place. However, they were not totally unaffected by the fire as reported in Section 3.2, where the post-fire characterisation of both fire-protected isolators, i.e. Isolator B and C, is reported. Indeed, high temperatures were reached in the proximity of the plates during the fire test. These regions were affected by deterioration of the rubber that caused the bottom plates to detach.

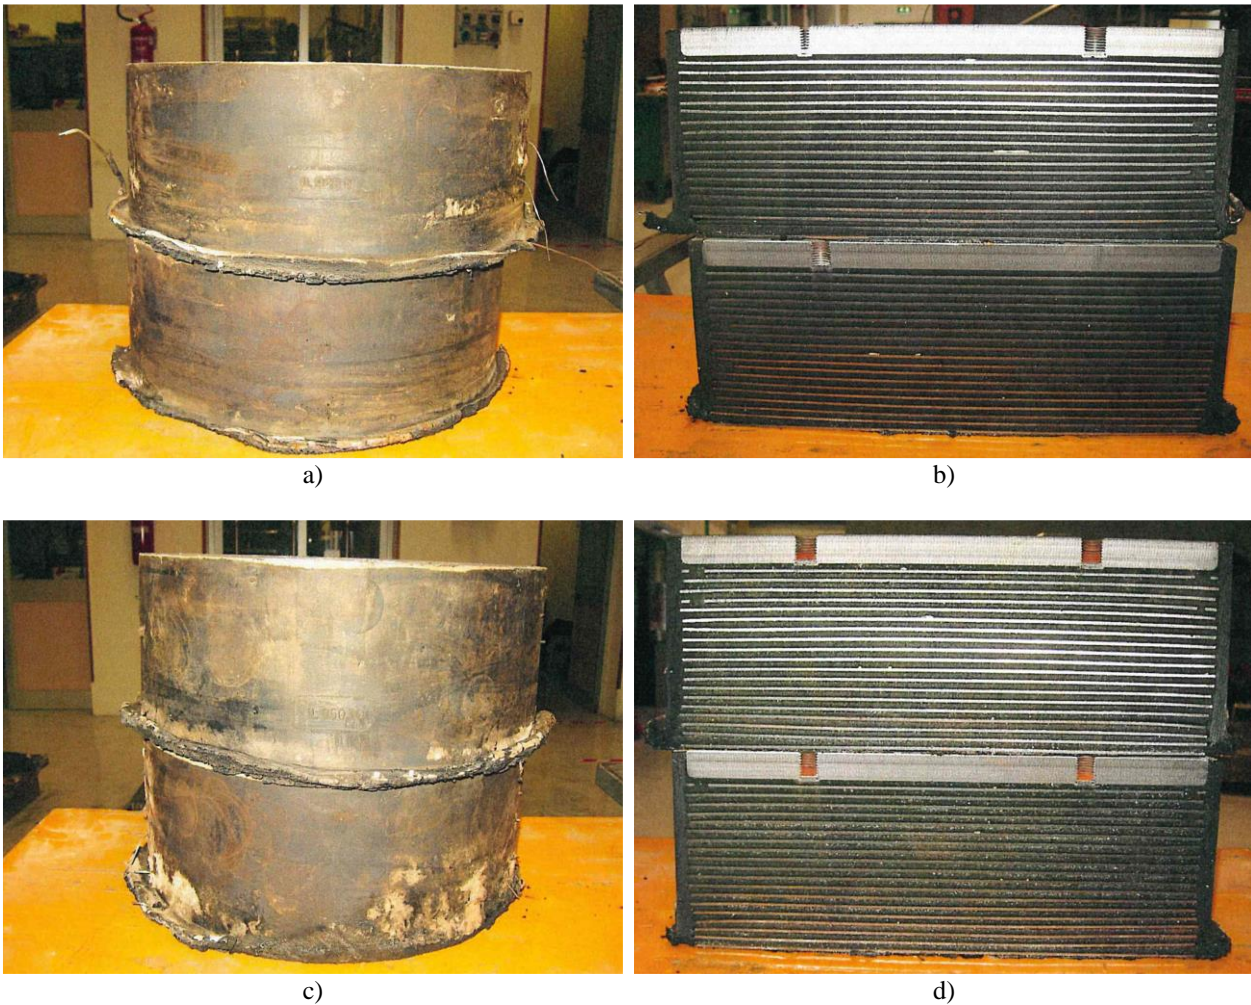
Figure 9. Visual inspection of Isolators B and C after the fire test.

After the post-fire characterisation, the devices were cut longitudinally for visual examination. Figure 9 shows the lateral rubber surface and the inner longitudinal section of the devices B (see Figure 9a and b) and C (see Figure 9c and d). Only the first layer of rubber, which was in contact with the bottom plate, reached very high temperatures during the fire test and it was severely deteriorated. The other rubber layers, as well as the rubber on the external surface, were in good conditions.
