Fatigue Corrosion Behavior of Friction Welded Dissimilar Joints in Different Testing Conditions

Abstract: Our study will be focused on stainless steel AISI 304—carbon steel ASTM A105 joints obtained by rotary friction welding and on their fatigue corrosion behavior in different testing environments. As a first thing, the joints will be characterized by microscopy and electrochemical techniques. The manuscript will then describe the optimization of the experimental setup and the validation of the testing procedure. After that, the fatigue behavior of the joints will be tested in different aggressive environments. This study pointed out that it is possible to build a simple and low-cost setup for the study of fatigue corrosion behavior of dissimilar joints while exploiting in situ electrochemical measurements to follow the fatigue corrosion process.

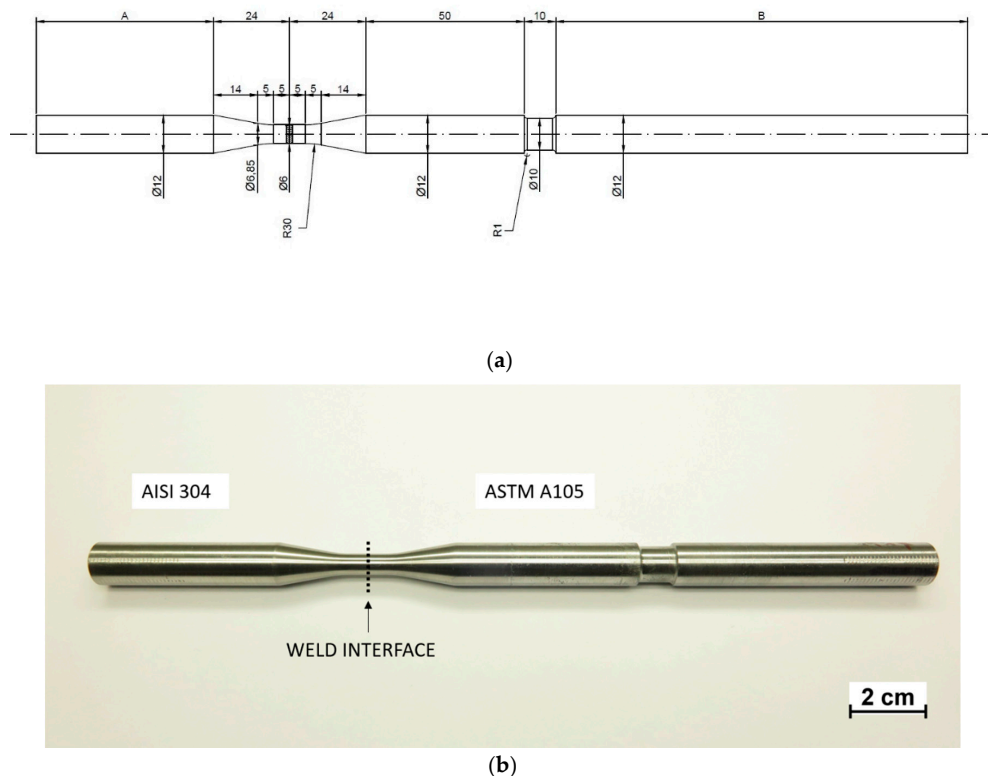
Figure 1. (a) Selected specimen design for fatigue tests (unit: mm); (b) image of the as-made sample.

The samples were produced by Tomet MECHANICS (Castelgomberto, Vicenza, Italy) joining a 21 mm diameter rod of ASTM A105 steel with an 18 mm diameter rod of AISI304 stainless steel. The samples were produced through the rotary friction welding technique. The as-provided samples needed further turning operations to achieve a shape suitable to be tested in fatigue experiments. The samples were lathe machined and then grinded until reaching a surface roughness value of about 2 μm (R_a). The final design of the samples was developed after preliminary tests in a universal testing machine (UTM), starting from the one suggested by the UNI EN ISO 11782-1 standard [33]. The specimen cross section in the welded area was reduced to about one third of the original so as to avoid influences of surface defects and to reduce the load bearing capability within the allowable ranges of the UTM used during fatigue testing. The weld is located approximately in the middle of the investigated cylindrical volume, having 6 mm diameter cross section and 10 mm length. A large fillet radius and a smooth bevel transition up to the 12 mm diameter of the cross section in the gripping regions was realized, in order to avoid the risk of failure localization at the fillet's base. The recess in the shaft was made in order to ease the sealing of the electrochemical cell. A sketch of the final sample geometry is reported in Figure 1.

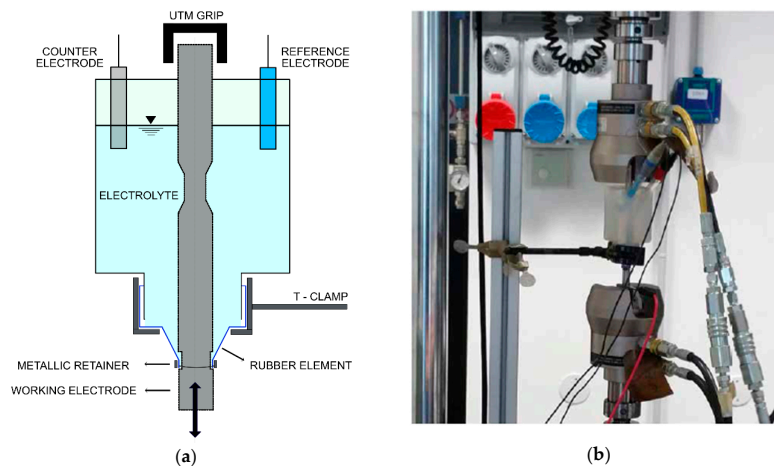
Figure 2. (a) Electrochemical cell design; (b) photograph of the experimental setup.

In order to exploit corrosion fatigue tests and apply a given potential to the specimens, it was necessary to develop an easy-to-build electrochemical cell, paying attention not to interfere with the fatigue tests and to avoid electrical contact between the samples and the testing apparatus. The design of the cell accounted for various factors, such as the ease to be built, to be operated, and to be replaced as well. The possibility of easily building and replacing the cell allows performing customizable tests. Figure 2 shows a sketch of the electrochemical cell and a photograph of the experimental setup.

The first challenge to be overcome arose since the hydraulic actuator of all UTMs available in the lab displaces the bottom grip of the specimen holder, thus making it impossible to position the cell on the bottom grip of the UTM. This problem was solved by providing the electrochemical cell an external support, realized with a T structure anchored on the bottom plate of the UTM and provided with an adjustable prong clamp. The second challenge consisted of guaranteeing a static waterproof seal between the cell and the specimen; very compliant polymeric elastic tubular elements were fixed to the cell and the specimen using mechanical retainers (steel cable ties). As a solution container, a polyethylene (PE) 200 mL flask three times wider in diameter with respect to the specimen was chosen. Holes were cut in the cap of the flask and in the bottom of the flask to allow the specimen to pass through. Two small holes were provided in the flask to support the electrodes without the need to use external supports.

The electrochemical cell, mounted around the specimen, was also useful to perform reference electrochemical measurements and thus interpret the time-current data that will be collected during corrosion fatigue experiments. These measurements were carried out with the same parameters used

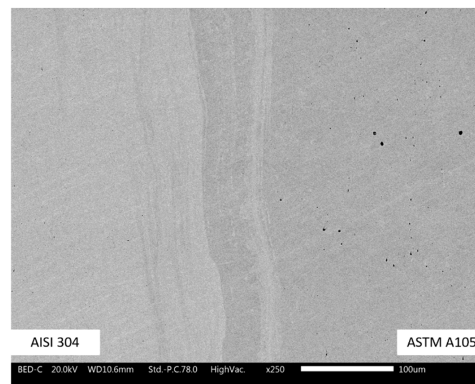
Figure 3. Scanning electron microscopy image of the welded specimen interface.

Figure 3 shows a SEM micrograph of the welded specimen interface. On the left the AISI 304 stainless steel, on the right side the ASTM A105 carbon steel. The interface between the two materials is not straight and continuous, but there is a gradual intermixing of the two steels, due to the rotary friction welding process. In addition to that, it is possible to highlight the presence of some black precipitates in the carbon steel side. The composition of the precipitates is not constant, but they are mainly composed of carbon, sulphur, molybdenum, and manganese.

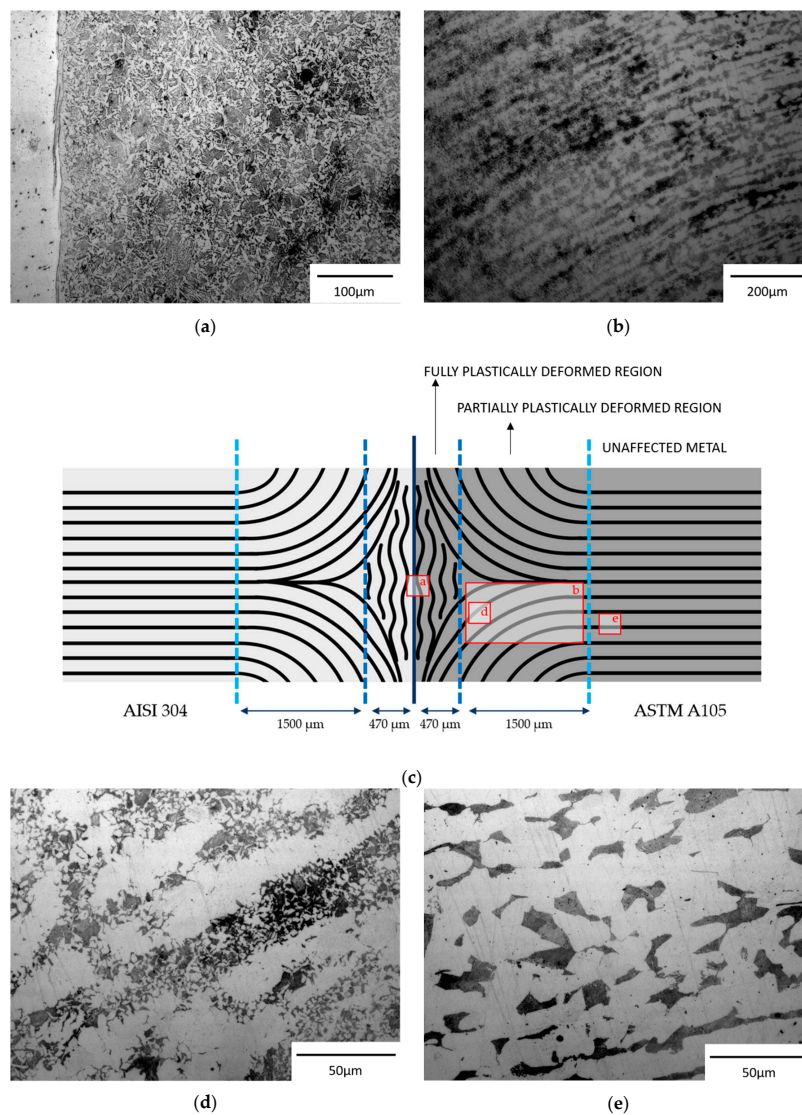
Figure 4. Optical images of the welded sample microstructures. (a) Interface region (AISI 304 on the left side and ASTM A105 on the right side of the interface); (b) intermediate region; (c) schematic representation of the sample; (d) intermediate region at high magnification; (e) base metal.

Figure 4 shows optical micrographs of the specimen interface. Welding defects, such as porosities and cracks are not present, thus underlining the good quality of the welding process. The dissimilar joint microstructure can be classified in three different regions. The first region, astride the interface and with an extension of 470 μm on either side of the interface, is the fully plastically deformed region. This region contains very fine small recrystallized grains of ferrite and perlite [36]. It is well known that pressure used to join the materials results in recrystallization leading to a grain refinement in the central region of the weld [37]. The second region is constituted by an area of the sample which underwent a partial plastic deformation; here the grains are larger than in the first region near the interface, but their shape is modified and stretched along the load axial direction. Its structure is constituted by ferrite

and perlite, as already reported for medium-carbon steels which underwent rotary friction welding processes [38]. The extension of this area is 1500 μm . The third area is represented by the undeformed base material microstructure, consisting of ferrite and perlite.

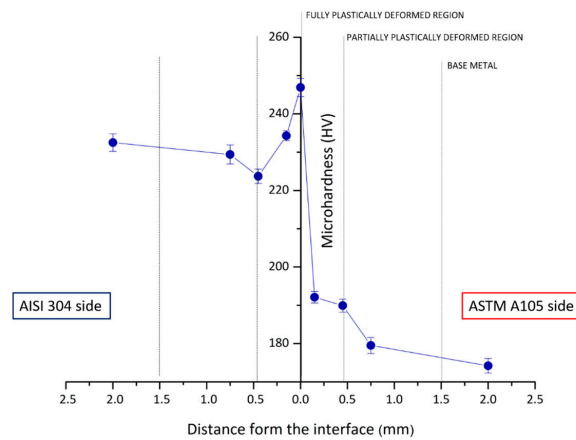
Figure 5. Vickers hardness distribution through the weld interface.

Figure 5 shows the longitudinal hardness measurements distribution of the test specimen. Hardness was measured across the weld interface, from 2.0 mm left and right on the AISI 304 and ASTM A105 metals.

A maximum hardness of 247 HV has been obtained at the weld interface. The increase in hardness at the welding interface is probably due to friction and oxidation processes which take place during welding processing. Similar hardness measurements were obtained by [36] for the AISI 304 stainless steel base metal and for the weld interface of AISI 304 stainless steel—mild steel friction welded joints. Other studies [13,39] report also higher values for dissimilar joints with 304 stainless steel.

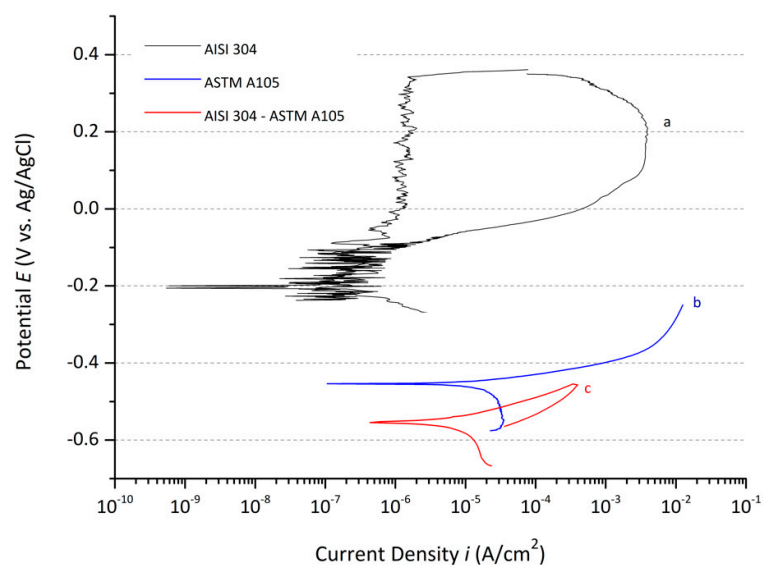
Figure 6. Potentiodynamic polarization curves in a 3.5 wt% NaCl solution of: (a) AISI 304; (b) ASTM A105; (c) welded AISI304—ASTM A105.

The curve (a), relative to the AISI 304 specimen, starts in the cathodic region, it reaches the corrosion potential (-0.206 V vs. Ag/AgCl) and then, it goes through the passivation region, where an

increase of the potential does not imply a variation of the current density. When the breakdown potential is reached (+0.355 V vs. Ag/AgCl) the curve rapidly deviates to higher values of the current density and corrosion takes place. Beyond this potential the pitting phenomenon is stable, and the material is not able to reform a permanent passivity layer anymore. The return scan clearly highlights the hysteresis phenomenon, that implies no immediate repassivation of the metal surface, in fact it is necessary to reach a potential lower than the breakdown potential for the passive layer to onset again. The curve (b) represents the linear polarization curve of the ASTM A105 specimen. At the lowest potential values, it is possible to identify the cathodic region under diffusion control, due to the oxygen reduction. After passing the corrosion potential of the material (−0.454 V vs. Ag/AgCl) the anodic current starts to arise. The corrosion rate of the carbon steel specimen increases with the potential, as typical of an alloy in an active state and no passivation tendency. The curve (c) represents the potentiodynamic polarization curve of the welded AISI 304—ASTM A105 sample. The shape of the curve is very similar to the one of the ASTM A105 specimen, but the corrosion potential is shifted to lower values (−0.554 V vs. Ag/AgCl). The electrochemical situation is very complex, as the sample is constituted by three different zones: The stainless steel region, the carbon steel region, and the welding area, which has a different composition with respect to the plain steels. A galvanic coupling between AISI 304 and ASTM A105 with the increase of anodic current density due to increase of corrosion rate of carbon steel was expected. The presence of a mixed phase with modification of the microstructure seems to further worsen the specimen behavior. This fact can be explained considering that the welding process produced phases with a different composition with detrimental effects on the corrosion response.

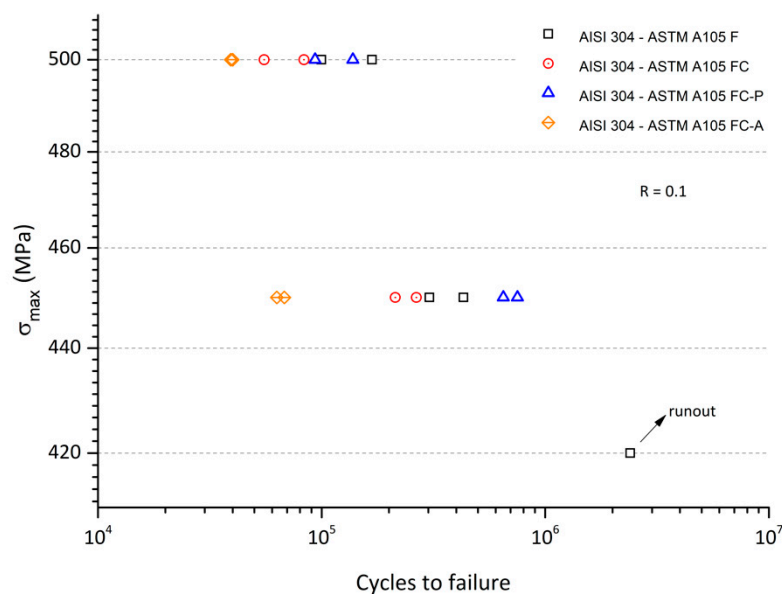
Figure 7. S-N curves for AISI304—ASTM A105 welded specimens under different testing conditions.

The results obtained by the fatigue testing of welded AISI304—ASTM A105 samples under different conditions: Fatigue in air (F), fatigue corrosion (FC), protected fatigue corrosion (FC-P), and accelerated fatigue corrosion (FC-A) are plotted in Figure 7. Fatigue tests started in such a way that the first tests were carried out at stress levels near but lower than the tensile strength (580 MPa) of the stainless steel [40] and carbon steel (min. 485 MPa) [41]. The stress levels were also selected to have single test durations less than 50 h each.

The fatigue tests in air (F) were carried out at three different loading conditions. The most severe loading condition resulted in a lower number of cycles to failure whereas the progressive reduction

of the loading led to longer sample lives. The specimen tested at the lower stress level has survived two million cycles, thus suggesting a transition from finite life regime to a fatigue limit. A further investigation in this stress range was beyond the scope of this research also considering the limited number of samples available. The FC, FC-P, and FC-A tests were carried out at the two more severe loading conditions. The presence of an aggressive environment led to a detectable decrease of the fatigue life. The imposition of the anodic potential drastically reduced the specimen's life due to the strong corrosion attack on the specimen. On the other side, the cathodic protection seems to exert a positive influence on the fatigue behavior by enhancing the fatigue life at the lower stress level up to values higher than those obtained for tests in a non-aggressive environment.

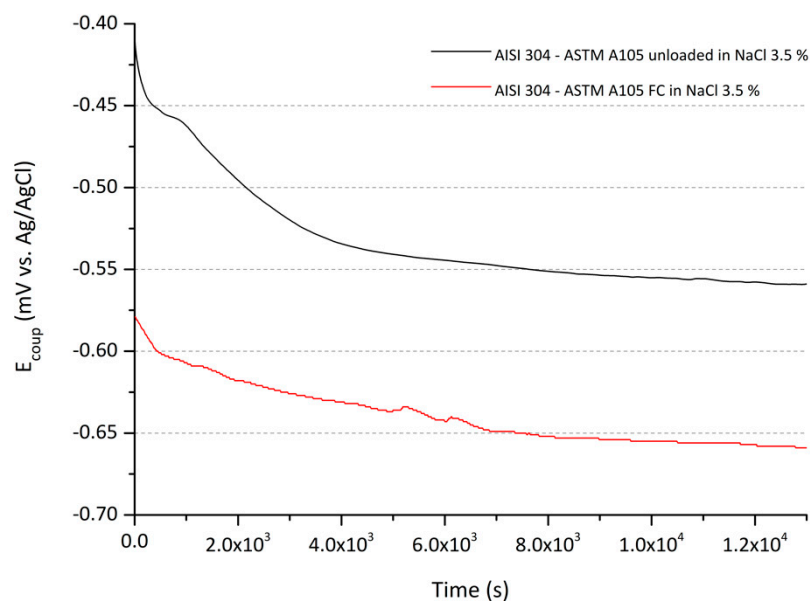
Figure 8. Potential evolution over time of coupled AISI304—ASTM A105 in a 3.5 wt% NaCl solution unloaded sample and on a loaded sample tested to fatigue corrosion at 500 MPa.

In order to have further insights on the electrochemical behavior of the samples during fatigue testing conditions, galvanic coupling tests were performed on the unloaded (reference) sample as well as on the loaded sample during the fatigue corrosion tests. Figure 8 represents the evolution of potential over time of coupled AISI 304—ASTM A105 in a 3.5 wt% NaCl solution for the two conditions.

Looking at the galvanic coupling potential of the unloaded sample, it is possible to observe that it reached a stable state after a transient. This behavior can be explained considering that the two alloys have a different behavior in the environment, thus, the transient regime represent the on-set of different corrosion mechanisms. In the case of an applied load, thus during fatigue corrosion experiments, the potential of the galvanic couple approaches more negative potentials with respect to what happens for the unloaded samples. This is clearly caused by the mechanical stress: Cyclic loading seems to activate the system and enhance corrosion mechanisms.

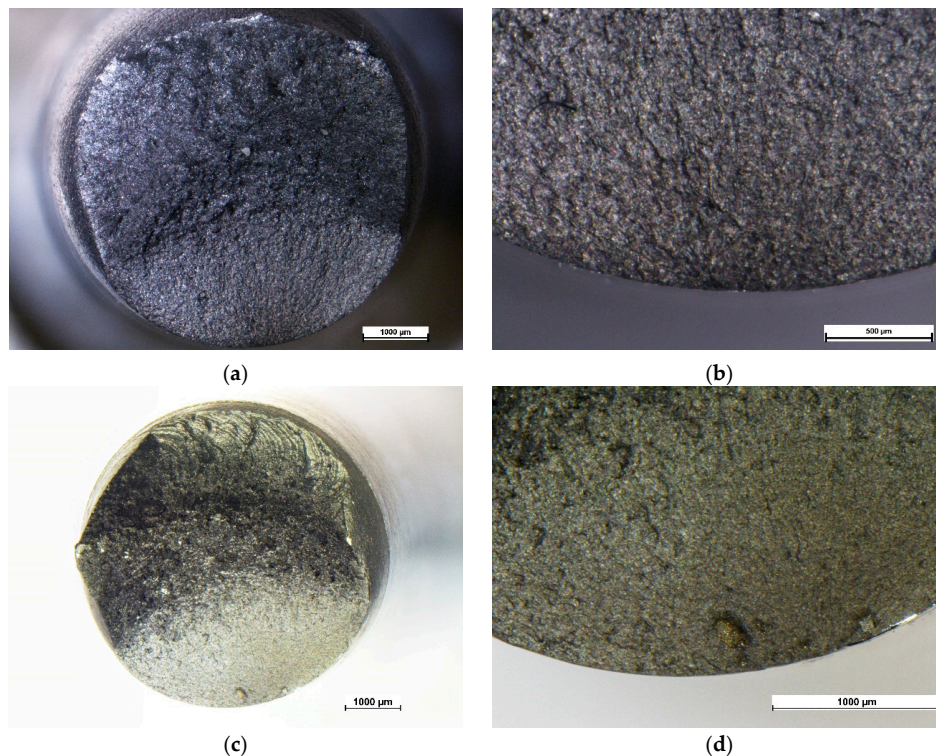
Figure 9. Optical images of the fracture surface of a welded AISI304—ASTM A105 specimen tested to fatigue in air (F) (a) Top view of the sample fracture surface tested at 500 MPa; (b) close-up of the fatigue fracture surface and crack nucleation area of the sample (a); (c) top view of the sample fracture surface tested at 450 MPa; (d) close-up of the fatigue fracture surface and crack nucleation area of the sample (c).

Figure 9 shows the fracture surface of two different AISI304—ASTM A105 specimens tested by fatigue in air. Figure 9a shows the presence of two different areas: The fatigue fracture area at the bottom of the sample, containing the origin where the fatigue cracks started and the unstable fracture area on the top (also called “sudden fracture zone”) [42]. It is possible to observe that the crack probably originated in a different plane with respect to the plane where the crack propagated, and this fact is highlighted by the presence of a shadow in this area. The sudden fracture area, on the contrary, is characterized by a higher roughness, because of the sudden propagation that led to the specimen failure. The same observations are valid for the sample tested at 450 MPa, shown in Figure 9c,d. The samples both failed in the region plasticized during welding at about 1 mm from the interface.

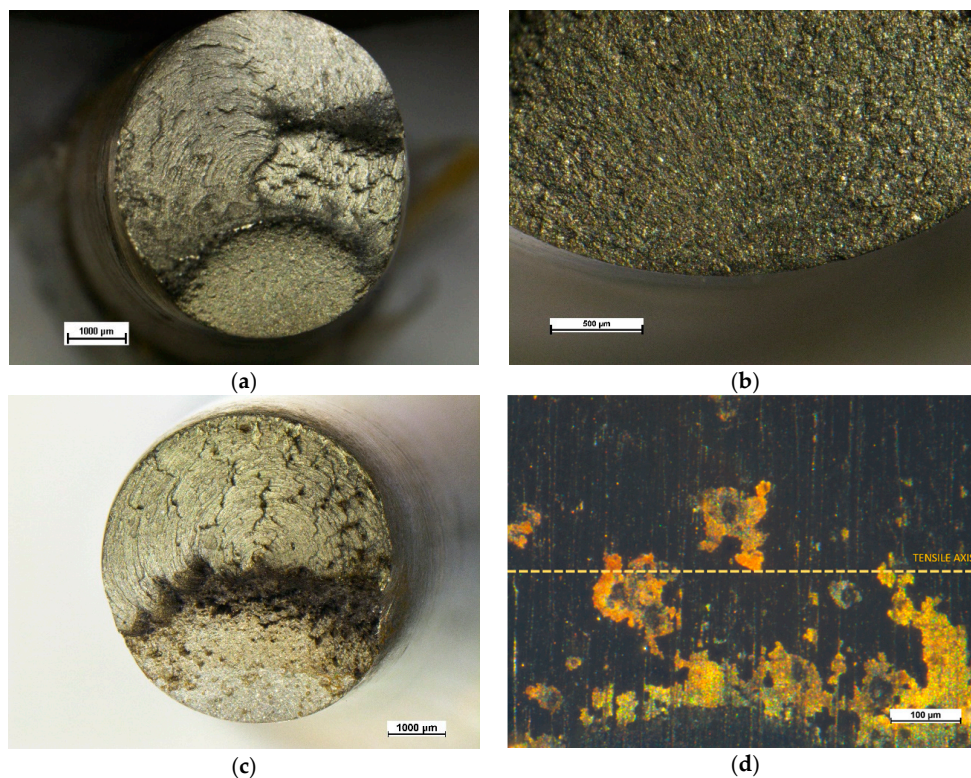
Figure 10. Optical images of the fracture surface of a welded AISI304—ASTM A105 specimen tested to fatigue corrosion (FC): (a) Top view of the sample fracture surface tested at 450 MPa; (b) close-up of the fatigue fracture surface and crack nucleation area of the sample (a); (c) top view of the sample fracture surface tested at 450 MPa; (d) external surface of the sample in (c) near the fracture surface.

Figure 10 shows the fracture surface of two different AISI304—ASTM A105 specimen tested to FC in a 3.5 wt% NaCl solution. The fatigue fracture area is very limited in dimension with respect to one of the samples tested to FA and the transition to the unstable fracture area is very marked. The unstable fracture area is characterized by the presence of circular lines, due to the rotary friction welding process: This fact gives some information about the failure mode of these specimens, as the unstable fracture area is very near to the weld interface. In addition to that, it is also possible to observe that only one main fracture plane was identified in the analyzed samples and the fracture happened at 0.75 mm from the weld interface. The behavior of the specimens and their lower fatigue cycle number resistance is probably related to the aggressive environment that weakened the specimen causing a localized corrosion attack, as it is possible to see in Figure 10d. In addition to that, it is also possible to observe that only one main fracture plane was identified in the analyzed samples.

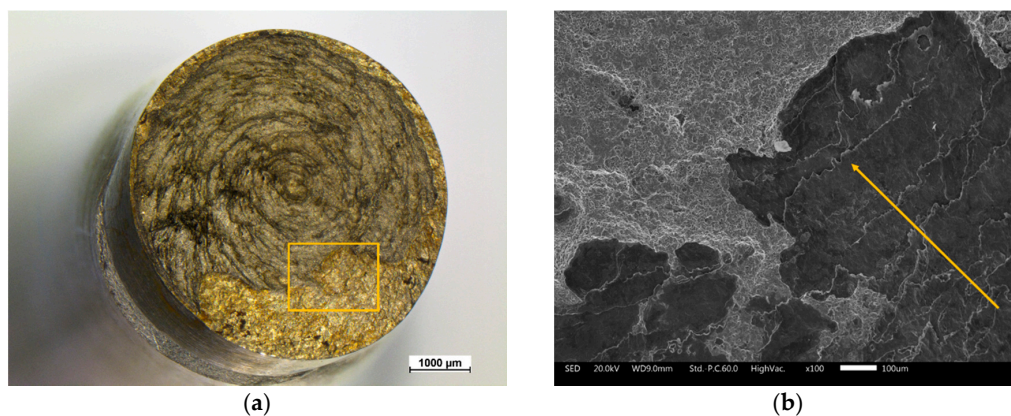
Figure 11. (a) Optical image of the fracture surface of a welded AISI304—ASTM A105 specimen tested to protected fatigue corrosion (FC-P); (b) SEM micrograph of the area in between the fatigue fracture surface and the brittle fracture surface.

Figure 11 shows the fracture surface of an AISI304—ASTM A105 specimen tested to corrosion fatigue in a 3.5 wt% NaCl solution with cathodic protection (FC-P). The cathodically protected specimen shows a behavior similar to one of the specimens tested in air: The transition from the fatigue fracture area (at the bottom of the sample) to the unstable fracture area is smoother with respect to those of the FC tested specimens. Figure 11b shows a detail of the area between these two regions: It is possible to identify the typical progression marks present in the samples tested to fatigue [41]. The failure of the sample happened at about 50 µm from the interface, as evident from the structure of the failure surface.

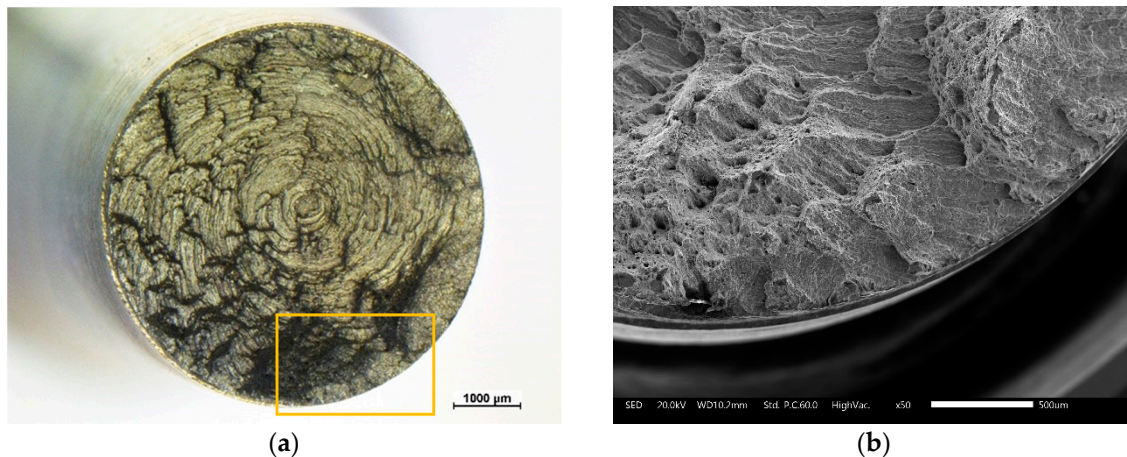
Figure 12. (a) Optical image of the fracture surface of a welded AISI304—ASTM A105 specimen tested to accelerated fatigue corrosion (FC-A); (b) SEM micrograph of the area in between the fatigue fracture surface and the unstable fracture surface.

Figure 12 shows a welded AISI304—ASTM A105 specimen tested to accelerated corrosion fatigue in a 3.5 wt% NaCl solution. The behavior of the accelerated test samples was different, and most of the failure originated from the ASTM A105 side. The sudden fracture area is very irregular, and the fatigue fracture area is very limited in dimension, as is possible to see from Figure 12b.
