## The Cartis Form for the Seismic Vulnerability Assessment of Timber Large-Span Structures

**Abstract:** Italy is located in a very active seismic zone, and many earthquakes have marked the country, some of them in the recent past. In order to take adequate measures of seismic prevention and protection, in the last decades, the Italian Civil Protection Department (DPC) initiated a survey and introduced a specific form for the quick and/or post-seismic assessment of buildings. This is useful to obtain statistics on the types of structures and their vulnerability and a judgement on the damage, leading to a decision about the possibility of reuse and/or the level of retrofitting to be applied. Those activities have been developed since the beginning of 2000. This task is currently carried out by the Italian DPC-ReLUIS project research, line WP2 on the inventory of building structures, setting up the CARTIS form for any structural type, like masonry, reinforced concrete, precast concrete, steel, and timber structures, the latter being mainly related to large span buildings, extensively used in Italy. In this context, the paper presents the first draft of the CARTIS form for large spa

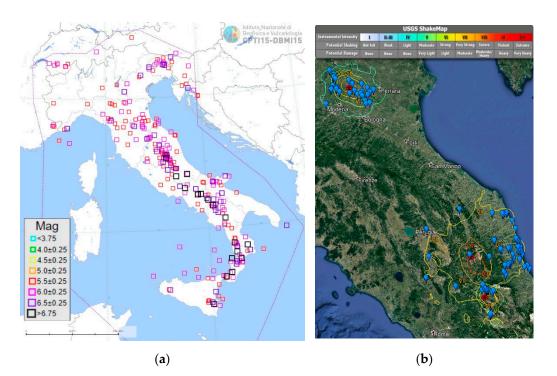
**Figure 1.** (a) Epicenters of the Italian earthquakes with moment magnitude greater than 5.5 in the period 1000–2014 and (b) sample distribution in Italy as respect to the intensity contours of Abruzzo 2009, Emilia 2012, and central Italy 2016 earthquakes.

The sample represents the structures built in the period 1981–2014. In order to identify the seismic zone in the national context, in Figure 1a, the epicenters of Italian earthquakes with a magnitude greater than 5.5 in the period 1000–2014 are shown. The distribution of the case studies on the territory is shown in Figure 1b, taken from the ShakeMap service provided by the National Institute of Geophysics and Volcanology (INGV), which shows the intensity curves of earthquakes.

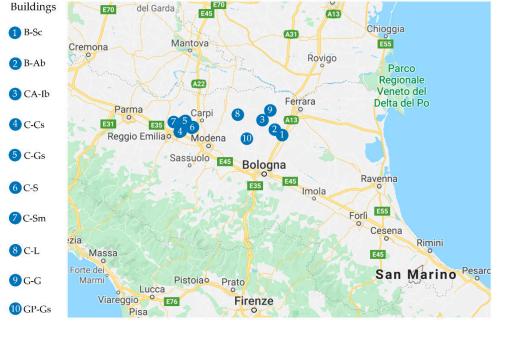
Figure 2. The sample of buildings.

In particular, the following 10 structures were analyzed in this work (Figure 2):

- (1) Bentivoglio—Shopping center (B-Sc);
- (2) Bentivoglio—Agricultural building (B-Ab);
- (3) Castello d'Argile—Industrial building (CA-Ib);
- (4) Correggio—Canteen of the Marconi state secondary school (C-Cs);
- (5) Correggio—School gym of the Luigi Einaudi Technical Institute (C-Gs);
- (6) Correggio—S. Francesco di Assisi State Primary School (C-S);
- (7) Correggio—Supermarket (C-Sm);
- (8) Crevalcore—Laboratory (C-L);

Looking at the utilization of these structures (Figure 2), agricultural or commercial buildings and school gyms represent 65% of the sample; the remaining part consists of sports halls, auditoriums, tourist centers, and other destinations of use. The information retrieved for each structure was detected from the documents provided by Rubner Holzbau, the executive drawings in every case, and the technical reports when needed.

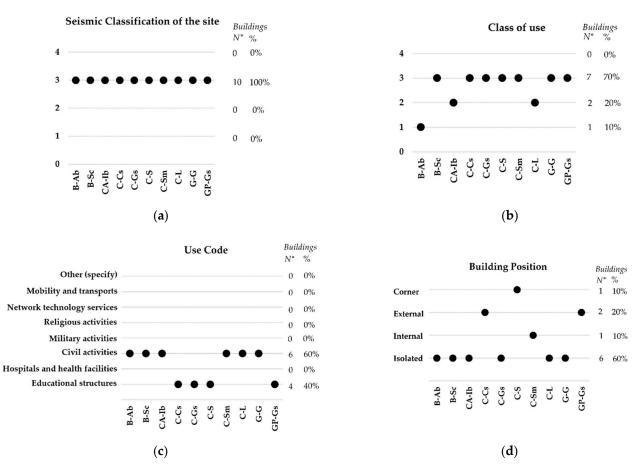
The construction is localized through the ISTAT (National Institute of Statistics) codes. It is possible to associate the construction site with the Italian seismic zones. The classification into seismic zones is available on the "Civil protection" website [20] through the document "Seismic classification by municipality 2020". All the buildings analyzed (100%) belonging to the sample are in seismic zone 3, based on the seismic classification of the Italian territory (with Peak Ground Acceleration, PGA, ranging between 0.05 and 0.15 g) (Figure 8a).

**Figure 8.** Section 0 CARTIS-Building. Location and Building Identification Data: (**a**) Seismic classification of the site; (**b**) Class of use of the building; (**c**) Use code of the building; and (**d**) Building position.

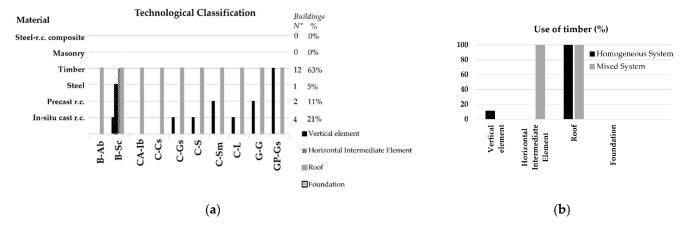
In Figure 10a, the material of the structural elements identified in the form is indicated for each case study. The structural system is recognized as mixed if it has structural elements with different materials. In particular, the vertical elements are made of r.c. for four out of 10 buildings (40%), in precast r.c. for two out of 10 buildings (20%), in steel for one out of 10 buildings (10%) and in timber for one out of 10 buildings (10%). Only one out of 10 buildings (10%) has a timber intermediate floor. In nine buildings (90%) the roofs are characterized by a timber structure, while one building (10%) has a mixed steel and timber structure. The foundations of the buildings are just assumed as in reinforced concrete, since they cannot be inspected at this level of analysis. The percentages shown in Figure 10a refer to the total number of structural elements made with the same technology (i.e., material). Therefore, 63% of the identified structural elements are made of timber, 21% of r.c., 11% of precast r.c., and 5% of steel. In the same figure, the type of element, such as vertical or horizontal intermediate elements, roof, or foundation, is reported through different columns for every case study related.

For evaluating the use of timber as a structural material for the building elements, the corresponding percentages are shown in Figure 10b, distinguishing both homogeneous and mixed systems.

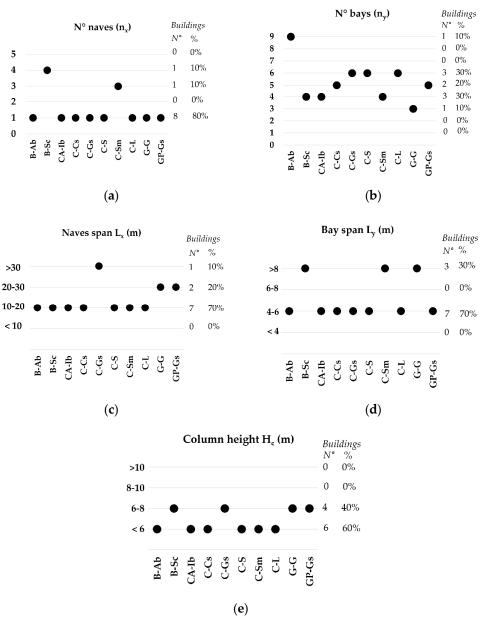
**Figure 12.** Section 1B CARTIS-Building. Structural grid parameters: (**a**) Number of naves; (**b**) Number of bays; (**c**) Naves length; (**d**) Bay span; (**e**) Column height.

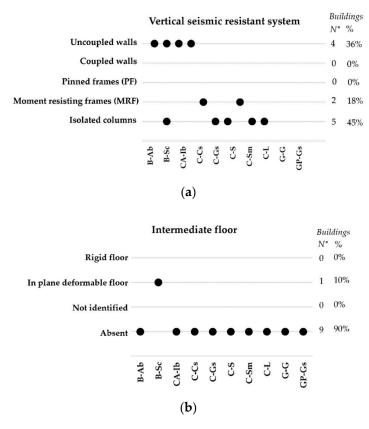
Figure 13a shows the vertical seismic-resistant system. In particular, for three out of 10 buildings (30%) it consists of uncoupled walls; for one out of 10 buildings (10%) of uncoupled walls and isolated columns; for four out of 10 (40%) of isolated columns; and for two out of 10 buildings (20%) of moment resisting frame.

**Figure 13.** Section 1B CARTIS-Building. Vertical structural system and relationship with intermediate floors: (**a**) Vertical seismic-resistant structure; (**b**) Intermediate floor.

Figure 13b shows the types of intermediate floors, which are mainly absent in the sample analyzed, since nine out of 10 buildings (90%) are single-story. One building (10%) is characterized by an in plane deformable floor.

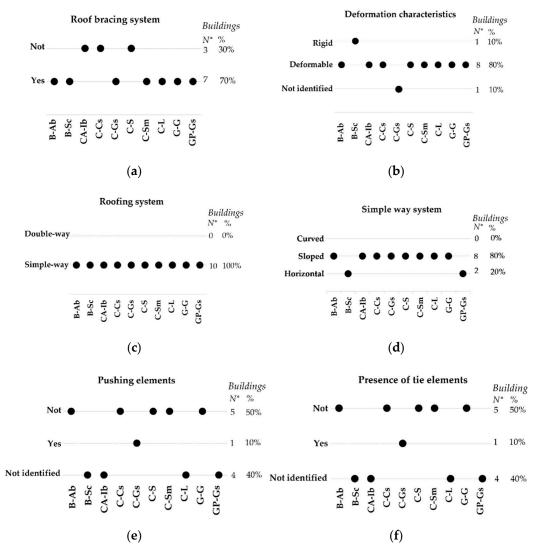
Figure 14a indicates the presence or absence of a roof bracing system. In particular, seven out of 10 buildings (70%) have a bracing system, and three out of 10 buildings (30%) do not.

Figure 14b shows the deformation characteristics of the roofing structure. In particular, eight buildings out of nine (89%) have a deformable system, and one building out of nine (11%) has a rigid system; for a building these data were not given. Figure 14c,d shows the type of roofing system: all the buildings (100%) have a simple-way system, two out of 10 are horizontal (20%), and eight out of 10 (80%) are sloped. Figure 14e,f shows the presence of pushing elements and their possible combination with tie elements. Data are not given for four buildings, for the remaining six buildings, one building (10%) has pushing elements but it has tie beams, five buildings, 50%, do not have pushing elements therefore do not have tie elements.

**Figure 14.** Section 1B CARTIS-Building. Roof: (**a**) Roof bracing system; (**b**) Deformation characteristics; (**c**) Roofing system; (**d**) Shape of the roof; (**e**) Pushing elements; (**f**) Presence of tie elements.

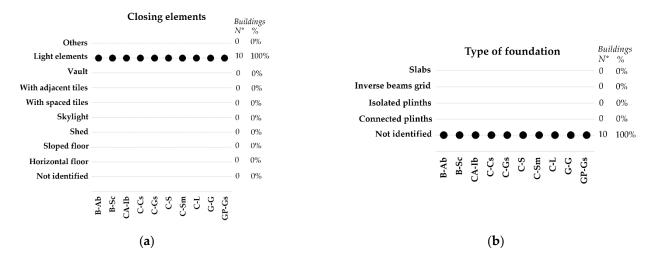
For all the analyzed buildings, it was not identified (Figure 15b).

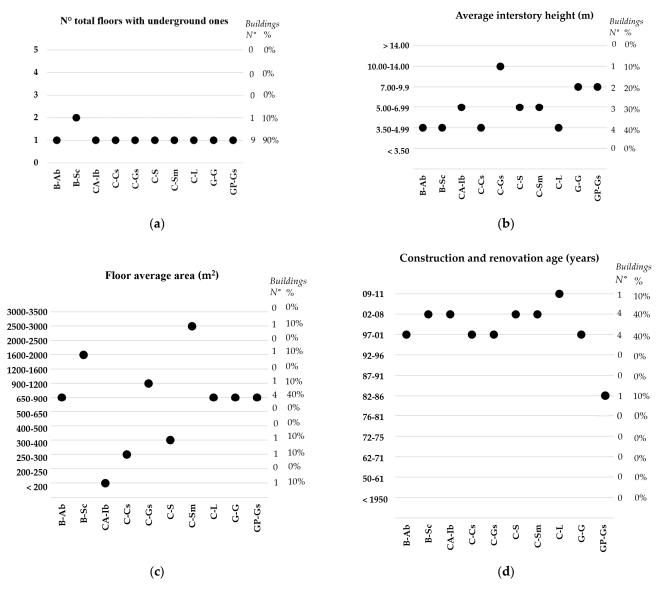
Figure 17a shows the number of total floors including the underground floors for each case study. Since there are no underground floors in any building analyzed, the number of floors shown in the figure corresponds to the number of floors above ground. In particular, nine out of 10 buildings (90%) are single-story and one out of 10 buildings (10%) has two stories.

**Figure 17.** Section 2A CARTIS-Building. Metric data: (a) Number of floors including the underground ones; (b) Average inter-story height; (c) Floor average area; (d) Construction and renovation age.

Figure 17b shows the average inter-story height for each case study, which for singlestory buildings can be assumed to be the total height of the buildings, as well as to the maximum height of the column. In particular, the height ranges between 3.5 and 4.99 m for four out of 10 buildings (40%), between 5 and 6.99 m for three out of 10 buildings (30%), between 7 and 9.99m for two out of 10 buildings (20%); and between 10 and 14 m for one building out of 10 (10%).

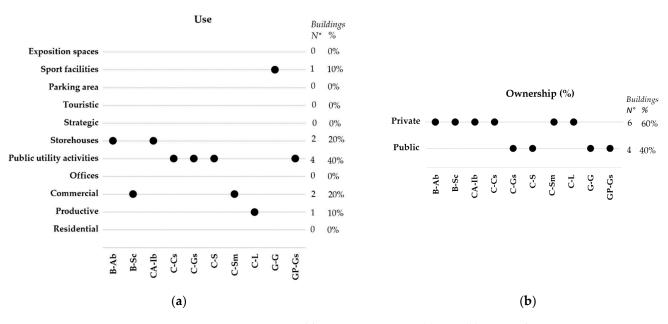
Figure 18a shows the use of the buildings specified for each case study. In particular, four out of 10 buildings (40%) host public utility activities (schools), one out of 10 buildings (10%) is a sports facility, two out of 10 buildings (20%) are storehouses, two out of 10 buildings (20%) are supermarkets, and ones out of 10 building (10%) hosts productive activities (industry). Furthermore, the percentage of use, for all buildings, is greater than 65%; however, it is not possible to define the number of occupants and the maximum number of people inside the building.

Figure 18. Section 2A CARTIS-Building. Use-Exposure: (a) Use; (b) Ownership.

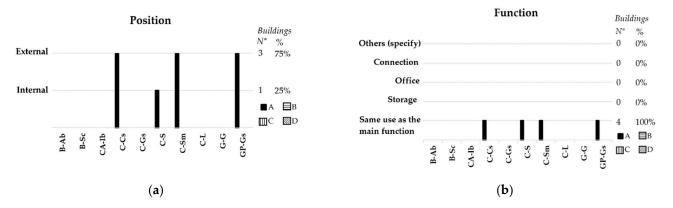
The section is divided into four parts, each one corresponding to an added block: A, B, C, and D (Figure 20). With reference to the analyzed sample, four out of 10 buildings (40%) have one added block. Figure 20a shows the position of the block as respect to the main structure. In particular, for three buildings out of four (75%) the block is external to the main structure; for one building out of four (25%), the block is internal.

Figure 20. Section 2B CARTIS-Building. Added block ID: (a) Position; (b) Function.

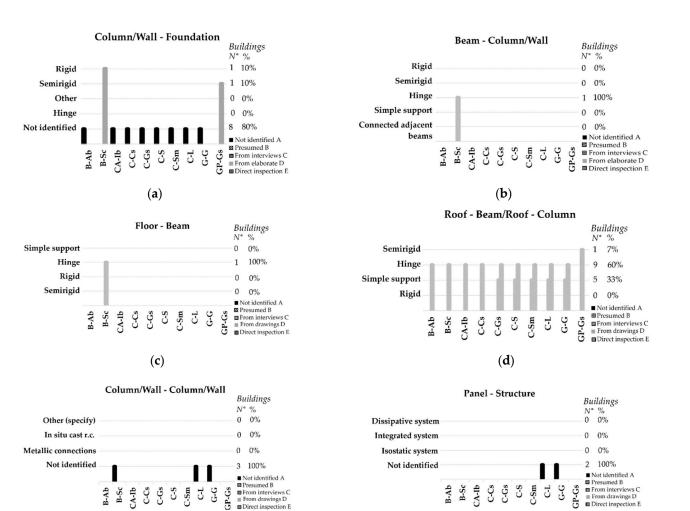
Connections are divided into six categories referring to the connected structural elements: column/wall to foundation, beam to column/wall, floor to beam, roof/beam to roof/column, column/wall to column/wall, and panel to structure. For each type, the method of investigation is indicated, such as how the information was achieved (not identified, presumed, from interviews, form drawings, or direct inspection), as well as the type of constraint expressed by the connection (hinge, semirigid, or rigid, Figure 22).

For the constructions analyzed, most of the information is related to the connections between roofing elements and between these last ones and the vertical structural system. In particular, for the "column/wall to foundation" connections (Figure 22a), for eight out of 10 buildings (80%), it was not possible to identify the type of connection, one out of 10 buildings (1%) has a rigid connection, and one out of 10 buildings (1%) has a semirigid connection; for the "beam to column/wall" (Figure 22b) and "floor to beam" (Figure 22c) connections, data are available for only one building (for the others it has not been detected), which has a hinge-type connection; for the "roof to beam/roof to column" connections (Figure 22e), nine out of 10 buildings (90%) have hinge-type connections, and among them five buildings (50%) also have simple supports; 1 out of 10 buildings (10%) have semirigid connections. For the "column/wall to column/wall" connections, data were only found for three out of 10 buildings, for which the type of connection was not identified (Figure 22f); for the "panel-structure" connections, data were found only for two out of 10 buildings, in which the type of connection was not identified (Figure 22f);

**Figure 22.** Section 2C CARTIS-Building. Connections: (a) Column/wall to foundation; (b) Beam to column/wall; (c) Floor to beam; (d) Roof to beam/roof to column; (e) Column/wall to column/wall; (f) Panel to structure.

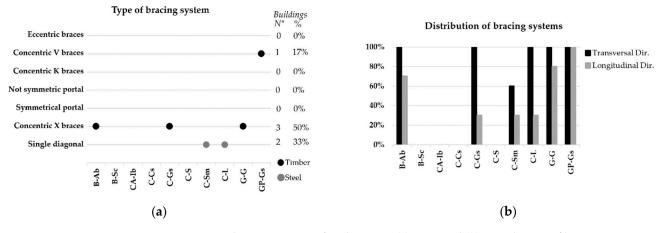
Figure 23b shows the distribution of the bracing systems in the longitudinal and transverse directions for each of the six buildings. In particular, in the transverse direction, five out of six buildings (83%) have braces on 100% of the length and one out of six buildings (17%) has braces on 60% of the length; in the longitudinal direction, one out of six buildings (17%) has braces on 100% of the length, one out of six buildings (17%) has braces on 80% of the length, one out of six buildings (17%) has braces on 80% of the length, one out of six buildings (17%) has braces on 70% of the length, and three out of six buildings (50%) have braces on 30% of the length.

Figure 23. Section 3D CARTIS-Districts. Characterization of timber type: (a) Type and (b) Distribution of bracing systems.

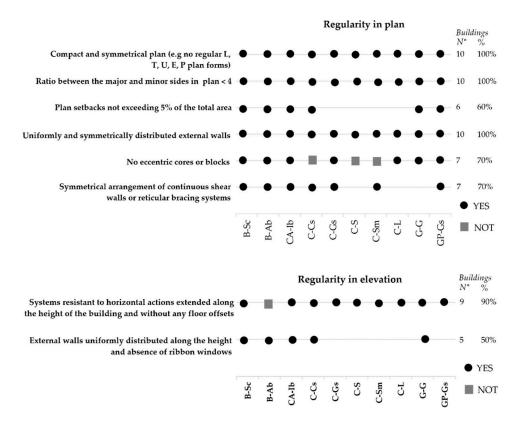
Figure 26. Section 3 CARTIS-Building. Other information: Regularity in plan and in elevation.

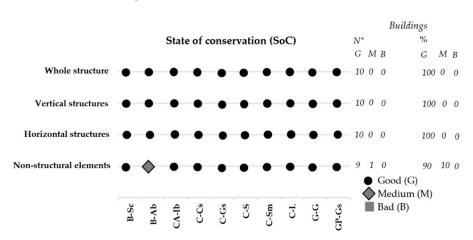
The state of conservation is specified in Figure 28 for each case study. It is worth noticing that the evaluation has been carried out simply by phone interviews to the buildings' owners or managers, asking them to describe the overall state of conservation of vertical and horizontal structures, as well as of the non-structural elements. The state of conservation has been evaluated as good, medium, or bad, and if there is no notice of damage, or notices of damage not compromising the functionality of the buildings, or notices of damages compromising the functionality of the building, were given, respectively. In particular, all buildings have a good state of conservation of the structures. As for non-structural elements, nine out of 10 buildings (90%) have a good state of conservation.

Figure 28. Section 3 CARTIS-Building. Other information: State of Conservation (SoC).
