# The case study of a brittle failure of a mountain bike frame composed by carbon fiber reinforced plastic

## Abstract

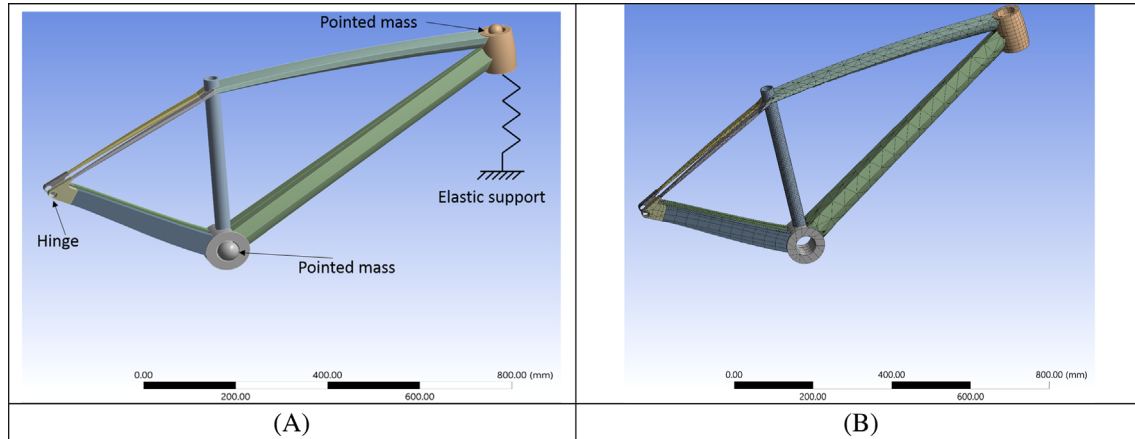
**FIGURE 10** (A) Applied boundary conditions. (B) Adopted mesh.**TABLE 5** Properties of the pointed masses.

fork is  $A = 2.18 \times 10^{-3} \text{ m}^2$  thus as  $K_f = K/A$  (Table 8). Figure 10B and Table 9 report the adopted mesh. The computed natural frequencies are reported in Table 10 and, due to the driver position/man mass real distribution and measured low elastic modulus, are observed quite low, from 3 up to 111 Hz for the first 6 modes, Figure 11A–F. Note that mode 4 has a frequency around 68 Hz and is thus compatible with a resonance imposed by the wavy nature of the grass and cycling velocity (previously computed as 69 Hz); also note that the related mode shape (Figure 11D) has the maximal relative displacement in the region of the observed fracture. We cannot thus exclude that the observed severe defects were further weakened by interaction with a dynamic resonance.
