# Engineering Failure Analysis

## General durability criteria for exposed timber structures based on the analysis and inspection of bridges and observation towers

<https://doi.org/10.1016/j.engfailanal.2026.110986>

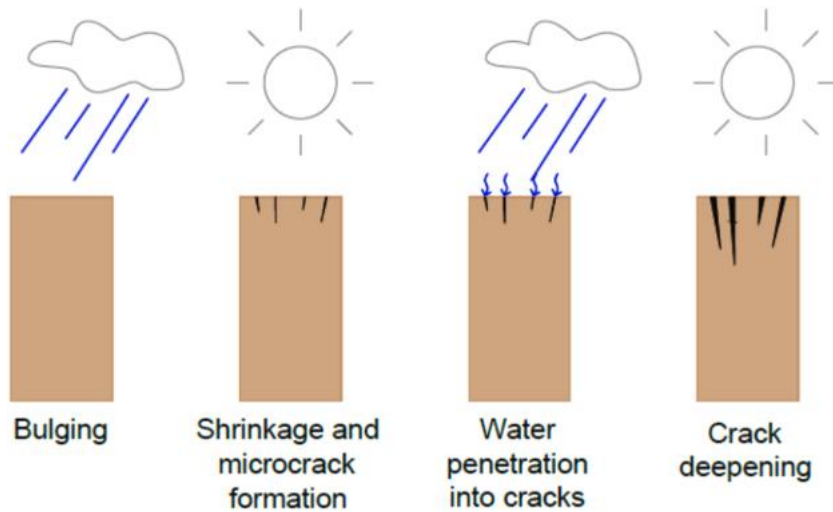
Wood cracks are inevitable, yet they can be designed to avoid becoming preferential paths for water ingress and retention, by orienting them to facilitate water runoff and/or reducing their width and frequency. On horizontal surfaces or where water runoff is slow, the combined action of rain and solar radiation produces cycles of swelling and shrinkage that gradually create deeper cracks, allowing water to penetrate and accumulate in the inner layers of the timber, as shown in the Fig. 10. In solid timber, proper drying is important to limit large cracks and elements should be oriented so that cracks face the less exposed sides. In glued laminated elements, the upper boards can be placed with the pith upwards so that cracks develop on the underside. Beam ends are particularly sensitive and should be tapered or inclined to reduce cracking. Round timber also tends to develop wide cracks, for which anti-cracking relief cuts can help reduce their size and frequency. Table 9 summarises such scenarios. In general, the relationship between cracking and durability is rarely addressed in the literature, making it an interesting topic for further experimental studies to better understand how crack management can affect water and vapor diffusion in timber and ultimately its durability.

Fig. 10. Formation and propagation of cracks.
