PROCEEDINGS OF  
7th INTERNATIONAL CONFERENCE ON  
STRUCTURAL HEALTH ASSESSMENT OF  
TIMBER STRUCTURES

# Proceedings of the SHATIS 2025 – 7th International Conference on Structural Health Assessment of Timber Structures

3rd – 6th September 2025, Zagreb, Croatia

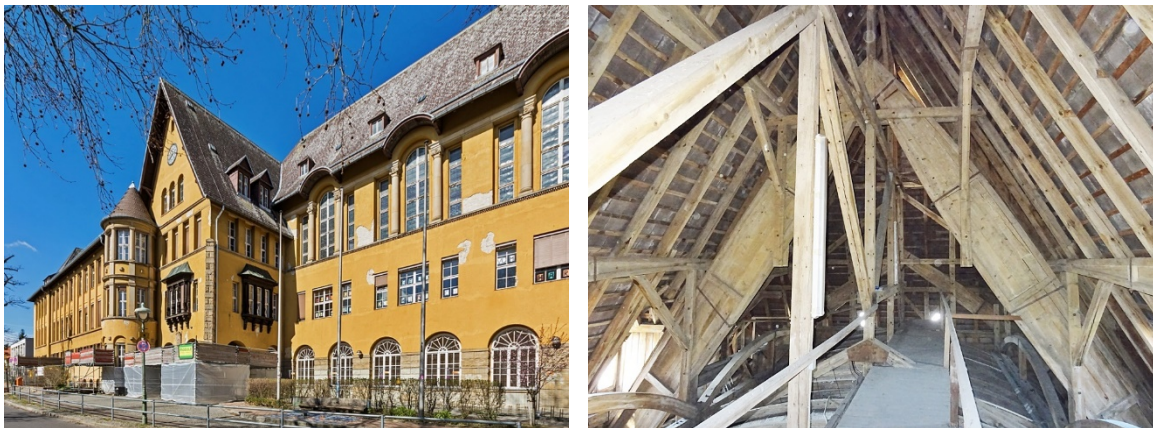
Figure 4. Fichtenberg High School, Berlin/Germany – left: exterior view; right: interior view of the roof construction

In addition to the investigations described above, the strength grading methodology was applied in comparative material test on sample material from historical, partially deconstructed timber structures (see [16, 17] and Figures 4 & 5). In the course of this, it was determined that minor adjustments to the methodology are necessary regarding the consideration of the load-bearing capacity-reducing growth and component characteristics.

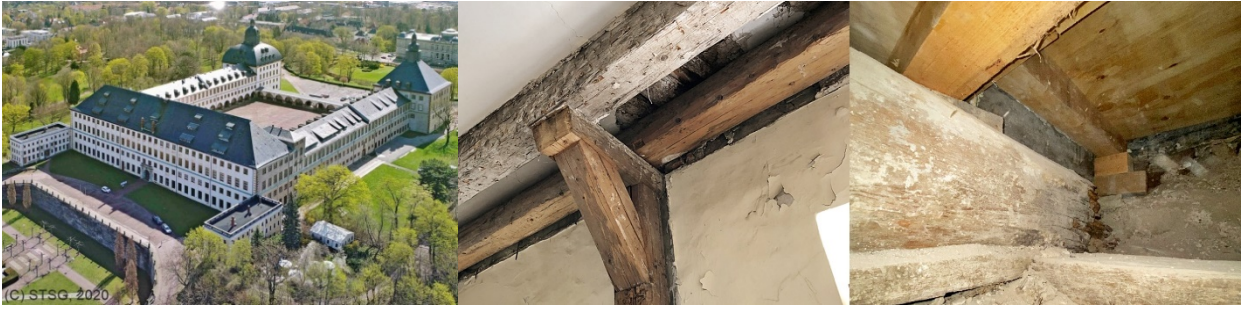
Figure 5. Castel Friedenstein, Gotha/Germany – left: aerial view; right: examined ceiling construction

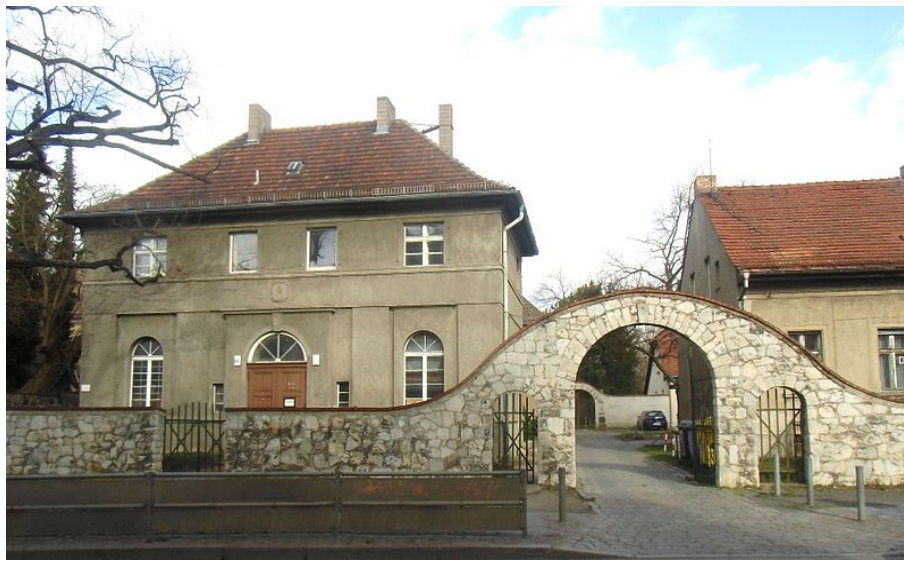
*Figure 6. Exterior view of the Margarethenhaus, Berlin, before the extensive redevelopment*

The Margarethenhaus – also known as Margareth-Hall (see Figure 6) – is part of a building ensemble which is listed as built heritage by the Berlin State Monuments Office. The building was erected in the 1920s as a community hall and is currently used by the protestant parish of Berlin-Heinersdorf.

The building consists of a two-storey main building with two corner risalits on the western and eastern sides. The second storey of the main building is set back and includes a balcony along the whole length of the building. The roof structure is formed by a pitched roof above the main building and hipped roofs above the risalits. The load-bearing structure of the roof is executed as a purlin roof.

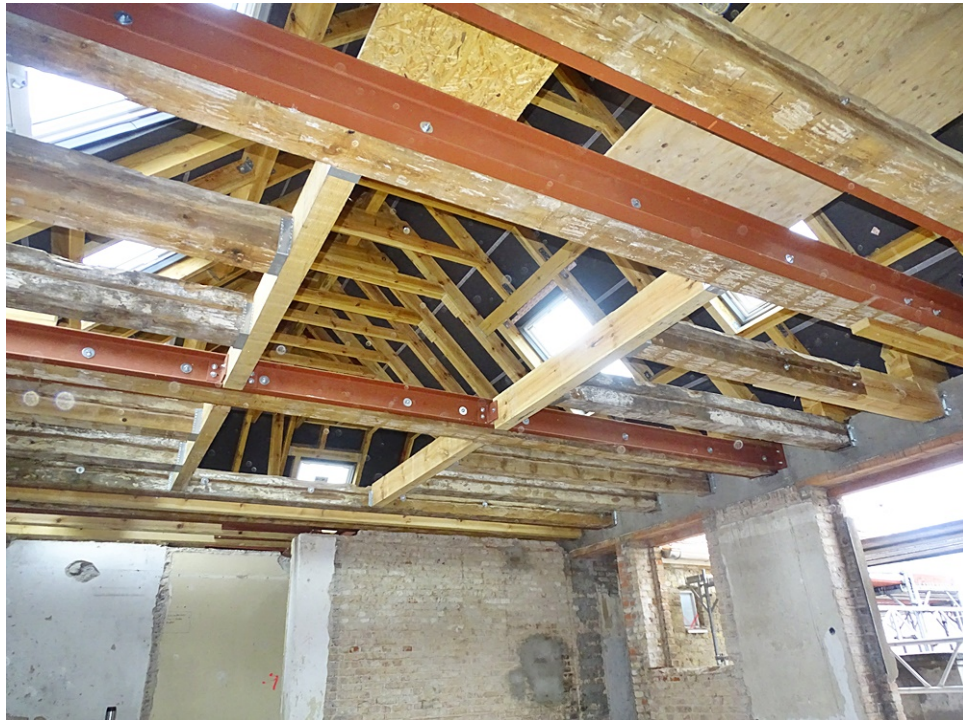
*Figure 7. Examined part of the ceiling structure*

The assessment of the material quality revealed that significant load-bearing reserves were present. Both strength grading level SGL 2a and SGL 3 resulted in an allocation of the floor beams to the strength class C40 according to EN 338 [13]. The solemn visual grading of the floor beams according to DIN 4074-1 [10] – which is comparable to strength grading level SGL 1 (see Figure 1) – resulted in the allocation to the strength class C24 according to EN 338 [13]. Based on the mechanical properties given in EN 338 [13], the apparatus-supported strength grading revealed load-bearing reserves in the range of 67 % concerning the flexural strength, respectively 27 % concerning the modulus of elasticity. Such reserves can be used to minimise the redevelopment measures, particularly the material usage.

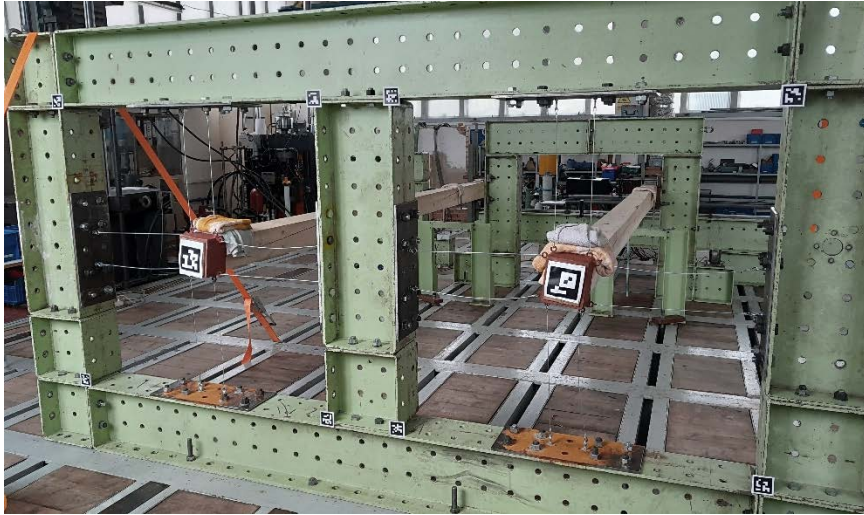
Figure 1. Beams in the testing hall equipped with ArUco markers [6] for precise displacement monitoring.

Two logs were prepared from Norway spruce with nominal cross-sectional dimensions of  $12 \times 14$  cm and a length of 400 cm. Each log was installed in a test rig with one end rigidly fixed, effectively eliminating all degrees of freedom to prevent any movement or rotation. The opposite end was secured using eight galvanised steel wires, each with a diameter of 2 mm, arranged in a pre-defined configuration as shown in Figure 1. This setup enabled the transfer of any torsional or longitudinal forces generated during drying into measurable tension in the wires, facilitating quantification of the internal loads induced by shrinkage and spiral grain effects. The logs were monitored throughout the drying process, beginning from the fibre saturation point (green wood condition) down to a target moisture content (MC) of 12%. The experiment was conducted in a controlled indoor testing hall, where the average temperature was maintained at approximately 23 °C, and the relative humidity remained stable at around 50%. These environmental conditions were chosen to simulate standard indoor drying scenarios and ensure consistent moisture loss across the duration of the test.

Monitoring of the displacements was carried out using optical measurement techniques [6], as well as through the analysis of vibrations in the steel wires. The recorded signals were processed using Fast Fourier Transform (FFT) to determine the eigenfrequencies, enabling indirect estimation of the forces generated during the drying process. The implementation was done using NumPy/Scipy libraries [5].

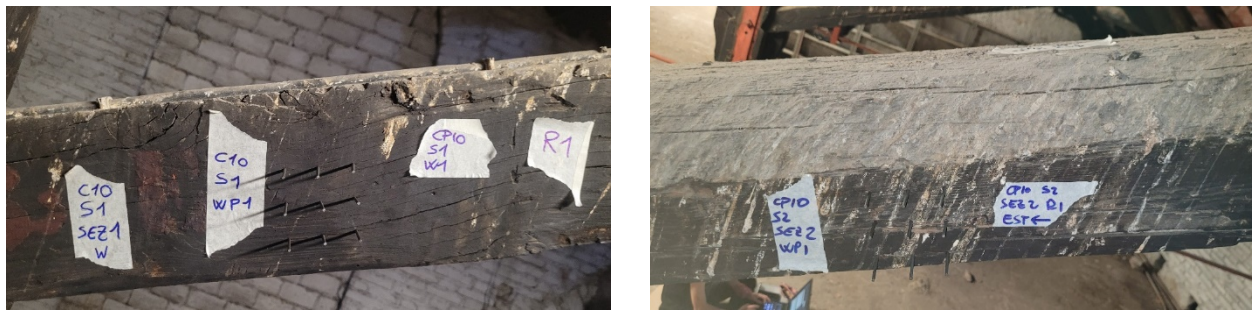
*Figure 2. Woodpecker and Resistograph tests on the same cross-section.*

For each section, tests were performed with the Resistograph and then the Woodpecker, ensuring they covered the same surface area for comparative analysis and to meet one of the research objectives. This was not possible on the king post due to surface conditions (Figure 2).

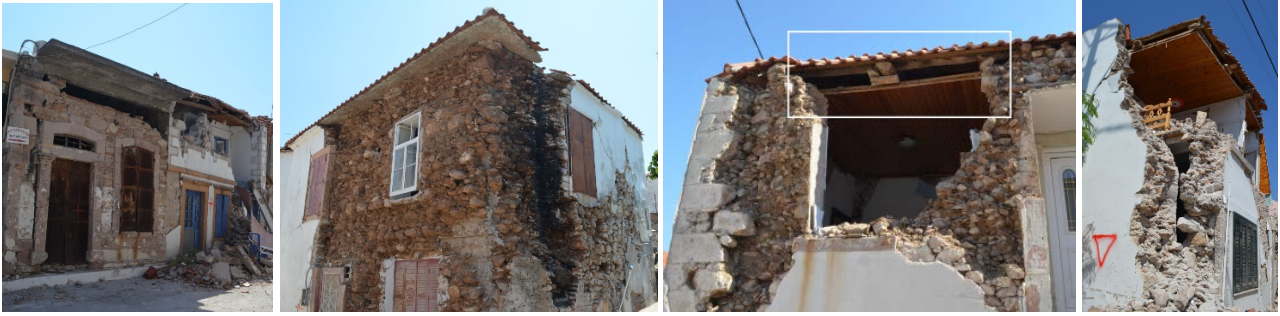
Figure 1: Vrisa village in Mytilini, Greece. 2017 earthquake. Severe damage and partial collapses were observed in masonry buildings reinforced with concrete slabs and concrete tie-beams at roof level, and in masonry buildings without timber lacing [6].

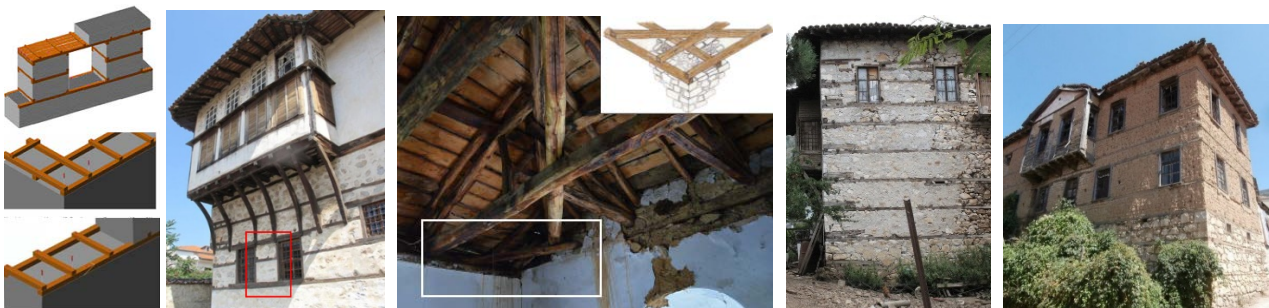
Figure 2: a) The typical horizontal timber reinforcement system of masonry [8]. The timber lacings are used at least at the level of the floor and the roof. They are also placed at the level of the lintel, the sill, and the middle height of the masonry piers between the openings. b), c), d), e) Masonry buildings in Greece (stone and adobe) reinforced with timber lacings. Special attention is given to tying the corners of the buildings, as well as the roof and floor structures, to the timber lacings. [4,5].

(oversized sections, insufficient anchorage to the masonry), as well as in cases where masonry walls were not reinforced with timber ties [6] (Figure 2).

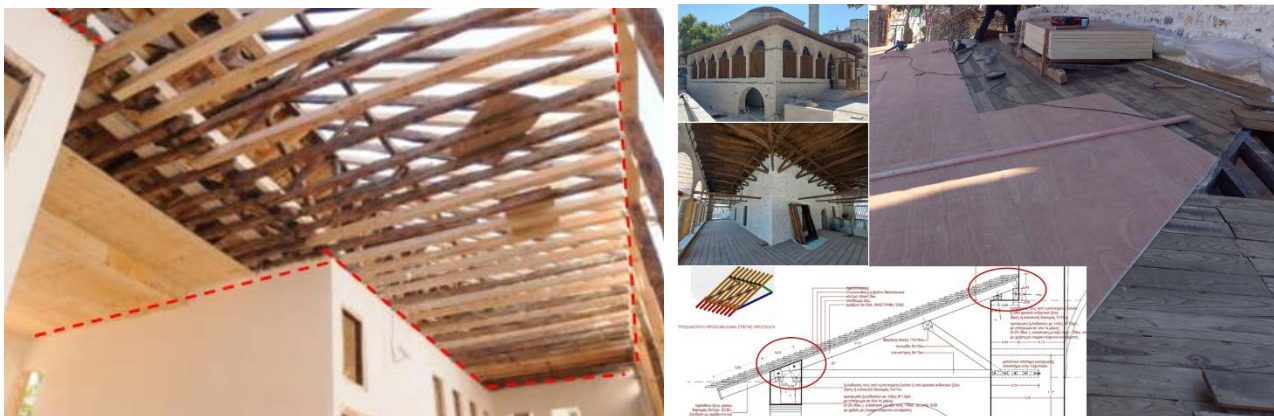
*Figure 3: a) Benizelos mansion in Athens. Application of 20mm plywood over the ceiling, with both layers screwed onto the ceiling beams of the roof (horizontal plane) [8]. b) Kaloutsiani Mosque in Ioannina. Application of plywood over the interior visible timber planks. The inclined timber diaphragm, anchored to the masonry walls through timber-tie beams (red circles), was used to enhance the seismic resistance of the angular porch, especially against out-of-plane forces [9].*

- Timber applied through various methods (planks and plywood), to improve the diaphragmatic action of existing or new timber roofs and floors (Figure 3) [8,9,10,11].

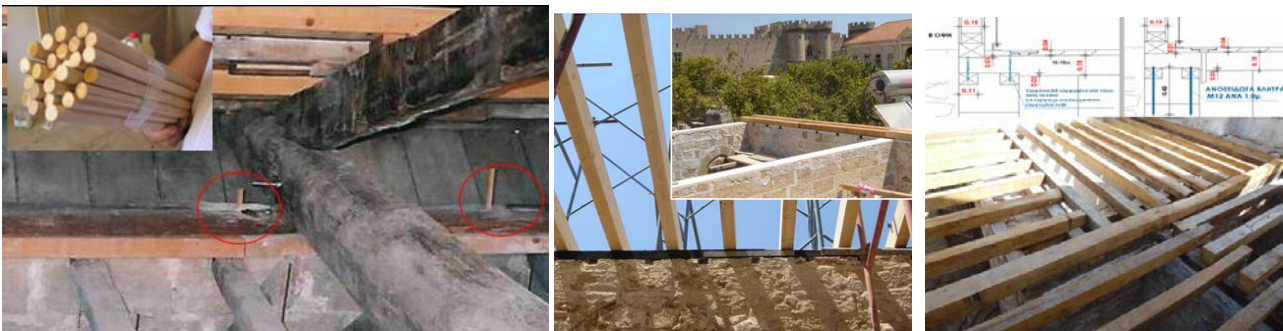
Figure 5: Hagı Mehmet Aga Mosque in Rhodes. a) Timber dowels ( $d=14\text{mm}$ ) were used instead of steel dowels to connect the timber lacings to the masonry beneath, since steel dowels had often caused significant damage to the porous stones of Rhodes. Benizelos Mansion in Athens and the Turkish mansion in Rhodes [11]. b) In these cases, the usual cross timbers of the lacing system—normally placed above the longitudinal elements—were instead embedded within the masonry beneath the longitudinal timbers and connected to each other with screws ( $d = 8\text{ mm}$ ) [8,12]. c) Timber floor beams screwed onto timber lacings anchored into masonry with stainless rods [11].

- Various methods to connect the timber ties to the masonry beneath, either more expensive (e.g., use of stainless steel or timber dowels) (Fig. 4c, 4d, 5a), or easy to apply (e.g., use of transversal timber elements embedded in the walls under the longitudinal ones, at floor and roof levels (Figure 5b) [8,9,11,12]. This anchorage method provides a low-cost alternative in situations where metal rods are unavailable. The use of cross timbers improves the connection between the two faces of three-leaf masonry and enhances the collaboration and cohesion of the timber grid with the surrounding masonry, functioning as a type of mechanical anchorage within the wall. Special care must be taken to establish the connection of these timber diaphragms with the walls that are parallel to the floor beams or with the gable walls of a two-pitched roof (Figure 6) [8,12].

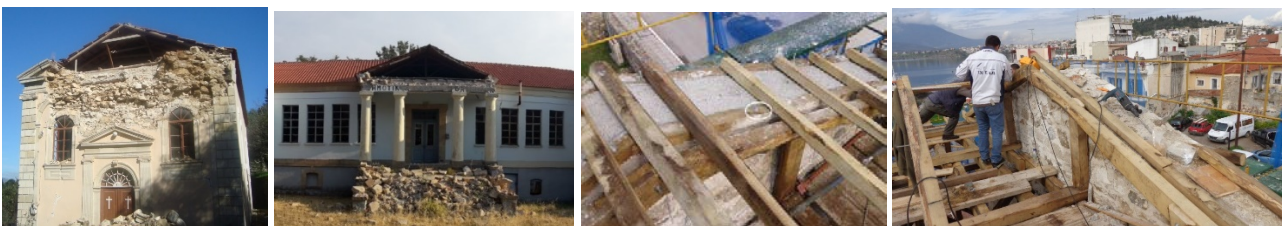
Figure 6: a) Kefallonia (2014), b) Mytilini (2017). Typical gable collapses caused by earthquakes. Bailos House in Chalkis. c), d) Timber lacings anchored with steel rods to the masonry are used to connect the gable to the roof inclined diaphragm, through the purlins that are screwed onto the timber tie beams [11].

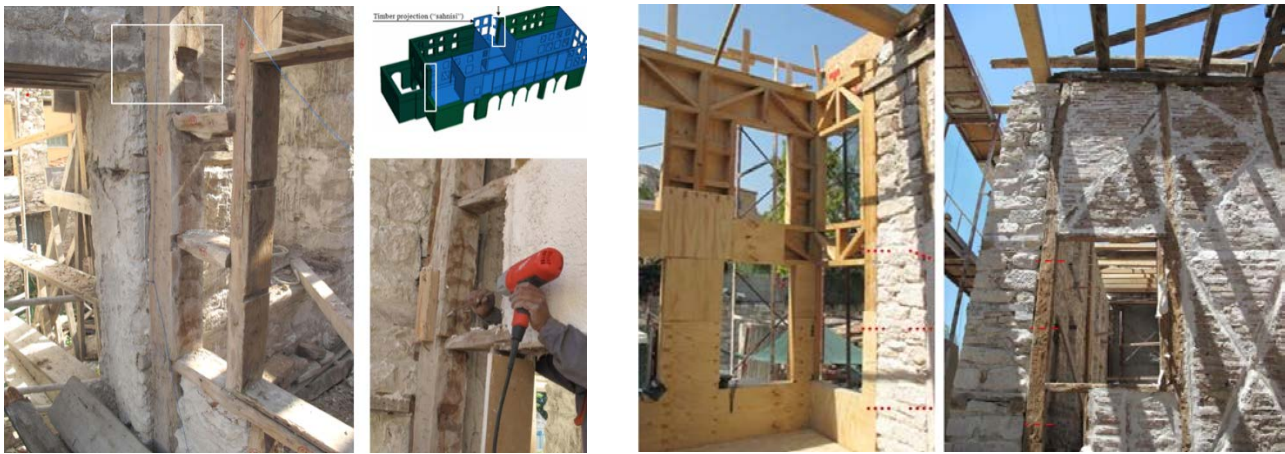
Figure 7: Benizelos Mansion in Athens. Connection with screws of the last post of the load bearing timber-framed walls of the building to the tie beams along the height of the masonry walls, using carbon steel screws (system WT) [8].

- Different techniques are used to connect the timber tie-beams along the height of the masonry (Figure 4a) to the load-bearing timber-framed walls of the buildings, establishing their collaboration and ensuring a “box behaviour” of the building during seismic actions. (Figure 7) [8].
- Different techniques for connecting the timber lacings along the height of the masonry, to non-load-bearing timber elements of the building (window, door frames, decorative elements, non-load-bearing timber-framed walls, etc.). Their contribution to the overall behaviour of the building may be important in the event of a strong seismic event, serving as a second line of defence, which is not usually included in calculations (Figure 8) [7,12].

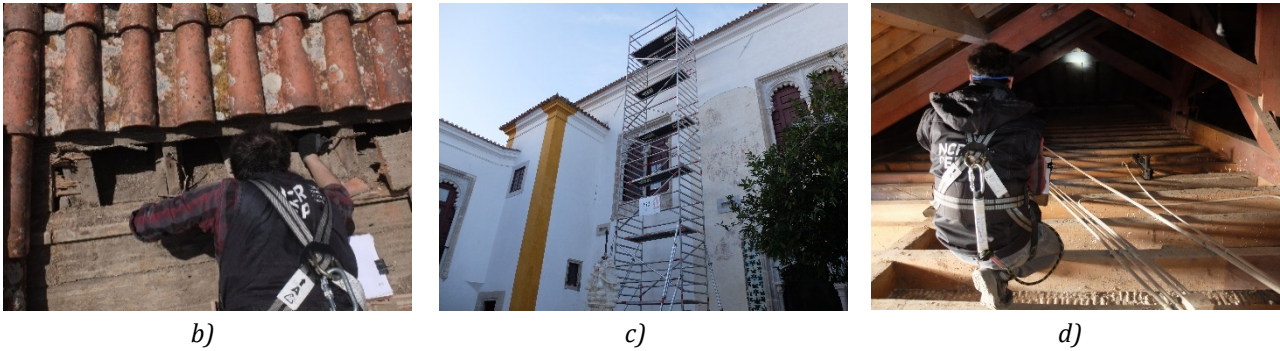
Figure 2. General plan of the palace with the location of the different survey phases and general photos of the access routes

Due to the magnitude of the project, the structural assessment work on the several roofs of the National Palace of Sintra was divided into three phases (Fig. 2a), and its main objective was to geometrically characterise the existing structural elements and obtain information on their state of conservation. One of the main obstacles to executing these works was the limited access to the roofs, conditioned by the preservation of existing valuable constructive elements and the need to avoid interfering with the palace's activities, namely, tourist visits. For this reason, the access to the roofs was primarily done from the exterior, through the execution of survey windows in the roof (Fig. 2b), which were accessed via auxiliary vertical elements, namely scaffoldings (Fig. 2c). The location of these survey windows was defined specifically for each roof based on the identified critical areas and to cover the largest possible area and the greatest diversity of structural elements. On some roofs, it was possible to access the interior and conduct a complete survey of the structure (Fig. 2d).

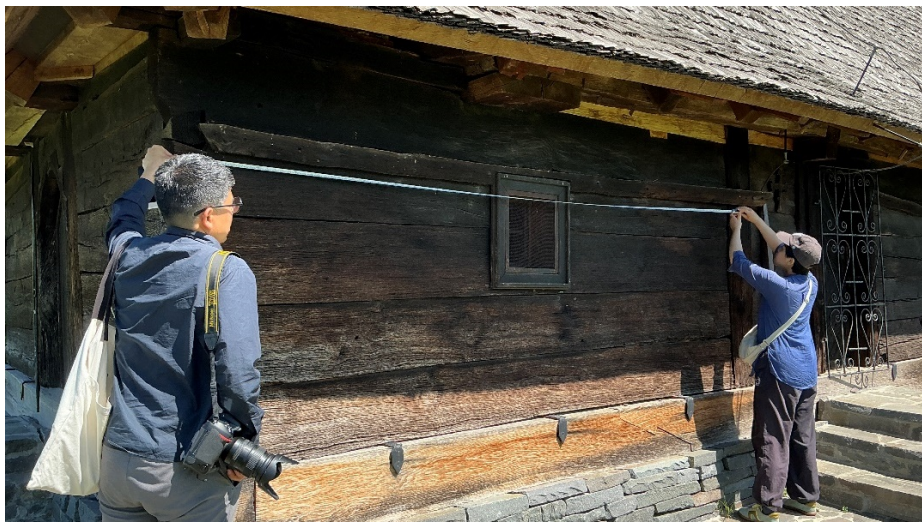
*Figure 1. The picture of field measurement activities*

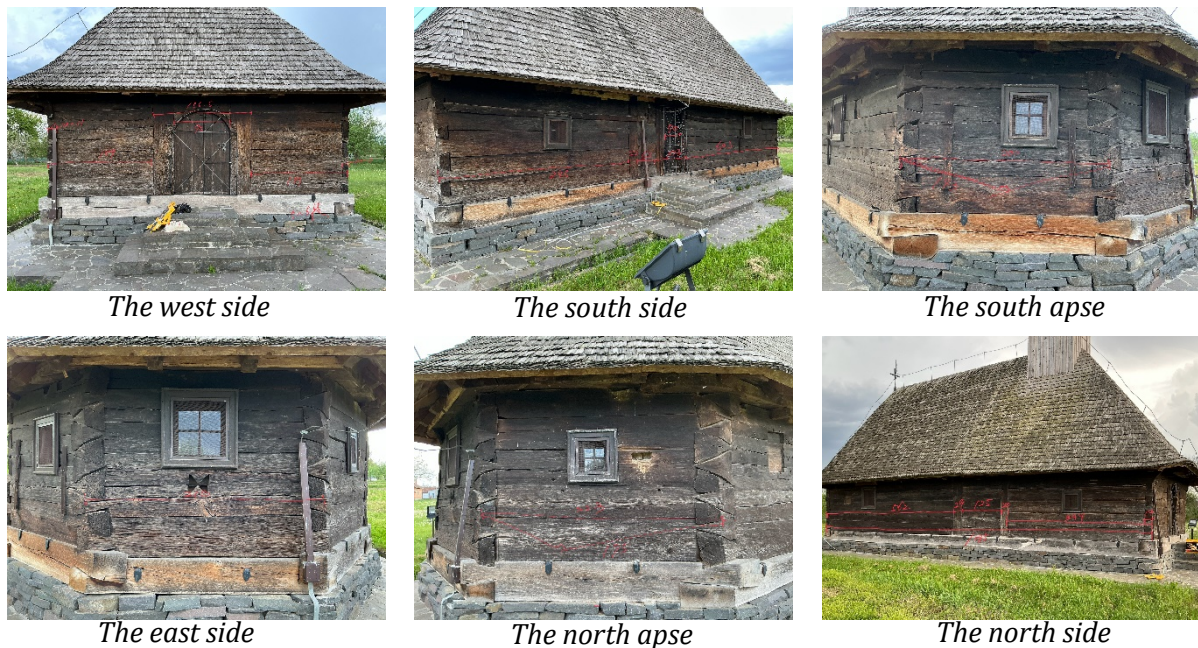
Figure 2. The pictures, when measured

All four sides were measured, and the dimensions were directly annotated onto the photographs. Drawings reflecting distortions were created from the 3D model, while details such as member positions and joints were recorded onto the drawings based on the field measurements.

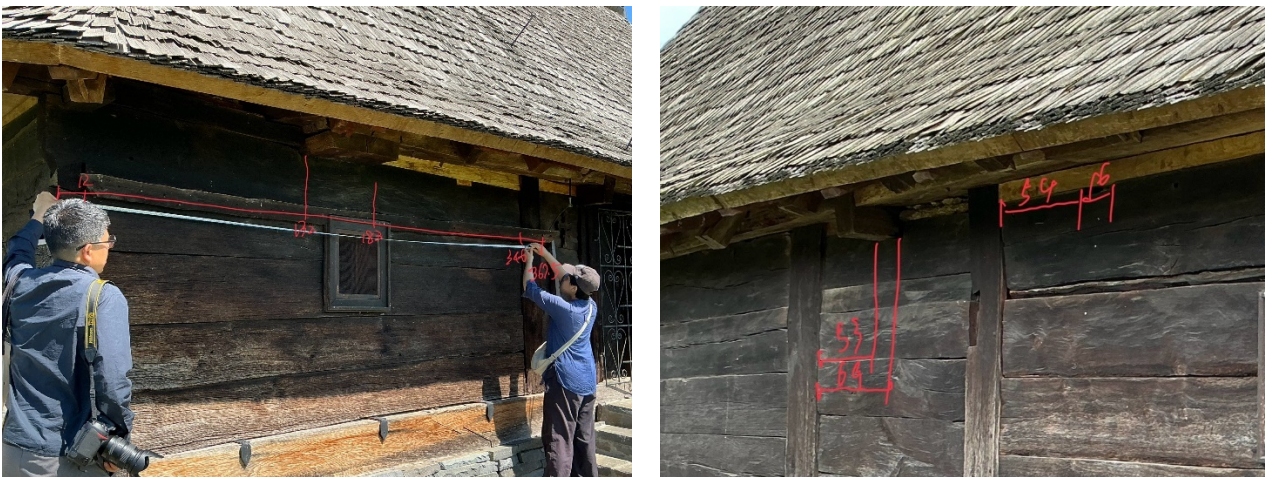
Figure 6. The pictures of the location of Gb and the beams for the partition

Typically, Gb functions as the base of the bell tower, but in this case, the bell tower is positioned further east, above Rb1 and Rb2. Gb is located at 132 to 183 cm from the front wall, with centre measurements indicating 150.5 cm. Why was this unusual configuration adopted? Clues to this question can be found by examining the traces of beams for the partition between the naos and pronaos, particularly those remaining on N1 and S1. The current partition is put over N2 to Sf1, located 53 cm and 69 cm from Nc2, respectively, on the northern side. In contrast, the beam traces on N1, S1 are located 54 cm and 70 cm from Nc1, Sc1, respectively—measurements that closely match those of the current partition. Moreover, the width of Nc1 and N2 is about 145 cm, which corresponds closely to the position of Gb from the front wall.

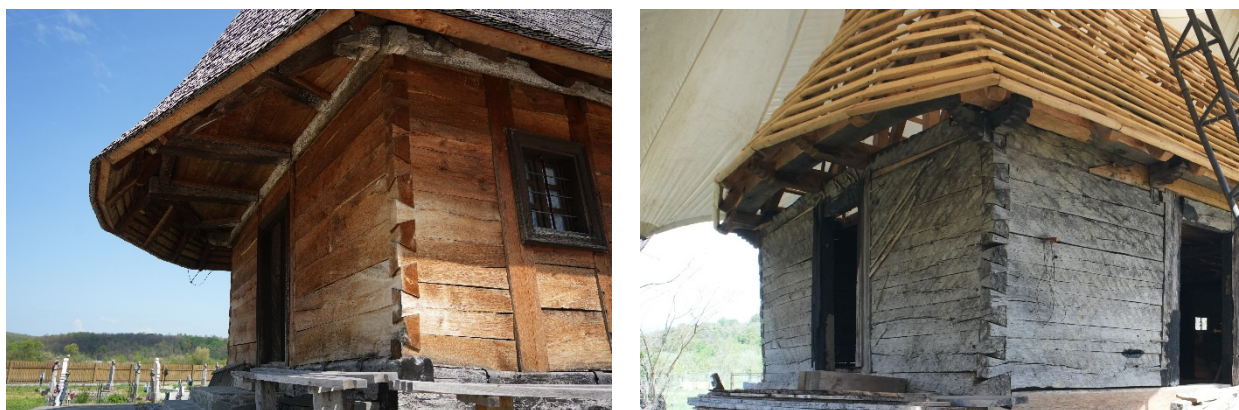
*Figure 13. The wooden church in Margina (left) and Povergina (right)*

Furthermore, this configuration is consistent with other wooden churches in the Bătești area, such as those in Povergina and Margina, which feature deep overhanging eaves at the front. Although the precise

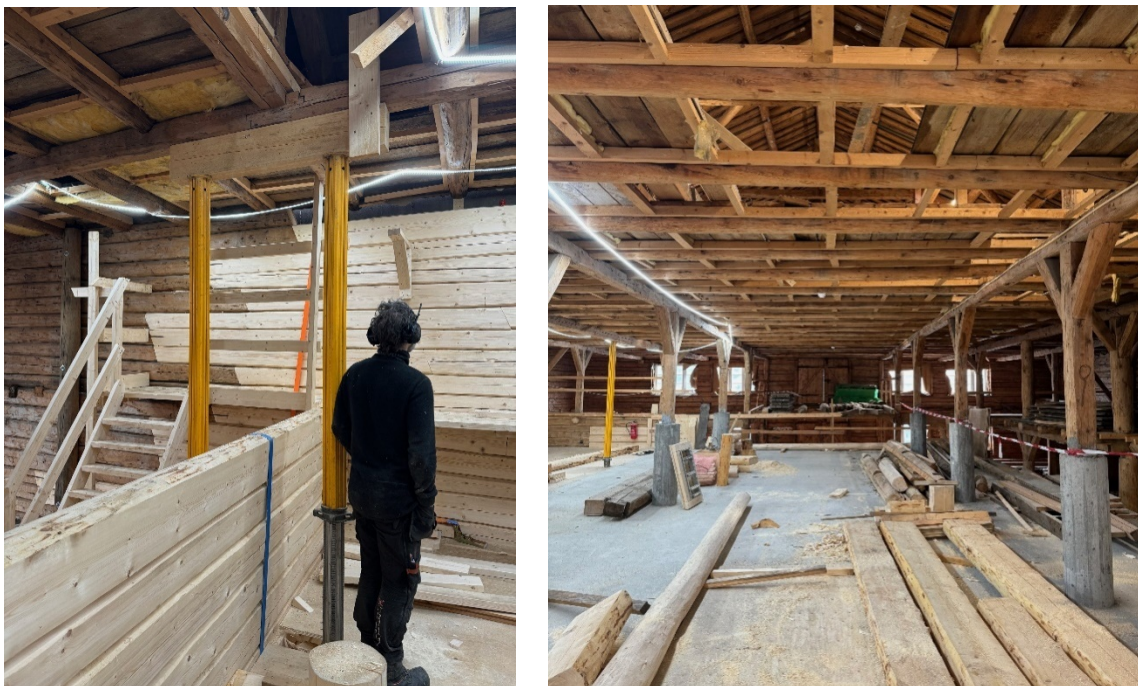
Figure 2. Brygge 15 during adaptation: replacement of rotten timber (left), concrete structure from the 1980s.

One of the buildings recently adapted for reuse, Brygge 15, shown in Figure 1, is from 1857 but has undergone renovation in the 1980s, Figure 2, when the inner timber structure on four stories was replaced with concrete, causing the timber flanks on all sides to deviate from horizontal position over time [1]. Thus, in the current adaptation, reinforcement of the roof structure was introduced. Brygge 15 is depicted from the riverfront in Figure 1 (left), and the top floor with roof frames before and after the adaptation is shown (centre and right). As many similar existing timber buildings will require renovation and adaptation, and their historical character and value are of importance, the assessment of the mechanical properties of the original timber is necessary. Some of the timber specimens can be acquired for testing, but the logistical, labour and laboratory costs are high. Thus, a campaign of different non-destructive and destructive tests was performed on the timber acquired from one wharf. A visual strength grading standard [1] has been recently released in Norway to support the effort toward timber upcycling and resource conservation. Among other proposals for grading [2]. Nevertheless, the current standardisation framework does not facilitate the reuse of recovered wood [3], even though its technical feasibility is being confirmed by ongoing research [4].

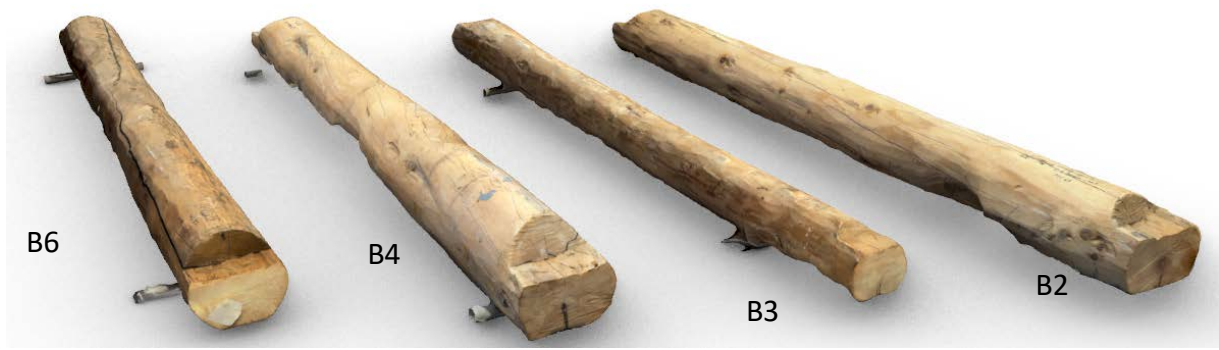
Figure 3. LIDAR scans of specimens B2, B3, B4, and B6 tested in the laboratory and recovered from Brygge 15, Trondheim

Timber pieces of Norway spruce (*Picea abies* (L.) Karst.) were salvaged from the wharf and transported to the laboratory for a non-destructive testing (NDT) campaign followed by a destructive four-point bending test according to the European standard EN408 [5]. In total, four laboratory-tested roof specimens, see Figure 3, and three field-tested roof specimens, see Figure 4, were analysed in this work.

Timber beams were scanned with LIDAR to store geometry data and visual characteristics for further analysis and to assess cross-sectional dimensions more accurately for stiffness and strength estimation. See examples of scans in Figure 3. NDT included: ultrasound pulse velocity (UPV) (Pundit Lab 200, Proceq), acoustic stress wave time (Microsecond Timer - MST, Fakopp, Bt), local density (Resistograph, Rinntech), moisture content (Lignometer, Lignomat), and acoustic stress wave resonance (Resonance Lumber Grader, Fakopp Bt.).

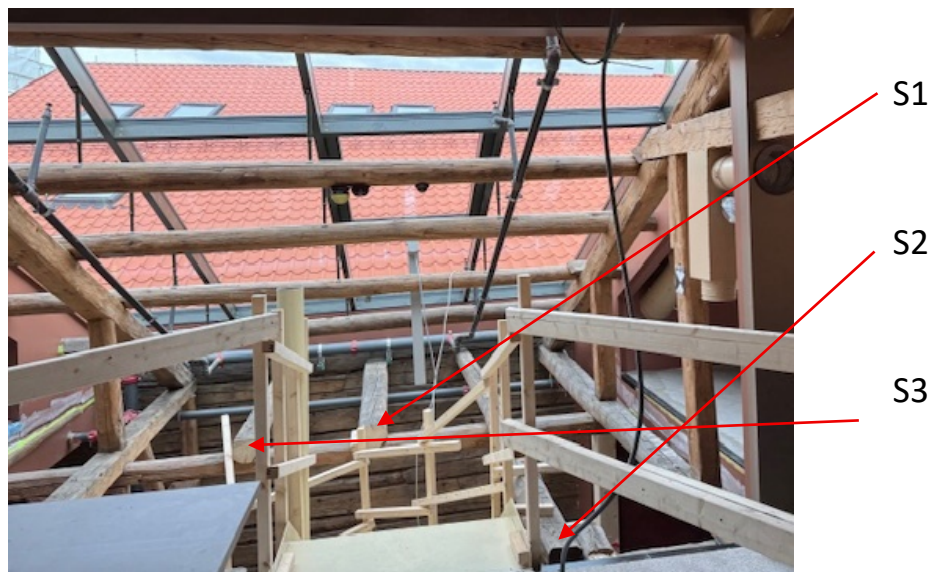
Figure 4. Specimens S1, S2, S3 measured in situ after adaptation (renovation), Brygge 15, Trondheim

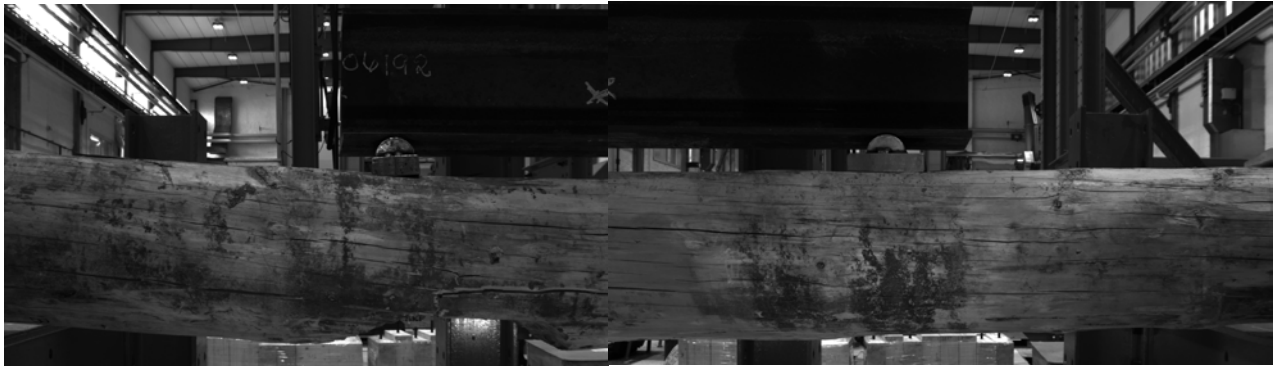
Figure 5. Set-up for destructive four-point bending test with typical failure in bending: fibre splitting.

Destructive testing was carried out following EN408 [5] with a four-point under static load conditions, see Figure 5. Force-displacement curves were obtained with displacement at the load cell position. The formula for the modulus of elasticity was modified to account for that using the following equation (3):

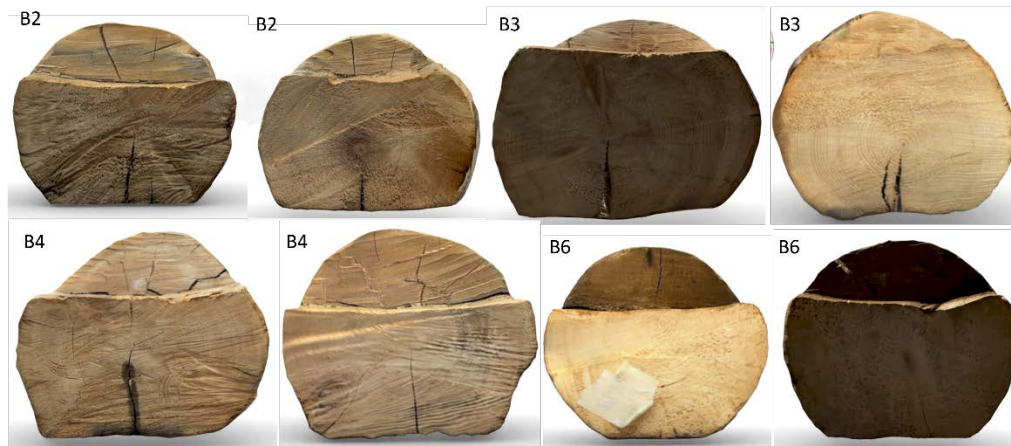
Figure 11. Specimen ends images from LIDAR scan.

The variation in density within profiles is higher than the variation between mean density profiles for all specimens, as shown in Table 1. This is reflected in the growth ring pattern, as can be observed in Figure 11.

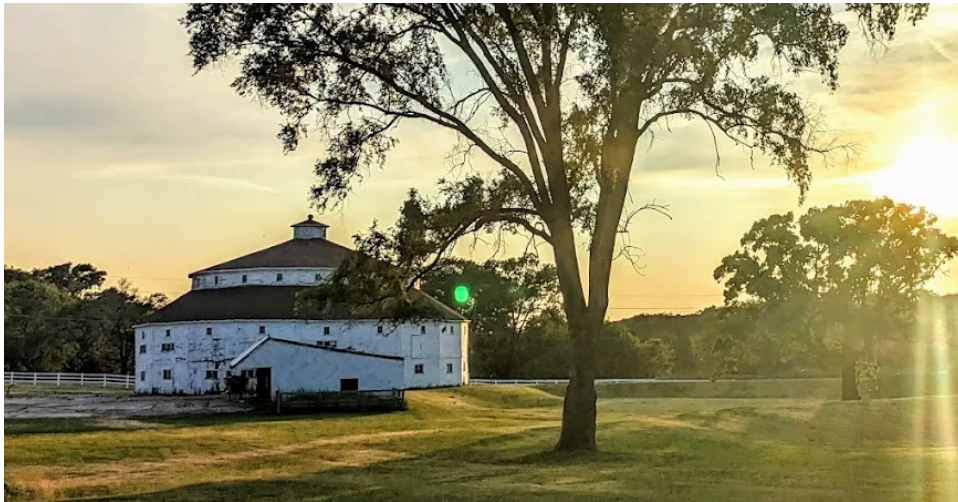
*Figure 1. The 30.48m (100ft) diameter Manhattan Round Barn [photo C. Bill Thorpe, 2024].*

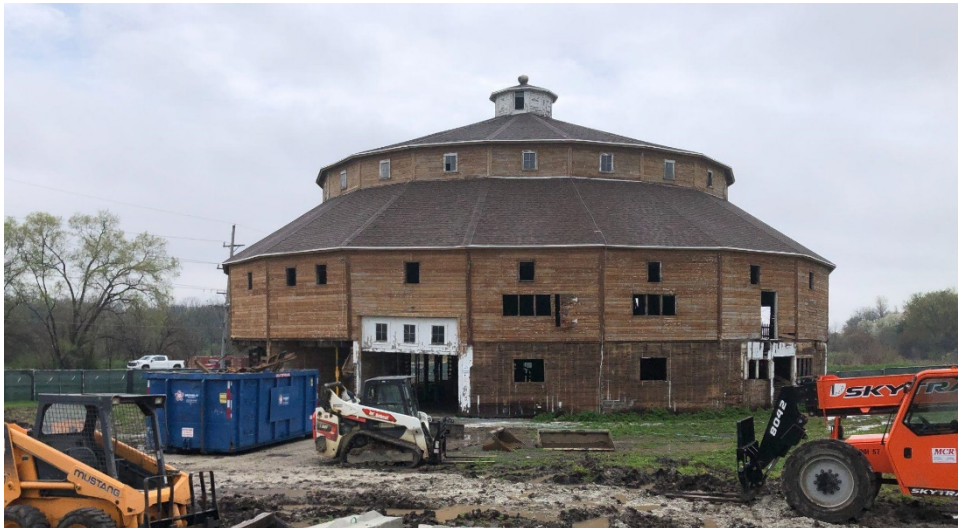
*Figure 6. The restoration of the Manhattan Round Barn*

4. Implementation: We commenced work on this important project several months ago, and the restoration is well underway. As we progress, our goal remains to honour the historic significance of the Manhattan Round Barn while ensuring its structural integrity and continued functionality for future generations. We assure quality in the work in two ways. The first is by integrating input and knowledge from all trades and building professionals involved in the planned methodology. There is a clear path for those completing the work to follow, grounded in the collective experience of the group. The second is by choosing partners that share our (and our client's) values and interests as much as possible. The restoration of this barn is not just about preserving a building; it is about preserving a piece of history that reflects the agricultural practices and architectural innovations of its time. Through this project, we all contribute to the ongoing narrative of rural architecture and the enduring legacy of the agricultural community in the Midwest.

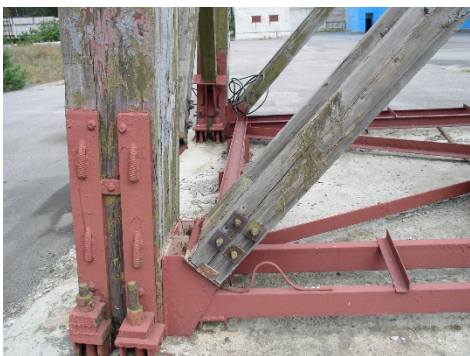
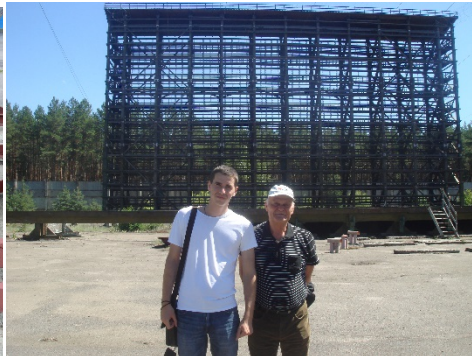
a) terminal device and towers b) general scheme of the complex

c) support fastening on inclined glued-in rods) examination 2011 (Prof. Fursov and PhD-student Bidakov)

Figure 2. Layout of the electrophysical complex towers and the terminal device

Active work during the development of the complex structures and their subsequent examinations under the supervision of Prof. V.V. Fursov, conducted for over 30 years, allowed the collection important data on the intensity of damage accumulation and the nature of its distribution along the framework of objects of the structural tower-shaped systems and the spatial structure of the wall or the terminal device (ОУ). The generator (ФУ) is a two-story building, isolated from atmospheric influences, featuring an electric-gas chamber that creates a powerful electric shock ( $\sim 10,000$  A and a voltage of  $\sim 5$  MV). Metal and reinforced concrete structures were unacceptable due to the requirement for dielectricity, radio transparency and magnetic permeability, and the percentage of fastening metal according to the technical specifications had to be below 5–7% of the weight of the material used. Therefore, for the first time in domestic practice, fibreglass rods were used in connections as dowels, and glued-in steel rods were used in open-air conditions for fastening tower branches to the foundation (Fig. 2-c), a project carried out with the direct participation of Prof. S.B. Turkosovsky.

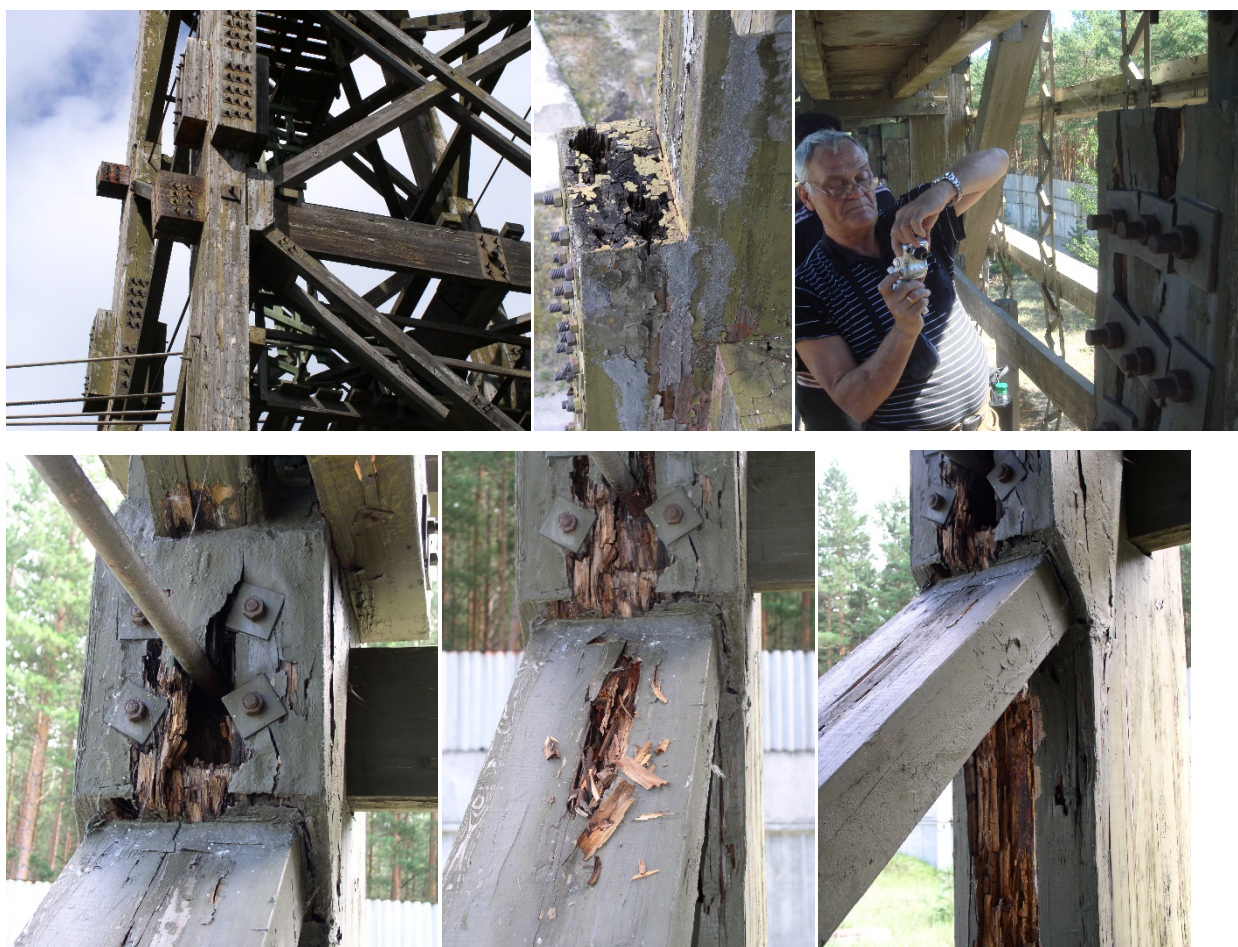
*Figure 3. Cracks in structural elements and nodes during inspection in 2011*

an electric shock. The elements with cracks remain the most vulnerable in terms of the electrical strength of the insulating structures, as shown in Fig. 3.

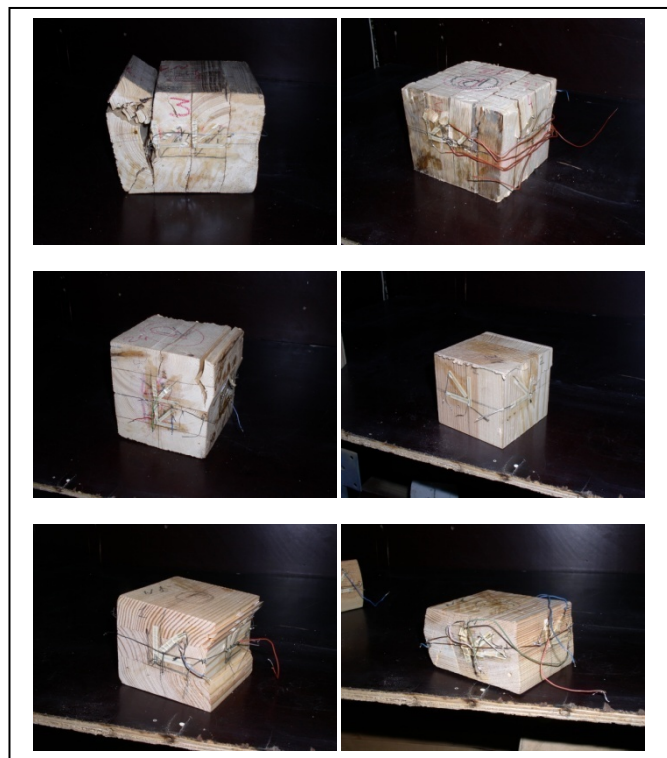
Figure 5. Combined diagram of elastic anisotropy of wood (a) and the nature of sample destruction (b)

Compression tests of specimens with different grain orientation relative to the direction of the acting force with the  $15^\circ$  step in angle change were carried out on specimens of different cross-sections: standard (2x2x3 cm), increased (2x2x6 cm) and large (9x9 cm and 12x12 cm); in the latter not the entire set of angles was considered, but only  $0^\circ$ ,  $45^\circ$  and  $90^\circ$ . Fig. 5 shows graphs of changes in the wood strength under compression, tension and bending at different angles for new and old wood. Curve "1" was obtained according to SNIIP [1], and curve "2" according to the tensorial equation (1). All series of tests were carried out using specimens cut from new or old wood that was undamaged by rot, allowing for a more reasoned comparison of the strength characteristics of the series tested in different years.

Large samples exhibited longitudinal cracks with varying opening sizes ranging from 2 to 3.5 mm, with a penetration depth into the section of up to 43 mm. When making samples, the outer zones of the original beam were discarded, so the core zones fell into the section.

For samples of old wood, a sharper decrease in strength was noted at angles from  $15^\circ$  to  $30^\circ$ , after which a kind of alignment of all curves occurred. In this case, the modulus of elasticity  $E$  of "old" wood for angles corresponding to the natural oblique grain ( $\sim 6^\circ$ ) decreases in strength characteristics more sharply than in new wood. The nature of destruction in all large samples, without exception, was the same: delamination of the cross-section began in the direction of the crack, after which the destruction of a smaller part of the divided volume occurred. The split passed through the core. It does not seem correct to judge the influence of the scale factor on the strength characteristics of "old" wood, although this issue was extremely interesting to many researchers between 1960 and 1985. During that period, the works of B. Madsen [14] and Prof. Yu. M. Ivanov [15, 16] became known, as well as the correspondence between the two scientists, which included discussions on approaches to accounting for the scale factor. The tests conducted on old wood show a sharp drop in the strength limits for samples with a cross-section of 60x60 mm, although its further decrease for samples of 90x90 mm was smooth.

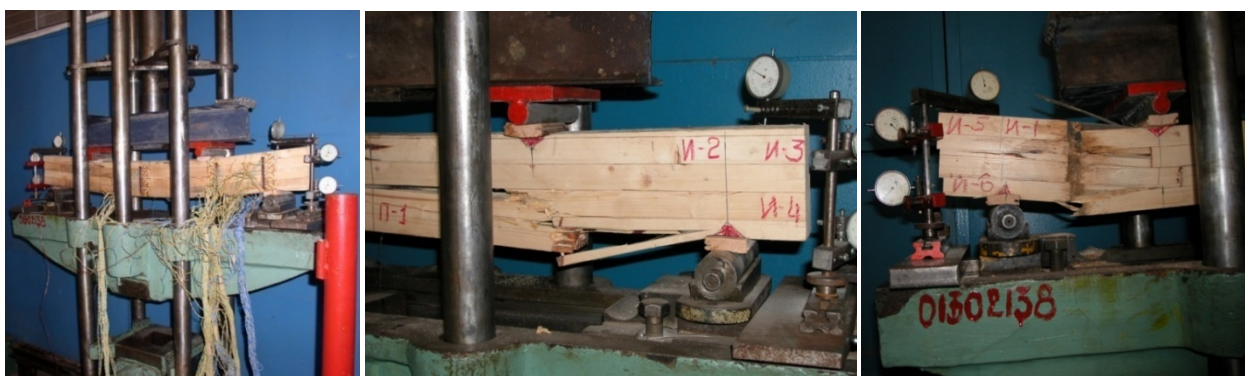
*a) beams under load and at the moment of destruction*

Figure 6. Destruction of experimental beams (a) and arrangement of strain gauges(b).

During the reconstruction of the GINT-12-30 electrophysical complex, samples 1,200 to 1,400 mm long were cut out from real dismantled glued-to-laminated beams with a cross-section of 140x600 mm and a length of 4,700 mm, consisting of three and four boards with a cross-section width of 55–56 mm and a height of 90, 60 and 127 mm. The elastic deformation was approximately 0.5 of the destructive load. The nature of the destruction of the experimental beams and the arrangement of the strain gauges are shown in Fig. 6.

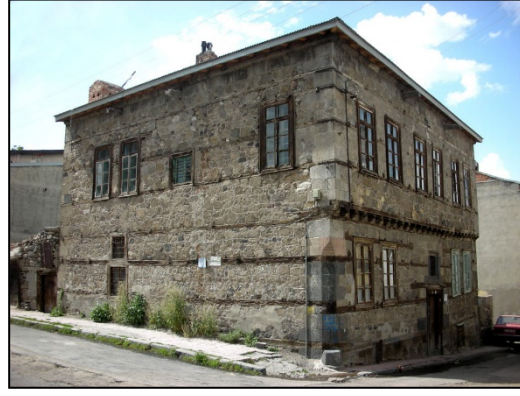
Figure 21. A house in Erzurum, (Foto: Dışkaya, H.)

Wood was an important lacing element in masonry structures, stabilising the walls while bearing vertical loads and maintaining interconnection between structural materials. An example of the timber usage in masonry walls was obtained from the excavations in Zincirli Hilani Tower, 10th century BC, shown in Figure 17 [14]. The traditional continuity in using this structure can be seen in the 19th-century still-standing wall detail from a house in Birgi (Figure 18), from inner western Anatolia, and a house in Erzurum from eastern Anatolia (Figure 19).

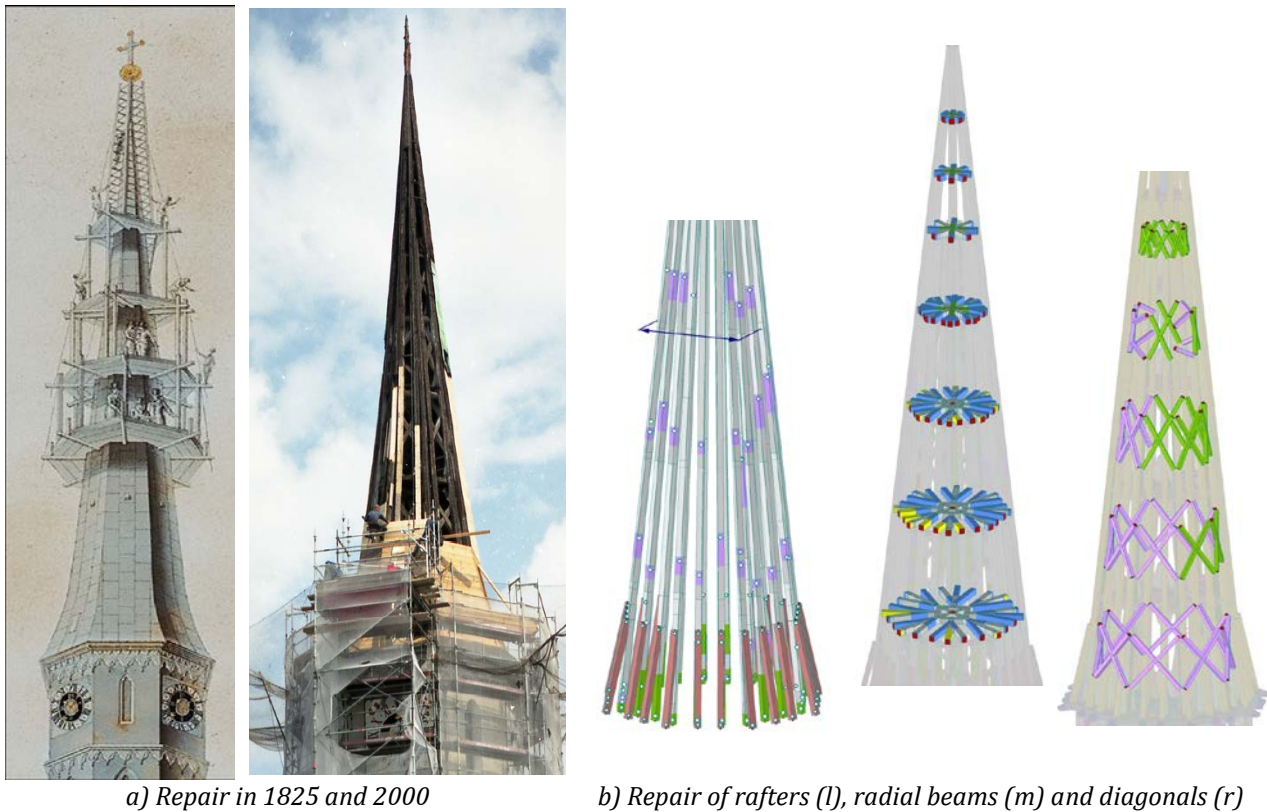
Figure 5. Numerous repairs over centuries

- The categorisation of special settings for hinges is highly recommended. Even if settings are identical, the implementation of several categories supports visual checks of input data for groups of similar structural elements. According to Fig. 5b, it is also helpful to get a survey on the irregular distribution of further connections induced by repair.
- The structural model must also incorporate 2D elements, such as wooden cladding or masonry walls, to be applicable in the context of CFD. Otherwise, the wind might pass through the single structural elements, resulting in much lower wind load for the whole structural system.
