PROCEEDINGS OF  
7th INTERNATIONAL CONFERENCE ON  
STRUCTURAL HEALTH ASSESSMENT OF  
TIMBER STRUCTURES

# Proceedings of the SHATIS 2025 – 7th International Conference on Structural Health Assessment of Timber Structures

3rd – 6th September 2025, Zagreb, Croatia

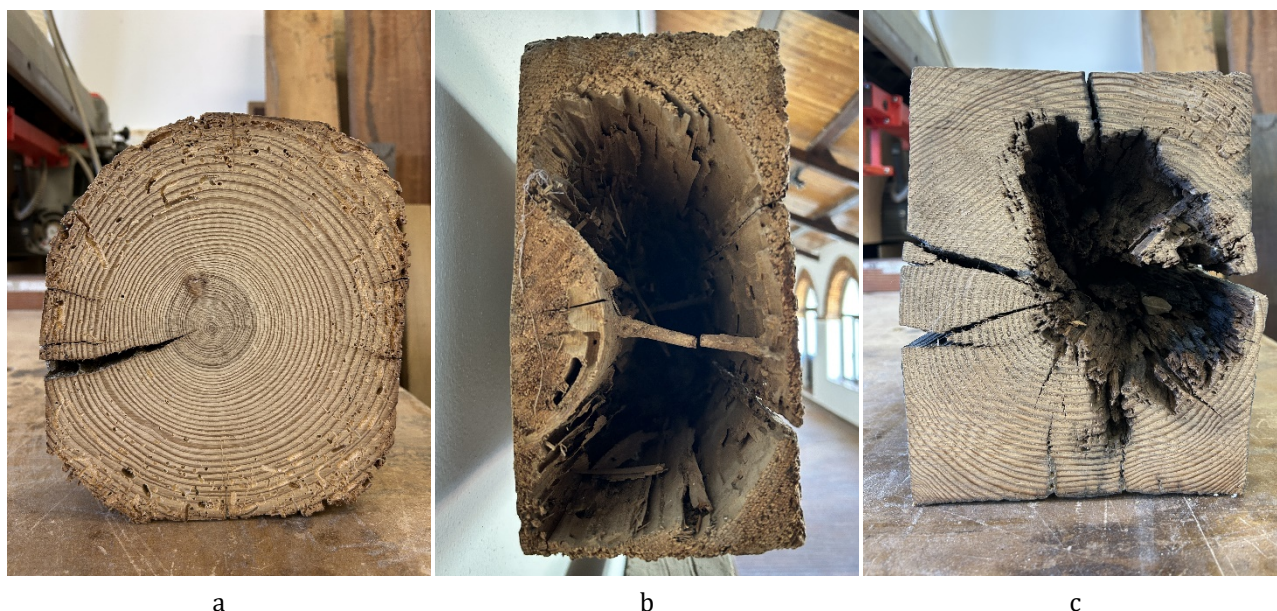
*Figure 22. Different types of biotic decay in wooden beams (a) galleries and exit holes of anobiid and cerambycid beetles in the outer part, corresponding to the sapwood; (b) termite damage affecting almost the entire cross-section, except for the outer layer, the knots, and the pith; (c) fungal decay affecting the inner part.*

Biotic degradation in timber structures is caused by biological agents such as insects and fungi [5]. Among the most common wood-boring insects affecting historic architectural elements are Anobiidae, Cerambycidae, and termites. In the case of anobids and cerambycids, their presence is often revealed by small exit holes and fine frass deposits. Insect attack is often perceived as the main threat to timber structures, but its structural impact is frequently overestimated [6], especially when the infestation is superficial (Figure 1a). In many cases, deterioration progresses slowly and may remain inactive for extended periods unless environmental conditions favour insect development. More concerning is termite infestation, whose destructive capacity can indeed be severe. Unlike other wood-boring insects, termites can cause extensive internal damage while leaving few visible signs on the surface, making early detection challenging (Figure 1b). Their colonies can remain active for years, progressively compromising the structural integrity of timber elements, especially in warm and humid climates. In most cases, fungi are the principal agents of wood deterioration [7]. Wood-decay fungi, including brown rot, white rot, and soft rot species, require high wood moisture content to grow and are generally more widespread and structurally damaging than insect infestations, though they are often less apparent in their early stages (Figure 1c). Poor ventilation, high relative humidity, and prolonged moisture exposure create ideal conditions for fungal attack, making this form of biotic degradation particularly insidious in historic timber structures. Fungal attack typically occurs in areas where moisture accumulates, particularly at interfaces between timber and other materials or in poorly ventilated zones where water tends to become trapped. The hygroscopic nature of wood, which allows it to absorb and release moisture from the surrounding environment, makes it vulnerable in such conditions, especially when exposed to condensation, infiltration, or capillary rise.

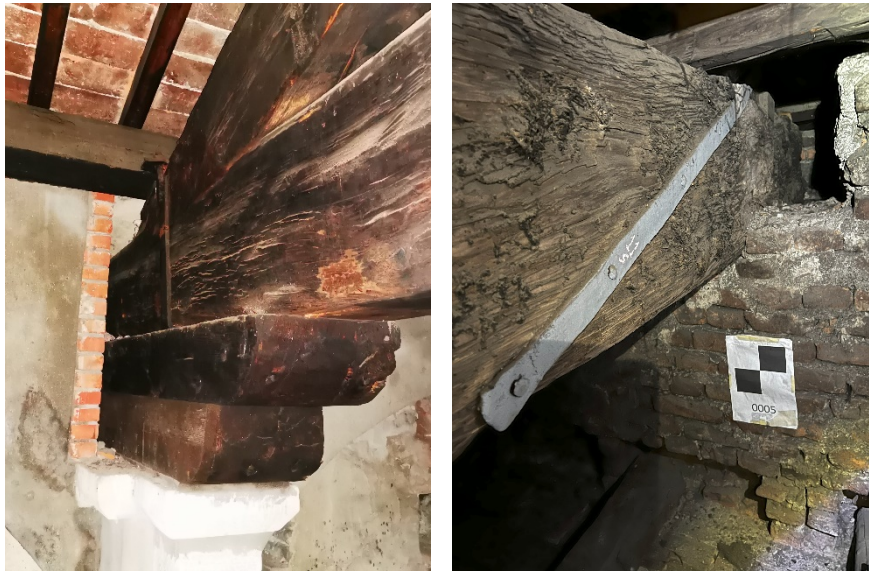
*Figure 23. Examples of enlarged masonry pockets at the truss ends*

In the context of historic timber structures, several traditional construction details emerge as key strategies for mitigating degradation risks, particularly those aimed at controlling moisture accumulation around wooden elements. Among the simplest and most common solutions were ventilated masonry pocket details, which allowed air circulation around structural elements, helping to keep moisture levels below the threshold for fungal growth. As shown in Figure 2, especially when the structure is not exposed, the pocket where the truss rests within the wall is enlarged to minimise the contact surfaces between the timber and the masonry. This configuration helps prevent moisture

accumulation and promotes air circulation around the embedded timber element. This simple strategy not only contributes to risk mitigation but also facilitates inspection of the structural area most vulnerable to deterioration.

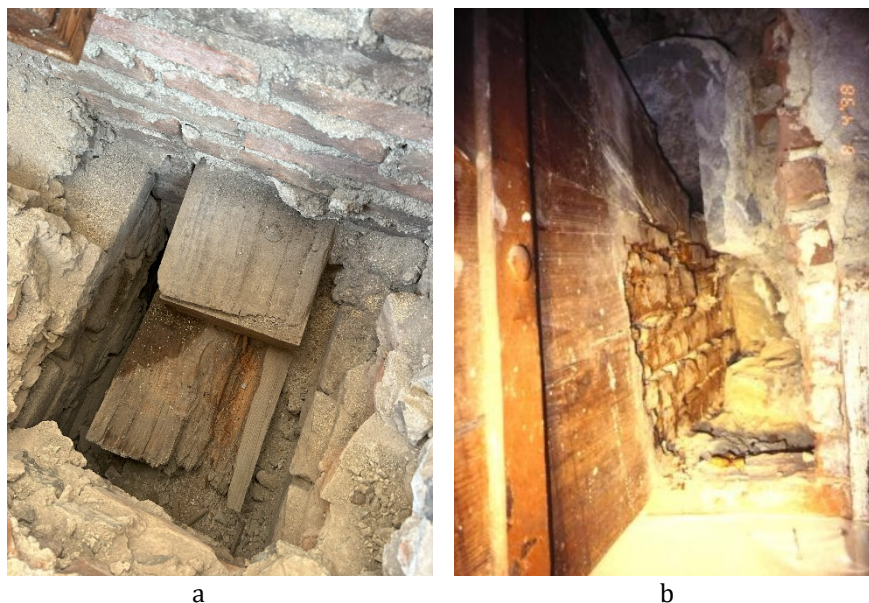
*Figure 24. (a) Ventilated cavity in the masonry; (b) Inverted C-shaped stone above the rafter and the fungal decay on the tie beam end*

When the roof structure is exposed, for aesthetic reasons, the masonry pocket where the truss rests is often in direct contact with the timber elements. In some cases, to mitigate the risk, the adopted solution was to create a ventilated cavity within the masonry, in contact with the outside through small ventilation holes (Figure 3a). Otherwise, the portion of timber in contact with the masonry is susceptible to deterioration phenomena, such as those visible in Figure 3b. In this example, water infiltration through the roof covering created the conditions for fungal attack. When the masonry surrounding the end of the truss was opened for a detailed inspection, an area with visible fungal decay on the tie beam end was found, along with a particular inverted C-shaped stone element positioned above the rafter to prevent direct contact with the masonry.

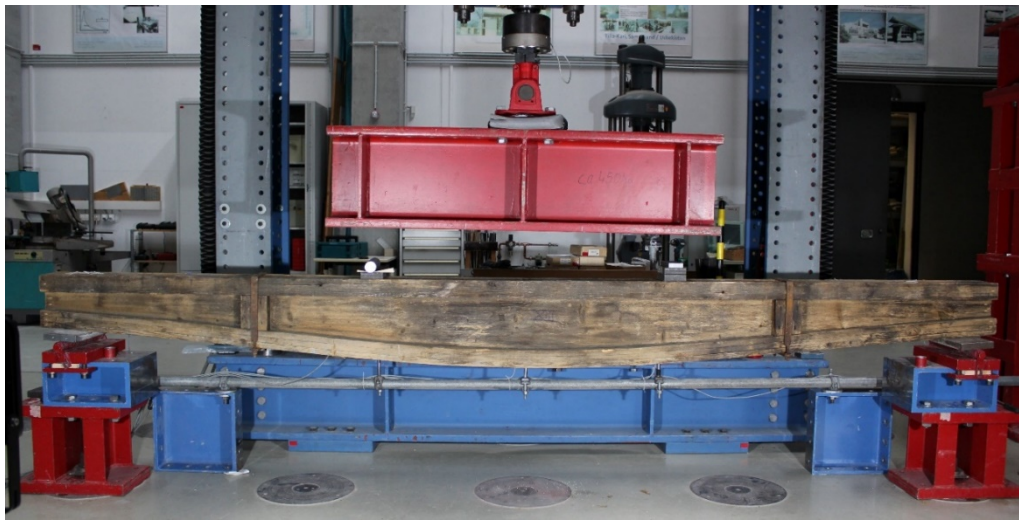
Figure 4. Bending tests

A total of 13 beams were available to determine the bending strength and the flexural elastic modulus. As already described, the different arrangement of the headbands in the first and second/third central purlin position results in two different support widths for the S 1 and S 2 series. The tests were carried out in accordance with DIN EN 408. [19] To measure the deflection of the beam during the test, displacement transducers were attached to the lower chord in the area of the supports, load application points and in the middle of the beam. In order to determine the global flexural modulus of elasticity according to DIN EN 408, the curve portion of the force-displacement diagram in the range between  $0.1 \cdot F_{\text{max,est}}$  and  $0.4 \cdot F_{\text{max,est}}$  must be subjected to a regression analysis, whereby the correlation coefficient must be greater than 0.99. This condition was met in all bending tests carried out. Thus, the modulus of elasticity for all beams was determined between an applied load of  $F \approx 7.8 \text{ kN}$  to  $F \approx 18.2 \text{ kN}$ ,

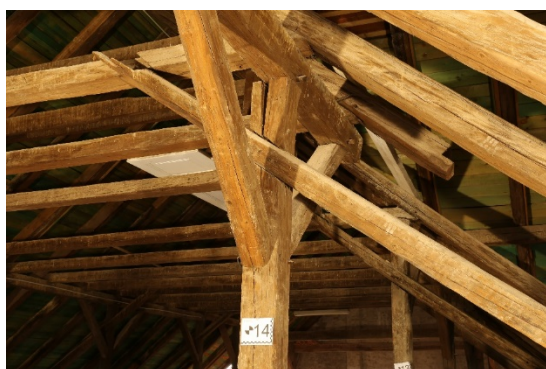
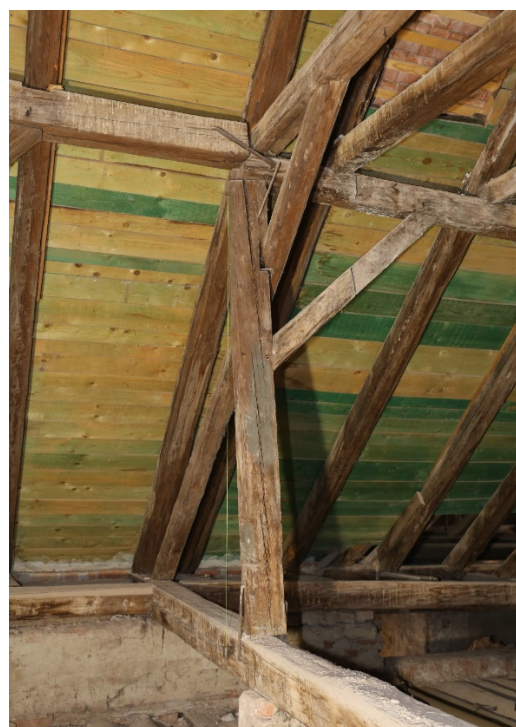
*Figure 1 a)-c). Upper Town High School (origin of the Zagreb University, 1695). The sequence of failures begins with inadequately chosen joints: the strut is too shallowly lapped on the post without a dowel, there is a too-small dovetail lap with the collar, and the collar does not adequately "catch" the purlin on top of the post. These lead first to shear failures at the upper left dovetail lap joint, followed by rotation of the post due to shear failure in the collar. As the collar tie fails, a crack forms in the post, and the post inclines outward (upper left). The lower sketch shows the incorrect layout of the rafter on the collar, which subsequently fails in shear. The right sketch presents a better solution for queen-post structures. Red lines indicate possible remedial measures. Iron clamps are not sufficiently strong and secure for binding the elements, particularly not in softwoods.*

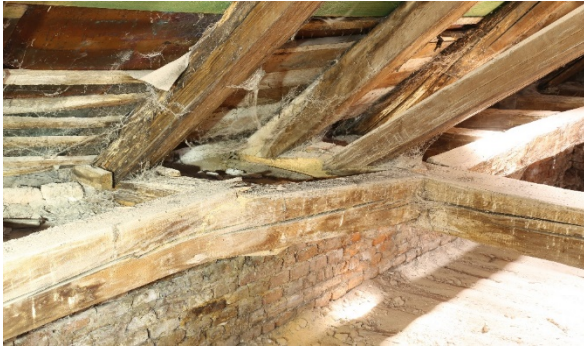
Figure 2 a)-c). The brittle bending failure of the grid beam is attributed to the inadequate positioning of the rafter at the end of the tie beam, resulting in eccentricity that causes upward spur rotation. The tie beam further bends due to insufficient support beneath the queen post (upper right). Right: the current configuration with a single wall plate (left), and the proposed configuration with two wall plates and iron braces (right).

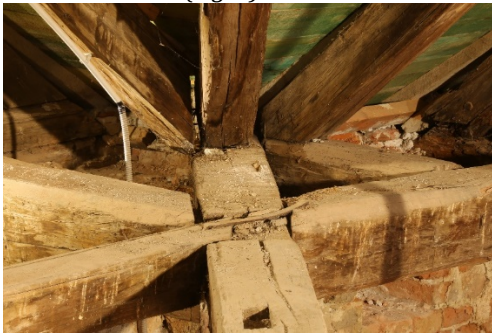
Figure 3 a) and b). The joints in the perimeter grid are positioned inadequately. Failure results when the lap joint and tenon coincide in plane, causing wood to fail in shear and tension perpendicular to fibres.

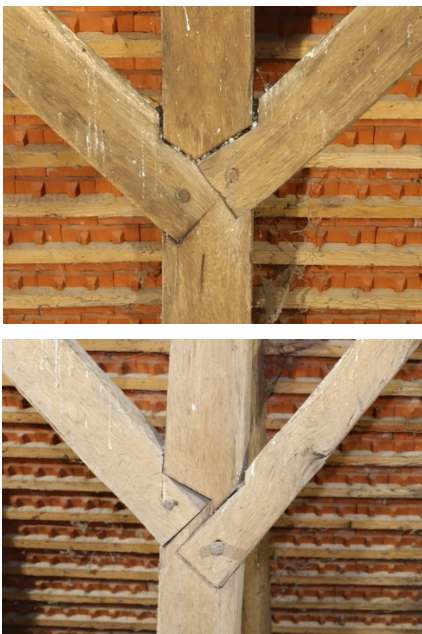
Figure 4 a)-c). Church of St. Michael Archangel, Prelošćica, 1832. Shown here are examples of curiously misshapen blind dovetail laps of knee brackets. The structural problems are as follows: depending on the load, the wood fails in compression perpendicular to fibres (compression) or splits in shear or tension perpendicular to fibres (tension). Additionally, positioning wooden pegs too close to the edge of the post can cause the post to split along its grain. These issues suggest that the church was presumably built by local carpenters with limited experience in carpentry.

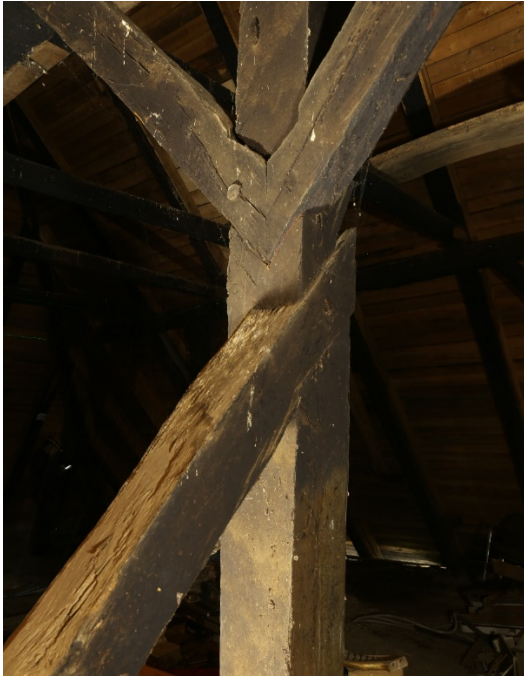
Figure 5 a) and b). Dovetail lap joints have too small an angle ( $<10^\circ$ ). When positioning two adjoining dovetail laps, poor alignment can cause wedge-like action, resulting in splitting of the post. To address this issue, refer to the suggested joint for this purpose located at the lower right.

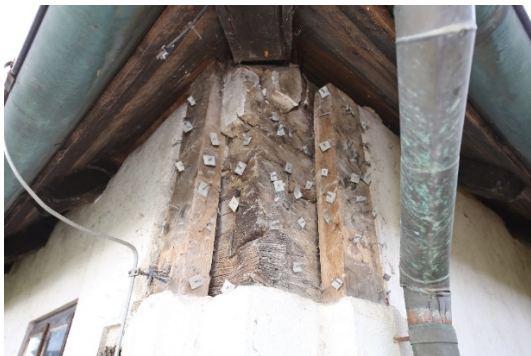
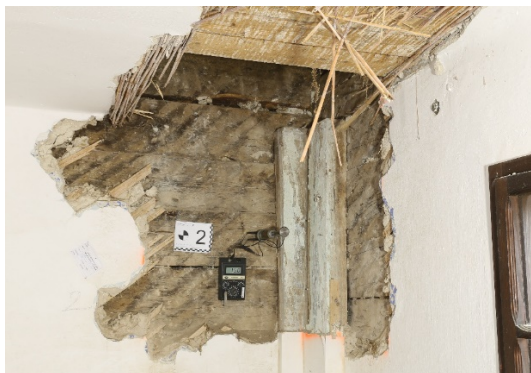
Figure 6 a)-c). Corner of the parish house in Mala Gorca (around 1830s). Initially, poor craftsmanship of the corners (dovetail notched joints) rendered the walls unstable. To address this, the walls were adequately, though not stylishly, improved by binding them with vertical planks and through the use of threaded bolts. Later, in the late 19th century, they were reinforced and plastered on both sides.

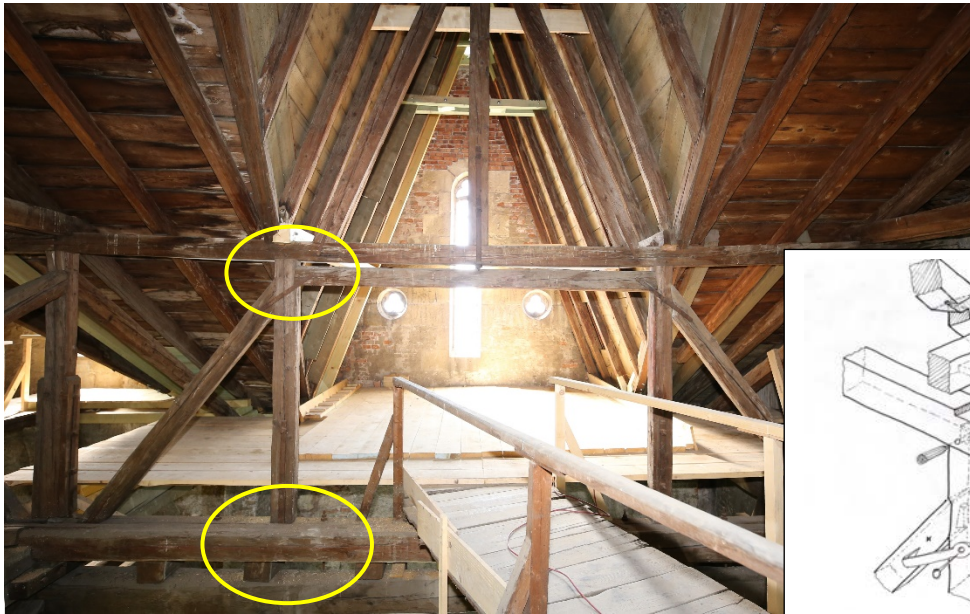
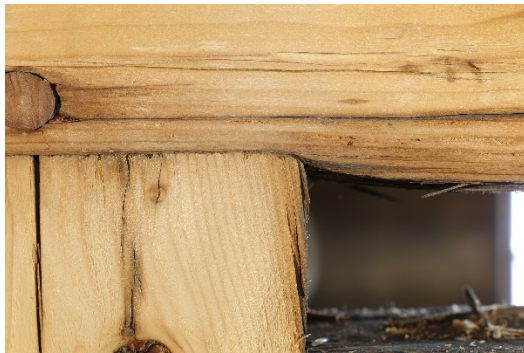
Figure 7 a)-c). Structure above the side aisle of the Zagreb Cathedral (1898). Each of the four segments of the roof with side gable walls spans approximately 6 m. To address this span, the solution involved constructing a beam-like structure, featuring wooden beams as flanges and wooden blocks with through bolts as a web (see lower detail). However, the structure deflected, partly due to the drying of the wood and the pressing of bolt washers into soft firwood, and partly due to the eccentricity of the loading. Additionally, the minimal end-grain surfaces of the queen posts caused compression crushing perpendicular to the fibres of the collar beam (left).

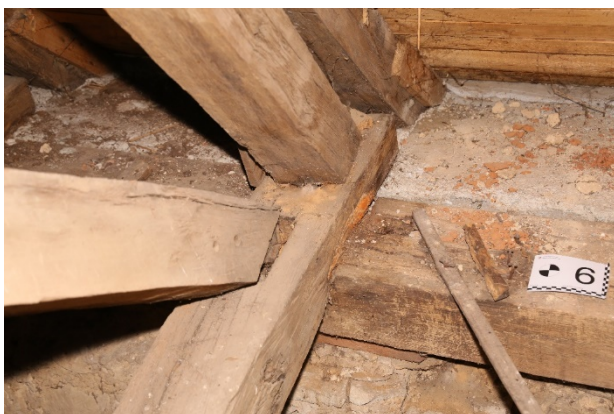
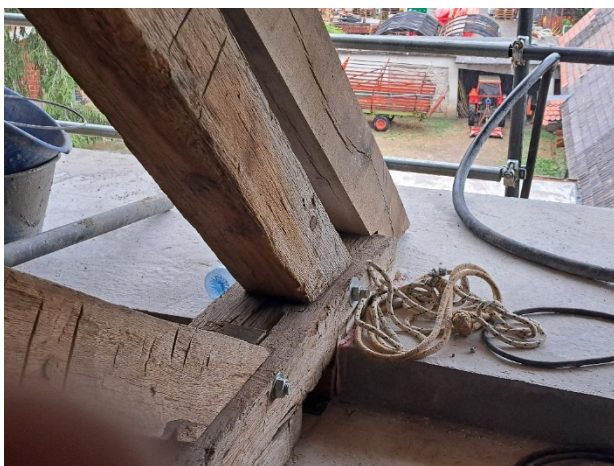
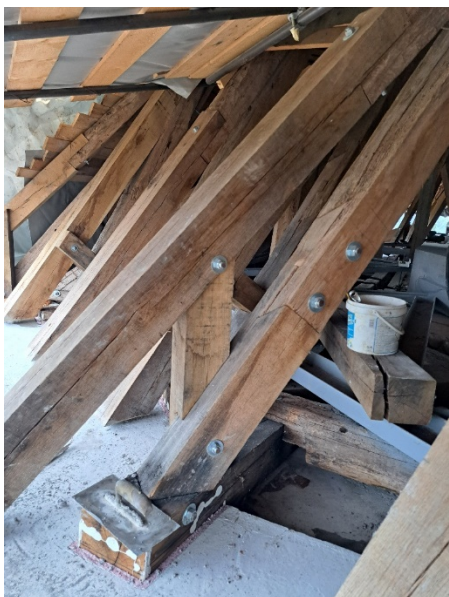
Figure 8 a) – f). Church of the Ascension of the Blessed Virgin Mary in Pokupsko (late 1700s). The Oakwood structure was damaged by distortion and opening of the joints and by biological damage (upper left). A reinforced concrete ring girder replaced wall plates, and rotten elements were partly replaced with prostheses. Tie beams and struts are now insulated in the concrete; the sprockets with birdmouth joint sit on the end of the beams (end grain opened for drying). Tenons and stop-splayed scarf joints with keys or wedges were used in reconstruction. These joints are fixed with threaded rods instead of the original wood pegs for reasons of better tightening and strength. Right column: Experts' sketches for the execution of joints and discussions with carpenters.

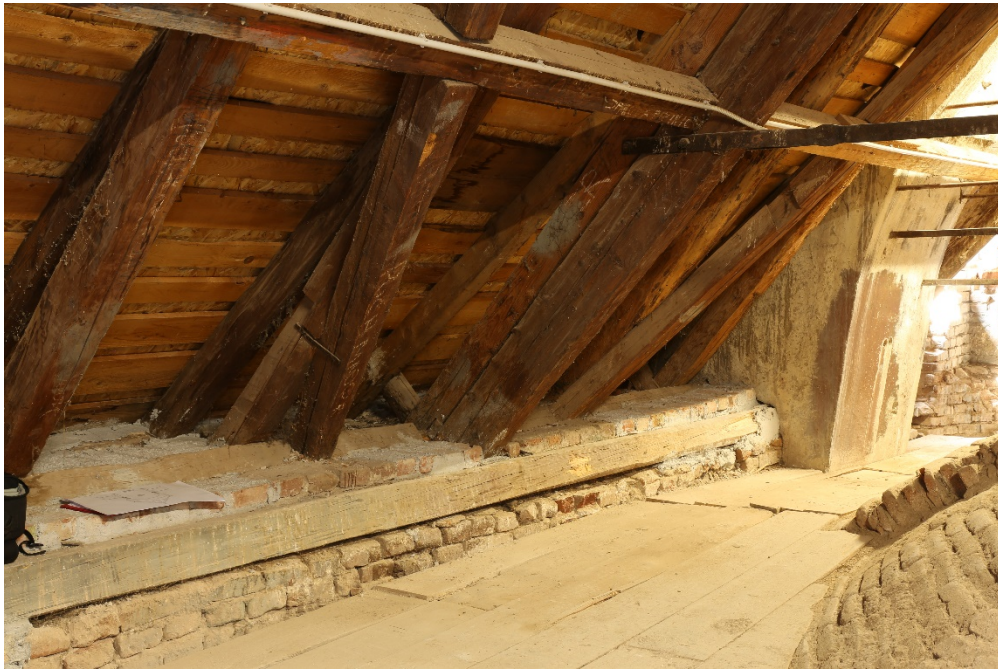
Figure 9 a) and b). Požega, Cathedral of St. Teresa of Ávila (1752). Due to the position of the dome, the roof was built as a reclining truss (in German "liegender Stuhl "). This popular structure relies heavily on load transfer to the wall supports, with tie beams installed only at the roof ends. Initially, the wall plate was laid in the brickwork; however, in later restorations, plaster or concrete was also used. This sequence exposed the wood at the supports to deleterious moisture risks and subsequent biological degradation. Once damage occurred, sketches of suggested replacements—including the installation of a concrete ring girder, a new ventilated and insulated wall plate, and prostheses for principal rafters and reclining struts—guided the engineer and carpenters in designing the final reconstruction.

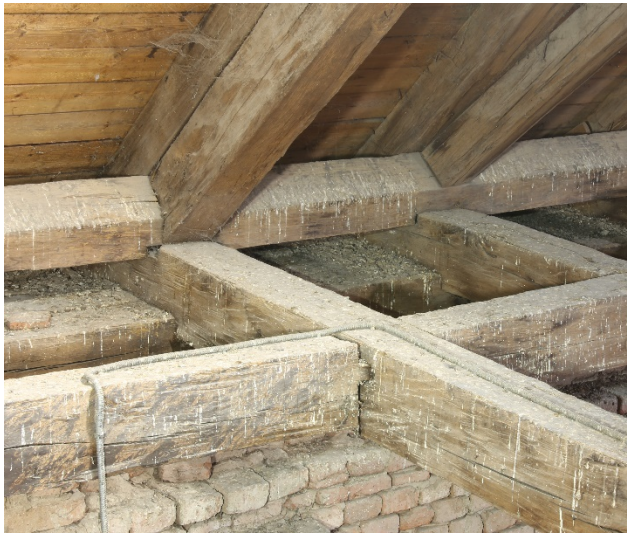
Figure 10 a) and b). Ivanić Grad, St. Peter the Apostle (1831). This is another example of a reclining truss. Initially, the double-wall plates exhibit biological damage, while the joints remain generally intact. The sketch on the right side shows a well-constructed assembly, with good execution of joints. The tie beams are correctly half-lap notched to wall plates, and the main beam is efficiently lapped with a crossed-tenon lap joint. As a result, even when wall plates are damaged, the joints and the rest of the structure remain stable. Such an assembly in oak wood, well-executed, presents a complex of very good stability in all directions; good craftsmanship ensures that there is no splitting or shear in the wood.

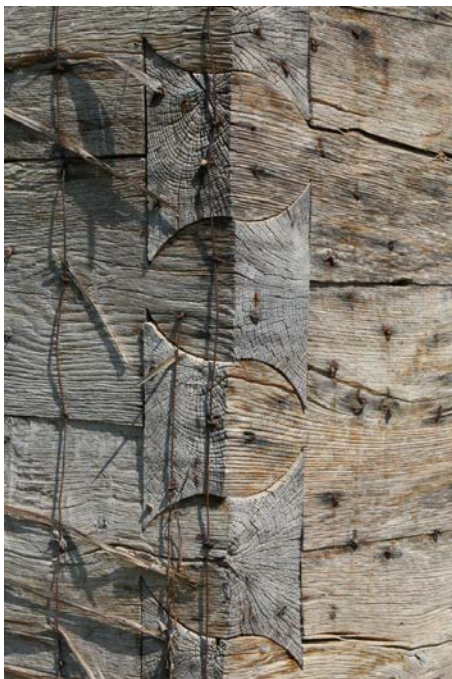
Figure 11 a) and b). Special type of dovetail corner joint (in German "Klingschrott") of a wooden Chapel of St. Mary (Brkiševina, central Croatia, early 1800s).

Figure 11 presents a rare dovetail corner joint with curvilinear cheeks of the tenons. The joint is very rarely found in literature; it was also rarely used, mainly in the alpine region (Bavaria, Austria, Switzerland [14]) and eastern European countries to build representative houses or churches. The photograph demonstrates excellent craftsmanship in the hand-making of these delicate joints. However, the joint possesses significant advantages over standard dovetailed corner joints:

The joint exhibits a notable self-tightening property: as the wood dries, the joint does not open but instead tightens toward the inner corner. In case of cracks or attempted failure, the shape of the joint blocks the propagation of cracks, preventing them from spreading through the connection. This sequence of self-tightening and crack blocking contributes to the joint's durability.

The engineer noted the strongly jointed walls in the small chapel. To preserve them, he decided to lift and relocate the structure during work on the foundations and new concrete slab. After repairing the foundations, the chapel can be lifted back into place.

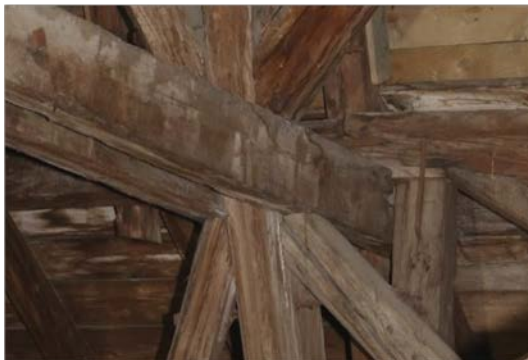
Figure 12 a) – c). The Zagreb Cathedral of Assumption of Blessed Virgin Mary (last reconstruction 1898). Joint of the principal rafter with double collar and wind-braces. A simple half-lap joint is prone to compression crushing when a moment is acting on the joint. When secured with bolts, the joint has smaller areas of compression perpendicular to the fibres, but the forces can be greater, although the bolts also provide the desirable friction. A cross-tenon lap joint, applied here, has 34% greater contact surfaces. Additionally, the compression in the shoulders is at  $45^\circ$ , which renders the compression strength (Hankinson's formula) approximately 26% greater than compression perpendicular to the fibres. In theory, a cross-tenon lap joint can withstand approximately 1.8 times greater stresses than a simple half-lap joint.

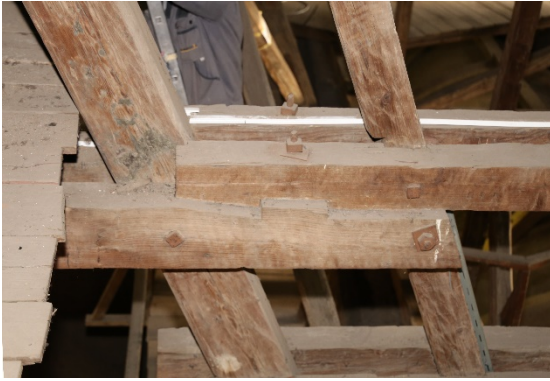
Figure 13 a) and b). Analysis of the joint between the principal rafter, double collars, and purlin to the side aisle. The crossed tenon lap joint between collars and rafter is very stable, with multiple half-lap joints secured by iron bolts. Interlocking in all three directions was assessed first. Subsequently, no wood failure—either in shear or in tension perpendicular to the grain—was recorded at any stage.

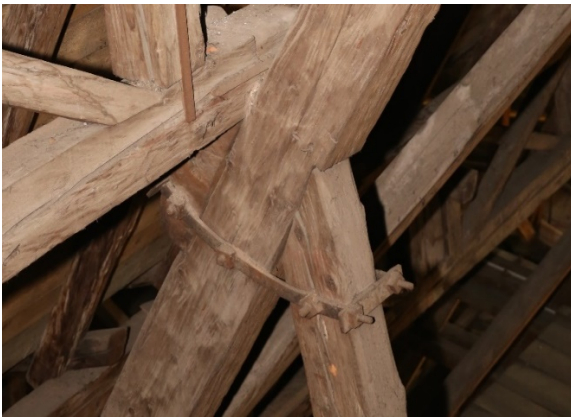
Figure 14 a) and b). Connection detail at the intersection of the principal rafter, main strut, and purlins. The main strut is tenoned approximately 2 cm into the principal rafter and further reinforced by a notched mortise-and-tenon joint to prevent lateral displacement. In the event of structural failure, loosening of the mortise-and-tenon joint would likely precede subsequent displacement, which would be restricted by the cleat and iron stirrup. The cleat and main strut are secured by a robust iron stirrup at the points of compound and I-beam purlin interface. These meticulously executed joints exhibit tight tolerances, high functionality, and exemplary craftsmanship, resulting in reliable structural stability.

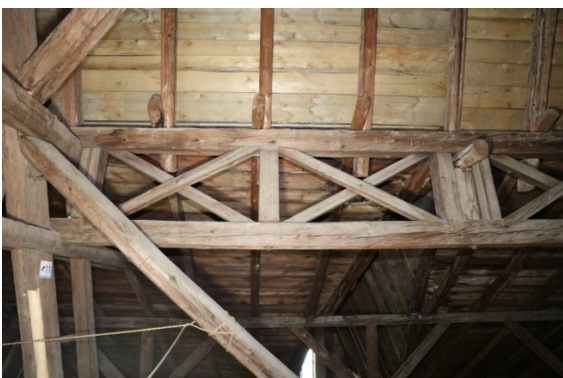
Figure 15 a) and b). At a span of 6.5 meters between the trusses, only a truss configuration is structurally feasible for the purlin. Minimal deflection is observed, while the roofing plane remains properly aligned. The precise assembly sequence of the complex joint is reflected in the firm and tight joints, demonstrating superior workmanship.

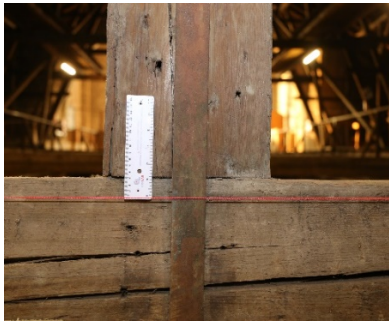
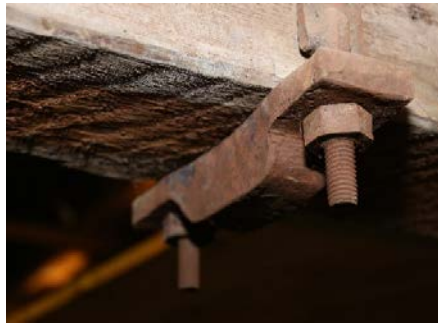
Figure 16 a)–c). Notable deviation from conventional engineering practice. The tie beams exhibit inverse deflection (left). Rather than maintaining a gap between the king post and tie beams, the beams are fitted with stirrups that induce upward tension toward the post (middle). Consequently, the entire truss assembly is tensioned, initiating at the tie beams and subsequently tightening each truss joint in progression.

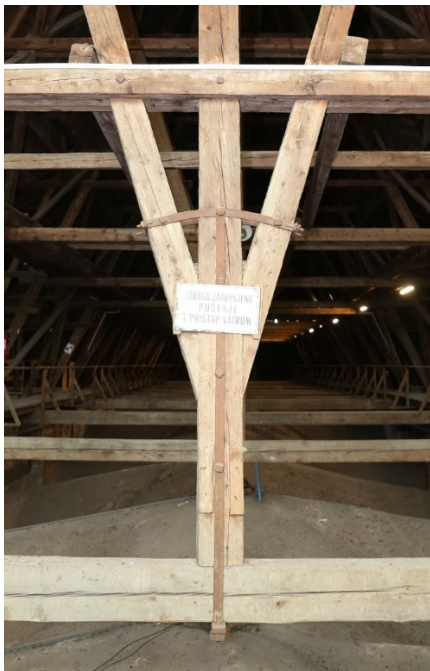
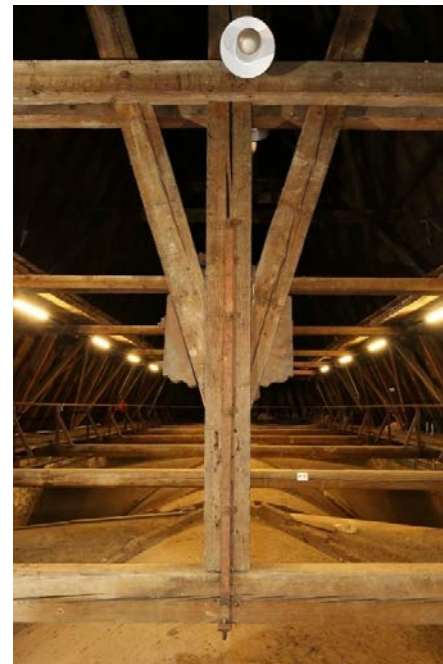
Figure 17 a) – d). This analysis shows the jointing sequence between the king post, tie beam, and supporting struts of the main aisle (two variants). The connections begin with housing and notched mortise and tenon joints, followed by the fitting of heavy ironmongery to secure tightness in all joints. Perfect craftsmanship and joint condition are observed.

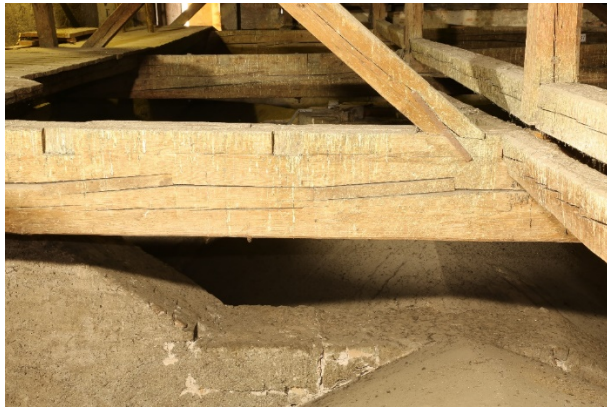
Figure 18 a) – c). An interesting complex is found in the roof of the side aisle of the Cathedral. The king post rests on a double beam with longitudinal stabilisers. Notice the insertion of skew blocks. They transfer the tension stresses of the upper beam to the compression side of the lower beam and vice versa [11]. This makes the double beam a true composite member. The stiffness and perfectly tight joints were affected only after the double beam sank into the wall insert due to extensive rot.

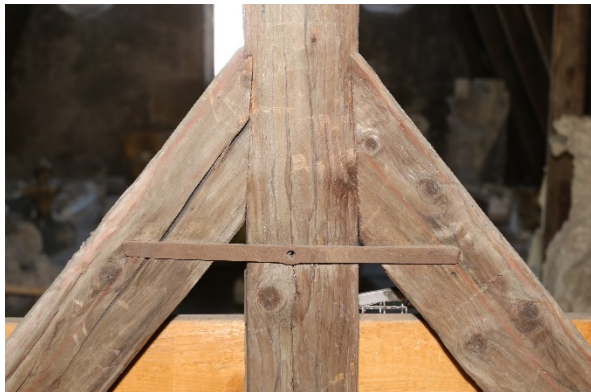
Figure 19 a) and b). Connections of the principal rafters to the king post at the ridge. Various solutions were found. The option seen in the photograph and the left sketch used housed notched joints with mortise and tenon. These were secured either by stirrups or by clamps with a central bolt. The solution on the right, a simple notched joint with clamps, was not firm enough and opened over time.

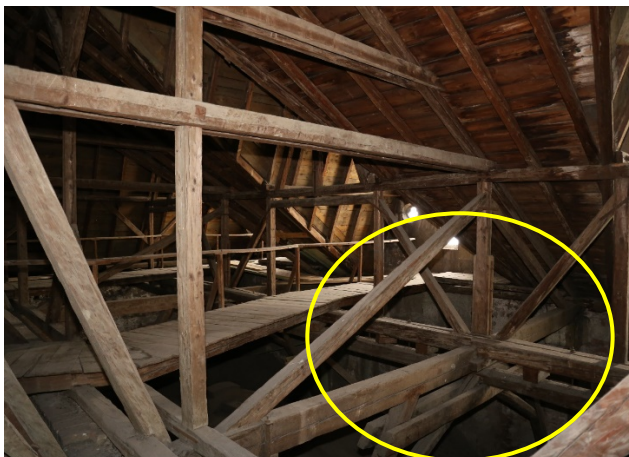
Figure 20 a) – c). Side aisle of the Cathedral. This is an example of a carpenter's ingenuity in complex spatial jointing. It features a composed I-beam, a queen post above, and a reclining truss underneath the joint. The forces are distributed evenly and transferred to the foundation (left sketch). The composed beam has lost some integrity due to the shrinkage and sinking of nut washers in the softwood, but it remains functional. Other joints, secured by iron connectors, still perform perfectly.

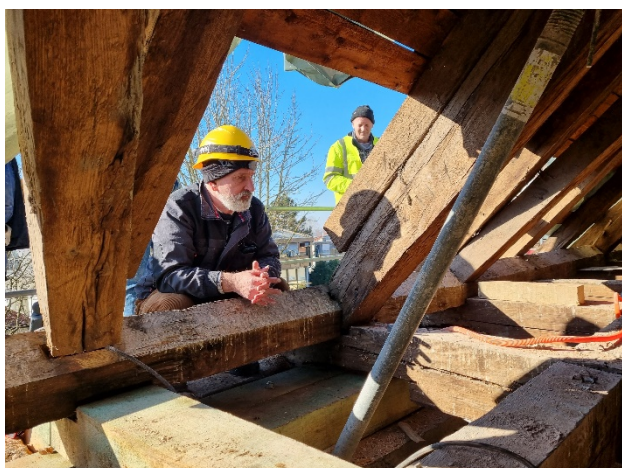
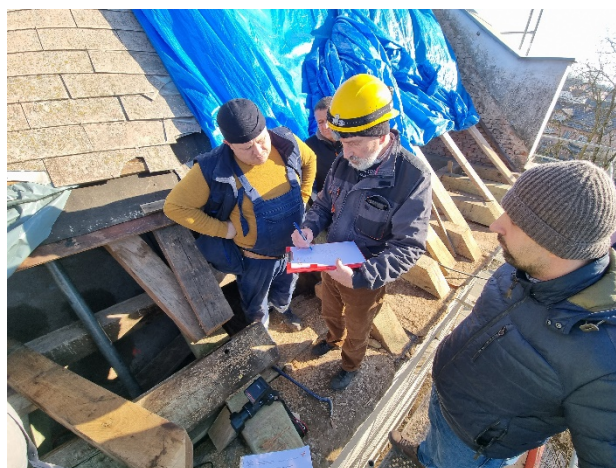
Figure 21. The work of an expert on-site consists of careful observations, crawling on the floor, and hanging from the trusses (the structural framework that supports the roof). The expert approaches the object with a camera and light, as well as measurement tools and scientific instruments used to assess its structural integrity. The process concludes with a discussion among all the involved parties, including carpenters, to achieve a satisfactory outcome for all. Photo by J. Pojatina.

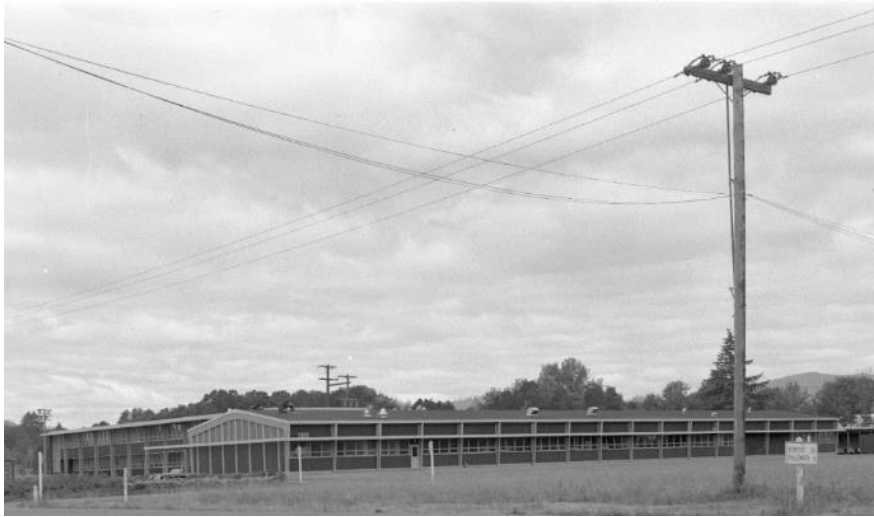
Figure 32. The Oregon Forest Research Laboratory (later renamed the Oak Creek Building), captured soon after completion in 1956 [17], showing a sunshade circumnavigating the perimeter of the building.

By comparing the existing configuration with the original blueprints, they identified several discrepancies, most notably, a missing portal in the east wing and the absence of a canopy that was originally attached to the exterior columns and ran along all sides of the building (see Figure 4), as confirmed by historical photographs (Figure 3) [17], [18]. The historical drawings do not include details of the timber connections, nor do they mention the bolted steel plates observed covering the face of all the inspected columns [18].

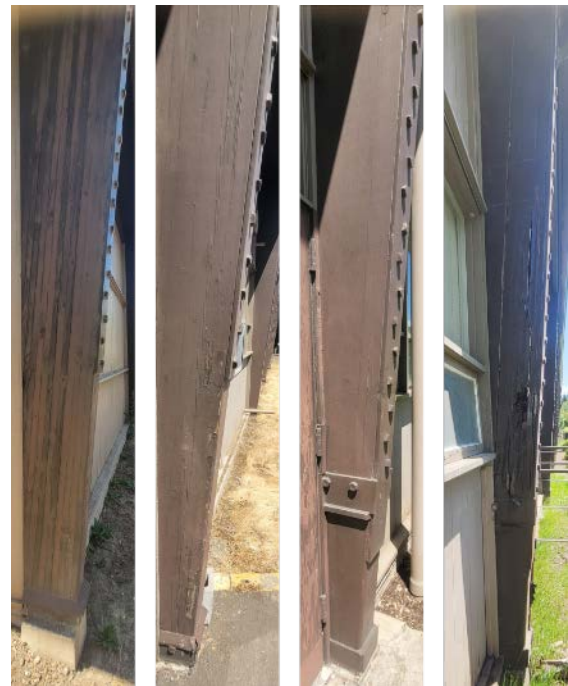
Figure 34. From left to right A13 with damaged coating, B8 with a wood prosthesis, D15 with a metal prosthesis and extended bracket, and D7 with notable brown rot in addition to a metal prosthesis and extended bracket.

Most glulam columns exhibited some degree of surface delamination. Discolouration, likely due to ageing and prolonged UV exposure, was also observed in several columns. Coating degradation ranged from minor to severe, with only a few cases showing extensive damage. In some instances, visible repairs had been made using either wood or metal components (Figure 5). One column, in particular, showed significant fungal decay and deep delamination (Figure 5); this element was flagged at multiple points throughout the assessment and should be prioritised for remediation.

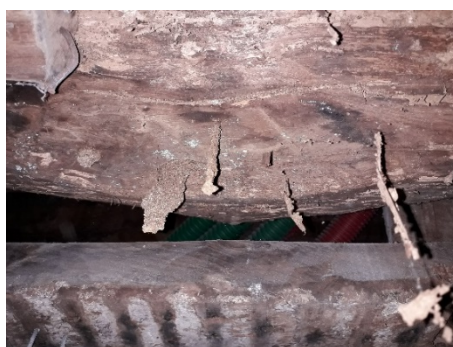
*Figure 1. Cocoons on one of the main beams of the 1st floor structure (ceiling of the Non-Teaching Staff Room)*

The Sá de Miranda Secondary School in Braga underwent renovations by Parque Escolar EPE in 2010, which included constructing new buildings and refurbishing existing ones. The original wooden floor beams and wall elements were preserved, while the floors, skirting boards, and wainscoting were replaced. Pine wood was used to replace the floors, whereas MDF was used for the panelling and some skirting boards. In 2015, signs of termite infestation were reported. A treatment was applied in March 2017. According to the Technical Specifications, this procedure involved: "Comprehensive treatment of the existing timber and timber to be used inside each room, including vacuuming of the air boxes, vacuuming and general cleaning of the entire structure, replacement of rotten or damaged solid timber in the existing slab structures (main beams, secondary beams, floor support beams and others), floors, skirting boards, wainscoting, door frames and trims. Treatment by spraying and injection with certified biocidal products such as XILIX GEL or equivalent, after removing the varnish and replacing the damaged areas" [1]. During a site visit in October 2018, signs of active infestation were still observed in untreated wood, although the effectiveness of the 2017 treatment is not necessarily in question. Specifically, in the Non-Teaching Staff Room, the removal of the false ceiling revealed the presence of termites in the structural elements of the ceiling/floor of Floor 1 (see Figure 1).

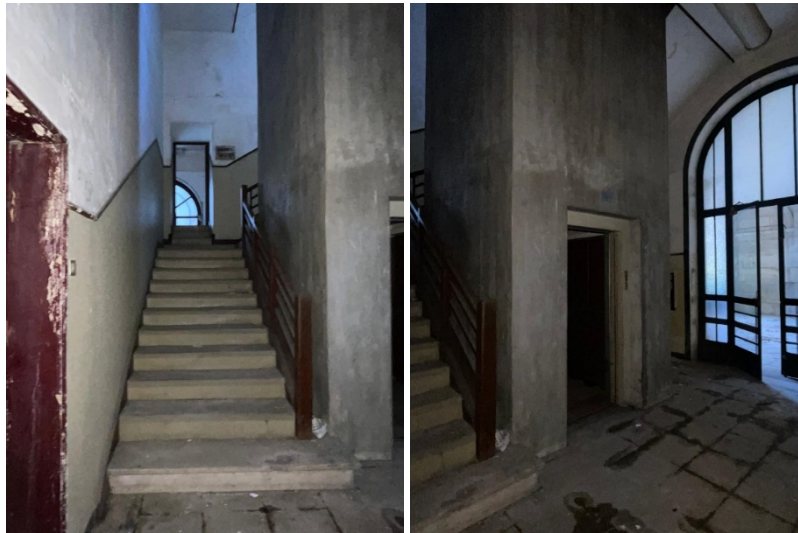
Figure 3. Reinforced concrete stairs and elevator shaft

In terms of its architecture, the building can be characterised as an example of the *Beaux Arts* style, stripped of ornamentation or with minimal decorative expression. The ornamental austerity observed in the treatment of the façades and the interior spaces is likely due to budget constraints and the functional nature of the program. The building's prolonged and uncertain construction process reflects limited resources, as evidenced by the project's incomplete execution. In addition to the original simplicity, there were several low-quality interventions throughout the building, including half-height brick walls, chipboard doors, exposed electrical and plumbing systems, styrofoam and plasterboard ceilings, unsightly light fittings with no concern for integration, etc. These changes contribute to a general sense of disorder and improvisation. As a result, the interior of the building lacks architectural or heritage value. This area previously accommodated various services of the University of Minho, featuring a functional character. Successive interventions conducted over time have gradually reduced architectural significance. In clear contrast to the private section, where the original architectural qualities have been respected, the public section underwent significant alterations, including the construction of a reinforced concrete staircase and an elevator shaft (see Figure 3).

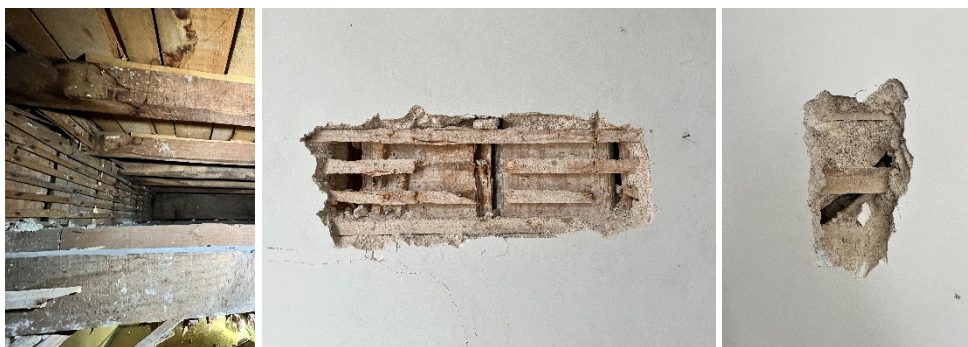
Figure 4. (a) Connection of floor beams with partition wall; (b) Partition wall with vertical planks; (c) Partition wall with diagonal planks

From a construction standpoint, the building adheres to the conventional architectural model of its era. The outer perimeter is delineated by load-bearing stone masonry walls, which are interconnected with similarly load-bearing, albeit narrower, stone walls. These walls are cross-linked to support the wooden structural elements, such as beams, upon which the parquet flooring and partition walls are constructed. Certain interior partition walls also serve a structural function. The roof structure, including the cupolas of the turrets, is composed of wood. The thickness of the granite masonry load-bearing walls ranges from 0.50 to 0.80 meters. In addition to the granite masonry walls, the majority of the interior walls are constructed using Scots Pine (*Pinus sylvestris*) boards, oriented either vertically or diagonally (Figure 4). While the granite masonry walls support the primary structure, some partition walls also function as intermediate supports for the timber beams.

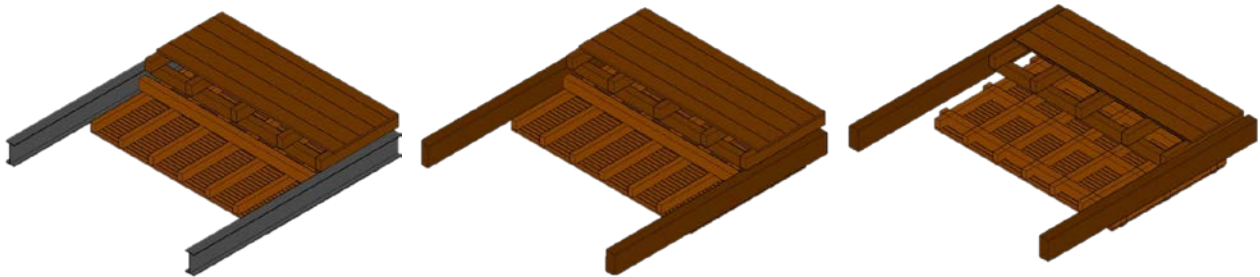
Figure 5. Floor systems: (a) Type 1; (b) Type 2; (c) Type 3

In general, it was observed that there are two semi-independent structures on each floor: one designed to support the loads on the upper floor and the other intended to support the ceiling on the lower floor. Both systems are anchored on the main beam structure made up of metal profiles and/or wooden beams. Floor Type 1 is made up of main beams made of metal profiles (IPN) embedded in the stone masonry walls. Two sets of wooden structures are laid perpendicular to these: one supporting the upper floor, and the other, the lower ceiling. The flooring system includes secondary sawn Riga Pine beams, which serve as support for the flooring beams and act as lateral support for the main beams. The structural system supporting the lower floor ceiling consists of secondary beams made of Riga Pine wood, onto which additional Riga Pine beams are fixed. The assembly is then enclosed by wooden boards, as illustrated in Figure 5, representing Floor Type 1 (a). The Type 2 Floor is a variation of the Type 1 Floor, where the metal beams are replaced by sawn chestnut (*Castanea sativa*) beams.

Accordingly, the main chestnut beams support both the upper floor and the lower ceiling structure, which remain identical to those described for Floor Type 1. Floor Type 3 differs from the others in that it has two completely independent structures. The structure that supports the upper floor consists of main chestnut beams embedded in the stone masonry walls, combined with dowel beams in Riga Pine, which support the beams that receive the flooring. On the other hand, the beamed ceiling is fixed to beams and dowels made of Riga Pine, which form a frame. For more details, the authors suggest reading [3].

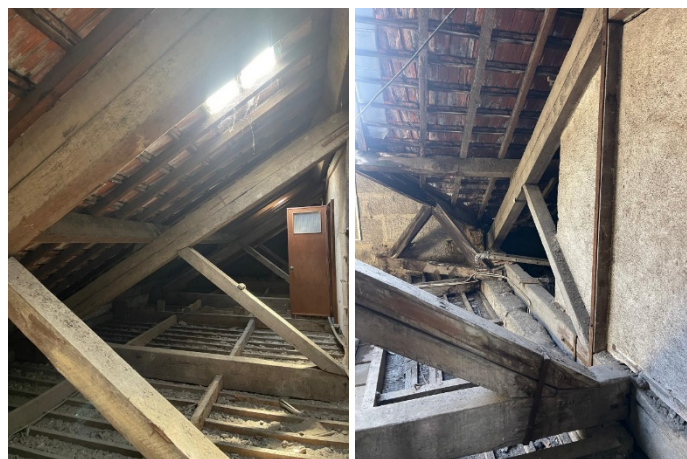
Figure 6. The roof structure is made out of wooden trusses with various geometries

The roof structure consists predominantly of wooden trusses, with different geometries, from simple to composite, varying according to the clear span to overcome and the function. The main trusses are composite, but there are also simple trusses (to support the corners), half trusses and others (see Figure 6).

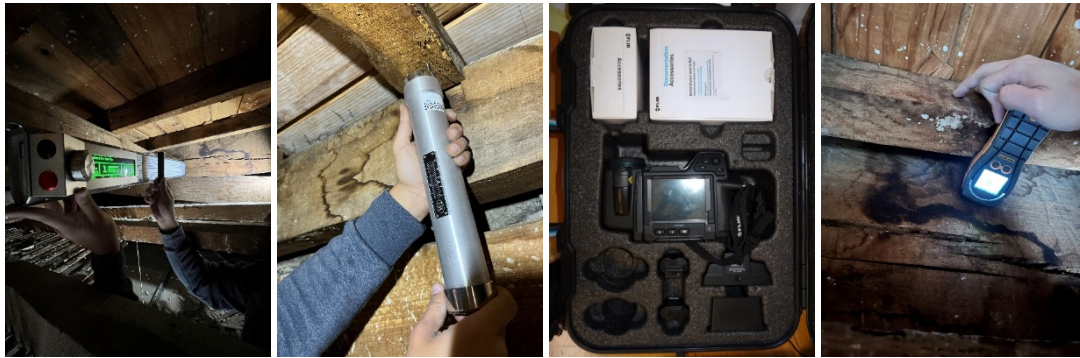
*Figure 7. (a) Controlled perforation test; (b) Surface hardness test; (c) Thermographic camera; (d) Water content measurement with hygrometer*

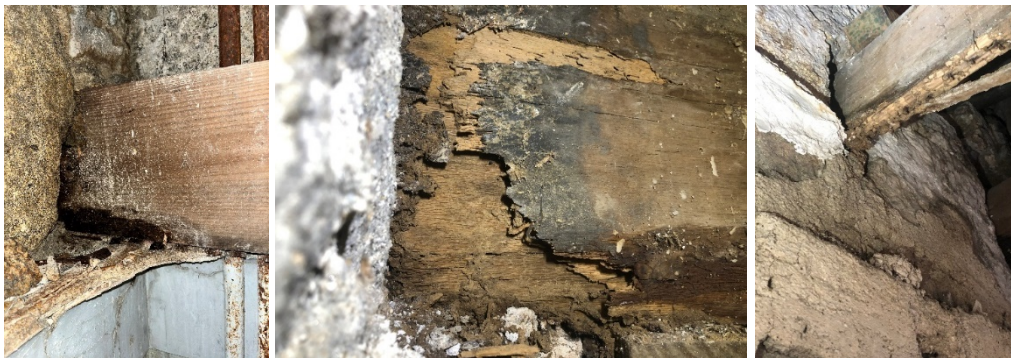
*Figure 8. a) Beam of the chain that supports the ceiling of room S1.3 with damp and rot fungi; (b) Beam of the main beam of room S2.8 with rot fungi and beetle infestation; (c) Beam of the chain that supports the ceiling of room S2.2 with rot fungi and beetle infestation*

Within the building, two areas were identified as being significantly compromised by advanced rot fungi, particularly in the encasement of wooden beams within masonry, as depicted in Figure 8. These pathologies remain active due to an unresolved source of moisture, which perpetually fosters conditions favourable for the proliferation of biological agents. In these affected areas, hygrometer measurements indicated a water content in the wood exceeding 30%. Conversely, in regions distant from the supports, the wood exhibited water content ranging from 10% to 12%, values that are consistent with the building's use and the prevailing environmental conditions (characterised by low relative humidity and high temperatures) at the time of measurement.

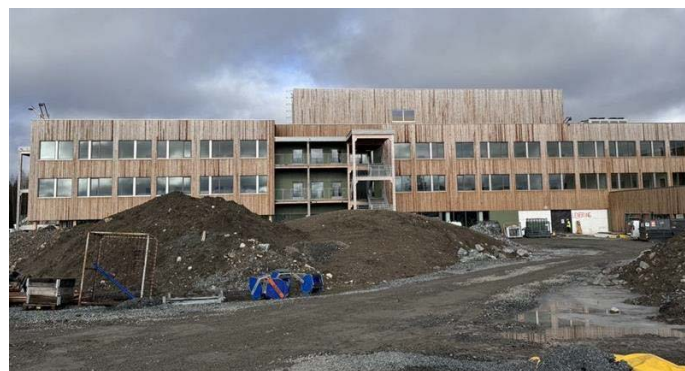
*Figure 51. Aursmoen School*

Aursmoen School is a three-story building in Aursmoen, Norway, under construction, shown in Figure 1. The building comprises five parts, totalling approximately 20,000 m<sup>2</sup>, and includes a new kindergarten with 10 departments, a resource department, adult education, a leisure club, and a sports hall. The structural system consists of columns and beams in GLT, and CLT shear walls, in addition to CLT floors.

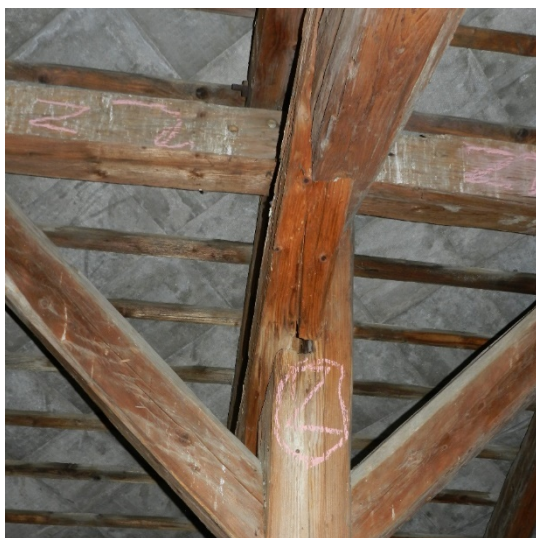
Figure 3. Loose connection of the strut and queen post

In the next phase, based on the onsite wood preservation observations [14] (Fig. 2), we intuitively adjusted the properties of the connections: the tension or compression limits were determined, and the stiffnesses were adjusted according to the gaps or the damage of the connections (Fig. 3-4).

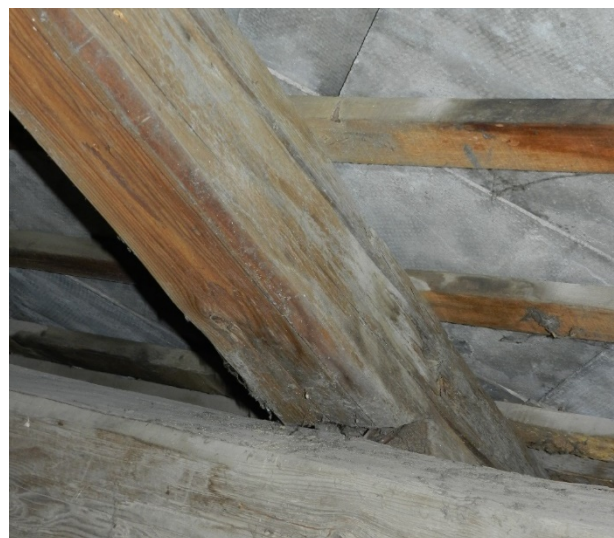
Figure 4. Loose connection of the rafter and lower purlin
