PROCEEDINGS OF  
7th INTERNATIONAL CONFERENCE ON  
STRUCTURAL HEALTH ASSESSMENT OF  
TIMBER STRUCTURES

# Proceedings of the SHATIS 2025 – 7th International Conference on Structural Health Assessment of Timber Structures

3rd – 6th September 2025, Zagreb, Croatia

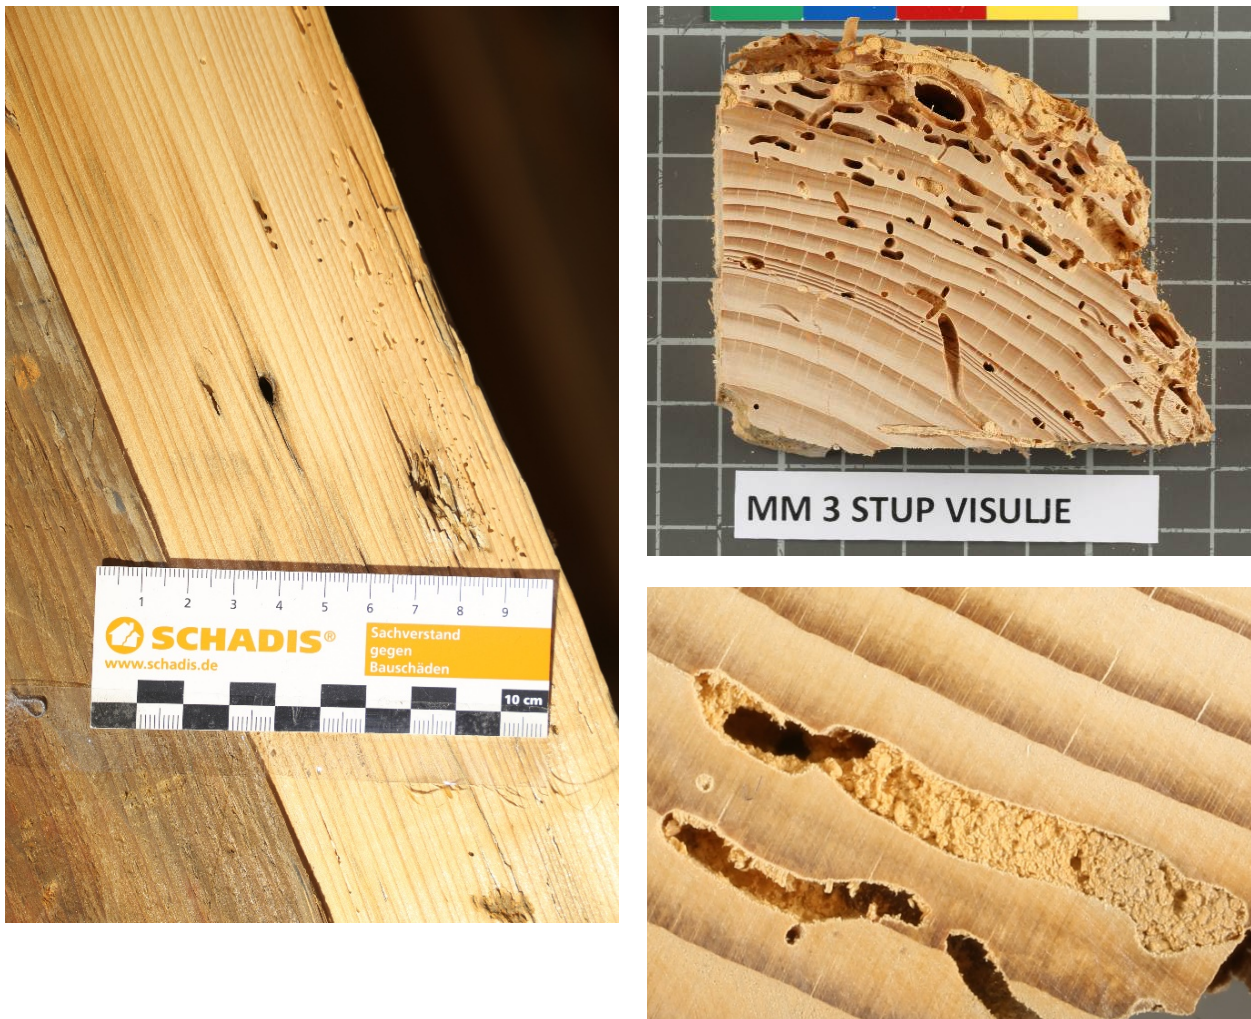
Damage along the beam edges is visible only at scattered exit holes. Beam edges contain sapwood, which is heavily infested by the house longhorn beetle *Hylotrupes bajulus* (elliptical larval tunnels, approximately 3×5–7 mm, filled with coarse yellow frass). Circular larval tunnels of 1.0–1.5 mm, filled with white powdery frass, indicate infestation by Anobidae. The moisture content was below 16%, so such damage can be ignored, provided the wood remains dry and the roof is well-ventilated. Often, softwood beams were more severely damaged than oak beams; however, insect damage was mainly limited to the sapwood. In large-section elements, infestations may be ignored unless there is an ongoing risk of increased moisture (Fig. 2).

*Figure 2. Left: half of the top surface of the beam was slightly planed to clean the dust and dirt. Damage can be seen only from sporadic exit holes, and only in sapwood-containing edges of the beam. Top right: polished cross-section of the edge of the beam containing a large amount of sapwood and larval tunnels. Bottom right: enlarged larval tunnel filled with coarse excrement.*

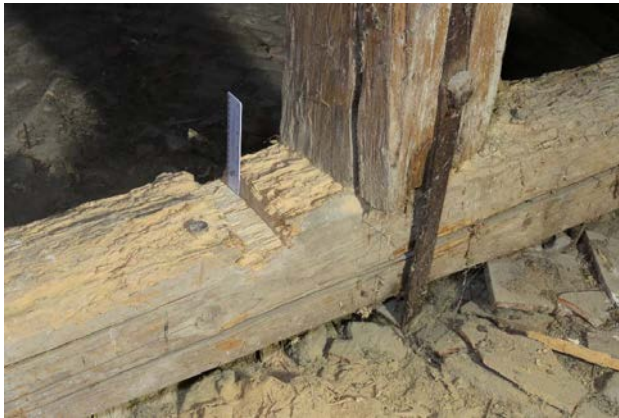
An example of a tie beam, hewn from a small-diameter log, is presented. Consequently, a substantial portion of the upper surface and corners comprises sapwood. The upper section is almost entirely decayed, while the remaining 4 cm exhibits extensive insect damage and staining from bird droppings. The proposed reduction in cross-section (1 cm on both sides due to hewing inaccuracy and surface loss, and 9 cm from above) leaves only 53% of the original effective cross-section intact (Fig. 5).

Figure 5. The tie beam was hewn from a small-diameter log; consequently, the large portion of the upper surface and corners contained sapwood, which was completely eaten by insects, leaving only 53% of the effective cross-section.

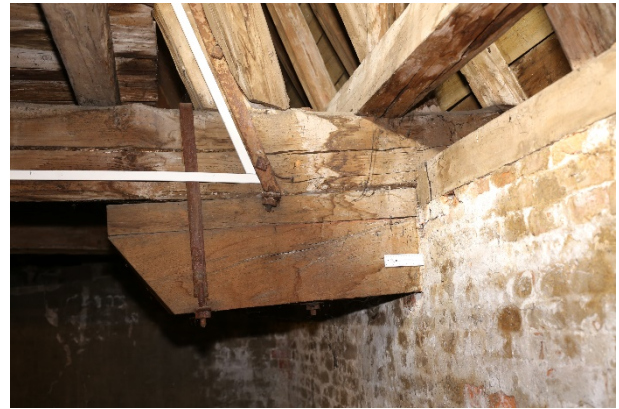
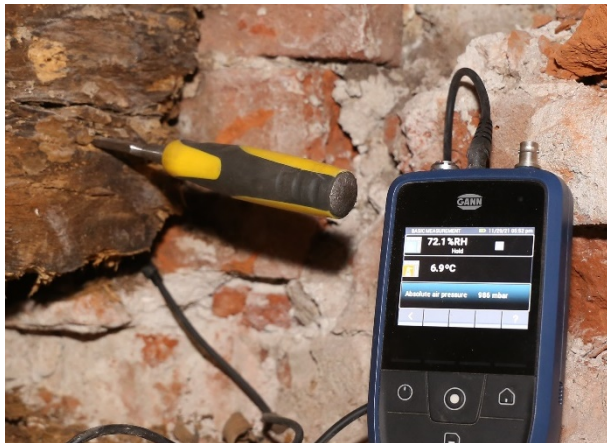
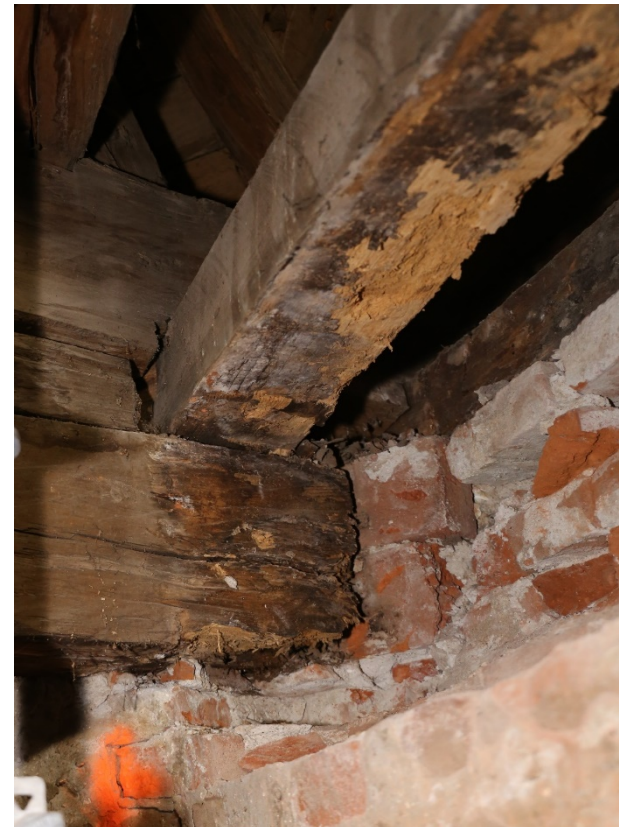
Damage to the support structure of the Zagreb Cathedral's central nave truss (1888) is classified as substantial and ongoing. The truss components (principal rafter, rafters, sprocket, and tie beam) consist of softwoods (SW, top left and right images, Fig. 6). Carpenters understood the risk of wood-brick contact and strategically used oak wood (OW) corbels to mitigate this risk. Visual inspection outside the wall reveals no deterioration. However, resistogram results (bottom left image, Fig. 6) show decay in the softwood, not the oak. Additional analysis was conducted. After partial brick removal (view from below, bottom right image, Fig. 6), extensive decay was evident on many corbels and wall plates. With a moisture content of 72% (middle left image, Fig. 6), the infection is deemed severe and active. These elements are recommended for replacement.

Figure 6. Severe damage to the support of the truss of the central nave of the Zagreb Cathedral (1888), with still ongoing decay activity.

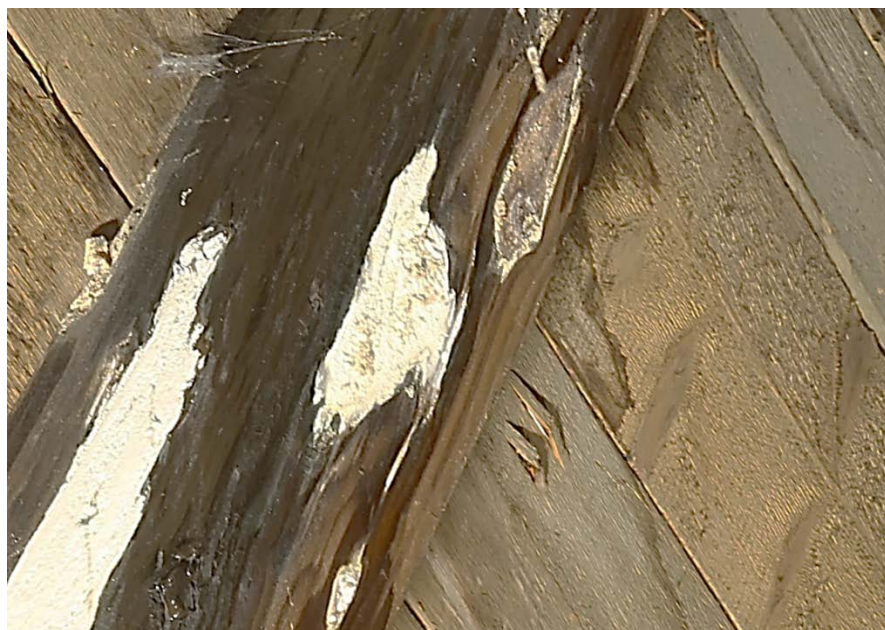
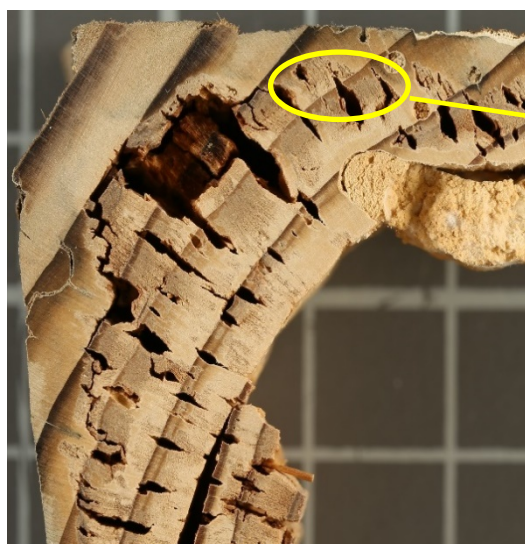
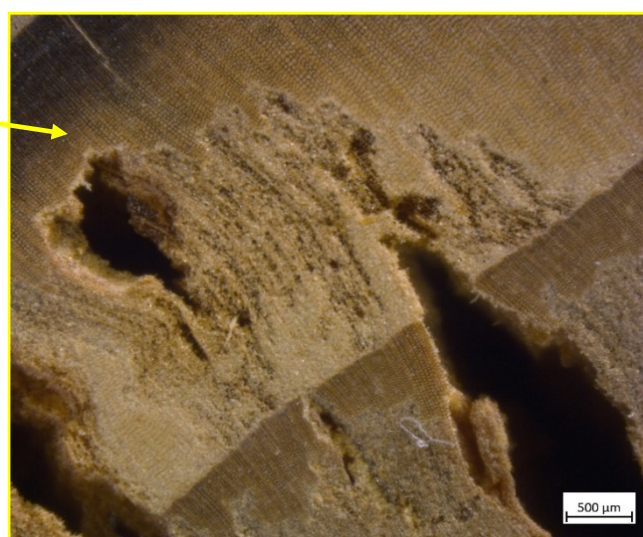
Catastrophic wet-rot damage (white fruiting body likely *Rhodonina placenta* (Fr.) Niemelä) developed beneath the leaking roof window. The fungus stains the surface brown, reddish-brown to dark brown, but leaves it apparently undamaged (top image in Fig. 9). This brown-rot fungus is notorious for causing internal wood decay. At the same time, the exterior remains visually intact or only slightly deteriorated, and it partially degrades lignin [16], [17], [18]. The micrographs (both bottom images in Fig. 9) corroborate the literature, showing that infection spreads via wood rays inward, destroying holocellulose and lignin in the inner earlywood layers. A detailed analysis of the bottom right image in Figure 9 reveals that the decayed wood tissue surrounding the cracks is darker brown than the adjacent tissue, likely due to a higher lignin concentration in these degraded areas (Fig. 9). Immediate remediation is required: repair the leak and replace the entire rafter.

*Figure 9. Catastrophic damage by wet-brown-rot: top-centre image – white fruiting body indicates most probably Rhodonia placenta (under the leaking roof window); bottom images – micrographs at different magnifications of decayed wood tissue in close to surface zone with lots of cracks.*

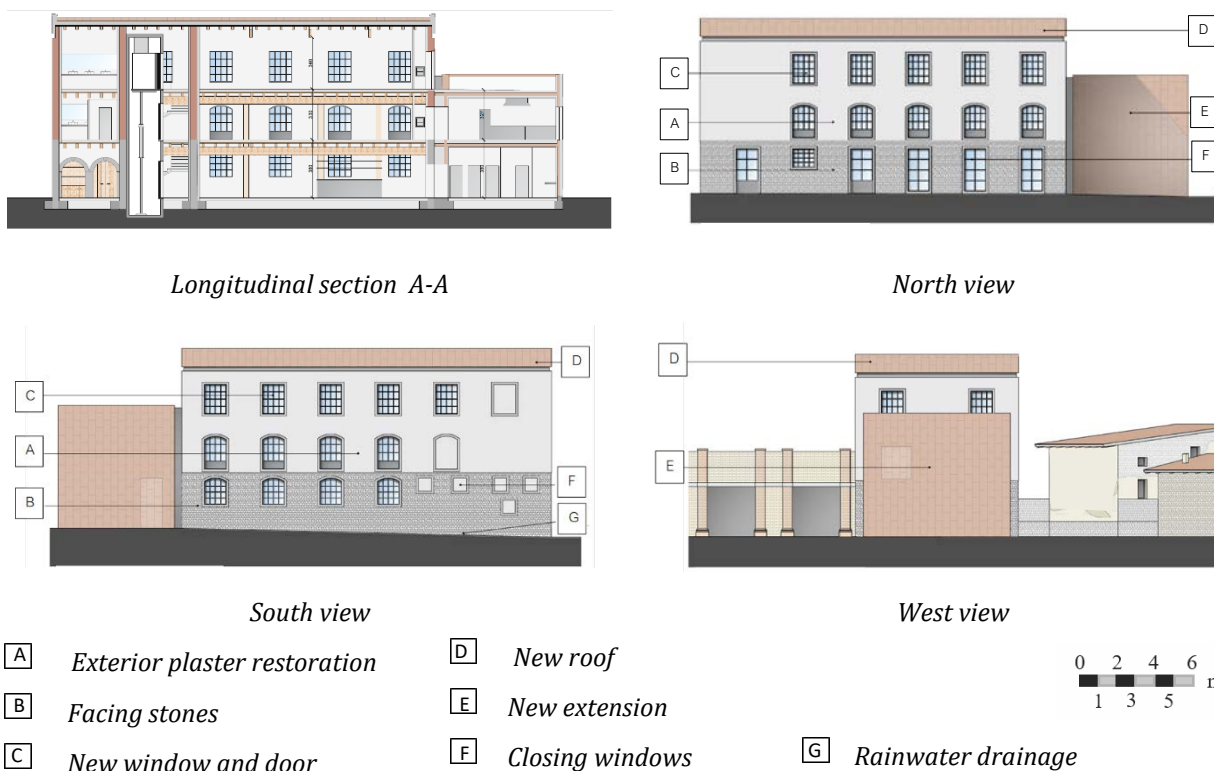
Figure 6. Project elevation views

In line with key architectural principles (i.e., distinguishability, material compatibility and preservation of historical memory), the intervention focused on maintaining the building's original forms, volumes, and external finishes ("skin"). A lateral building extension with a Cross-Laminated Timber (CLT) structure, seismically separated from the historic building, was designed using materials that are clearly identifiable even from the exterior and was positioned either detached or recessed in relation to the historic construction (Figure 6).

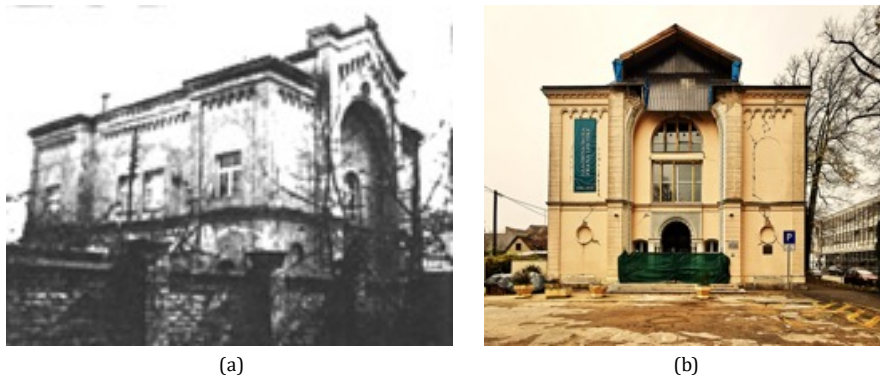
Figure 1. Building before the earthquake (a) and its front western façade after the 2020 earthquake (b).

The earthquake on December 29, 2020, caused significant damage to the masonry walls. The western façade's gambrel collapsed, and the façade walls developed severe cracks, especially along the contacts of the original and infilled parts of the walls in the original openings (Figure 1(b)). On the ground floor, cracks appeared along the contacts of the reinforced concrete floors and the supporting masonry walls (Figure 2(a)). On the first floor, damage occurred in the masonry arches and spandrel parts of the masonry walls (Figure 2(a)). The lightweight timber dome supported by masonry arches remained undamaged. Overall, the western massive part of the building sustained major structural damage, likely due to the tilting of the western part of the building caused by local ground properties where liquefaction might have occurred during the earthquake.

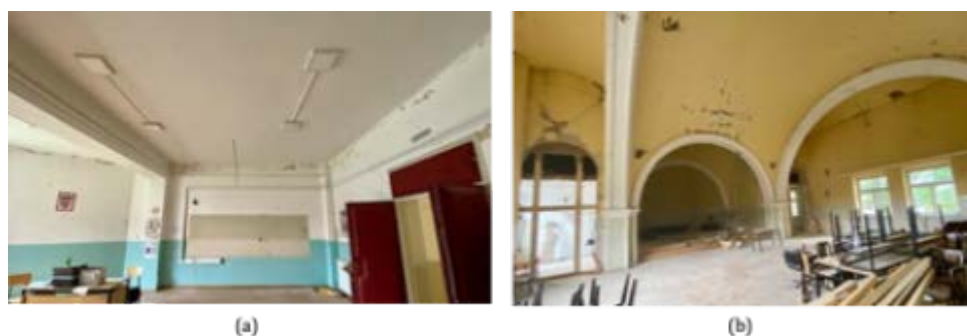
Figure 2. The damaged interior: the south view of the ground floor(a) and west-north view of the first floor (b).

During WW2, the synagogue ceased its function, and the state authorities repurposed it for public service. The ground floor interior was changed by adding partition walls of different thickness. The two-floor central hall was divided in height by massive new floor structures (Figure 2(a)). Façade windows were partially or entirely closed by masonry infills. The massive masonry arches supporting the timber domes and domes themselves were preserved in the original form, while passages between rooms were partially or entirely closed.

The original structure has a laterally softer upper story, which results in large deformations and severe damage to walls and arches, as shown in Figure 2(b). The lower, stiffer story suffered shear damage mostly along the contacts of reinforced concrete and supporting masonry walls (Figure 2(a)). The observed consequences of the earthquake are well simulated by the herein presented 3Muri assessment. Therefore, it can be presumed that the computation model and method of structural analysis give a realistic prediction of the strengthened structure's behaviour, as presented in Figures 6, 8, and 9. Figure 9 illustrates the distribution of damages at the significant damage (SD) limit state due to the action of the earthquake in the longitudinal (X) and transversal (Y) directions. The colour codification of damage levels is shown in Figure 8. More than half of the masonry piers and walls, as well

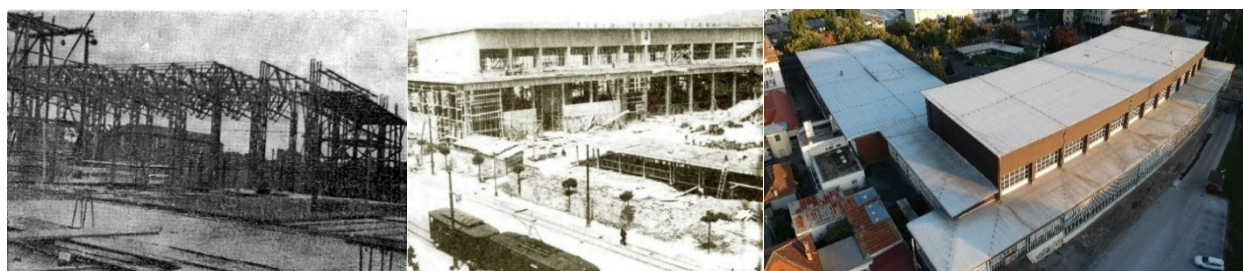
*Figure 2. Photos from the construction phase of the museum AND museum building filmed by UAV*
