# Study of the Corrosion Behavior of Stainless Steel in Food Industry

**Abstract:** AISI 304L stainless steel is widely used in the processing equipment and food and beverage handling industries due to its corrosion resistance, hygienic properties, and cost-effectiveness. However, it is prone to pitting and crevice corrosion phenomena, the development of which can be influenced by factors such as chloride concentration, temperature, humidity, and bacterial presence. Surface treatments, including roughness levels and residual tensile stress, can significantly affect the corrosion behavior and resistance of the material. This study aims to evaluate the impact of three different surface treatments on the durability of AISI 304L steel. The correlation between surface roughness resulting from pre-treatment and pitting potential values will be examined. Additionally, the influence of different concentrations of biocide additives on surface durability will be assessed to determine the maximum effective concentration for preventing pitting phenomena. Passivation processes will also be evaluated as a potential solution for improving the pitting potential and overall durability of the compo

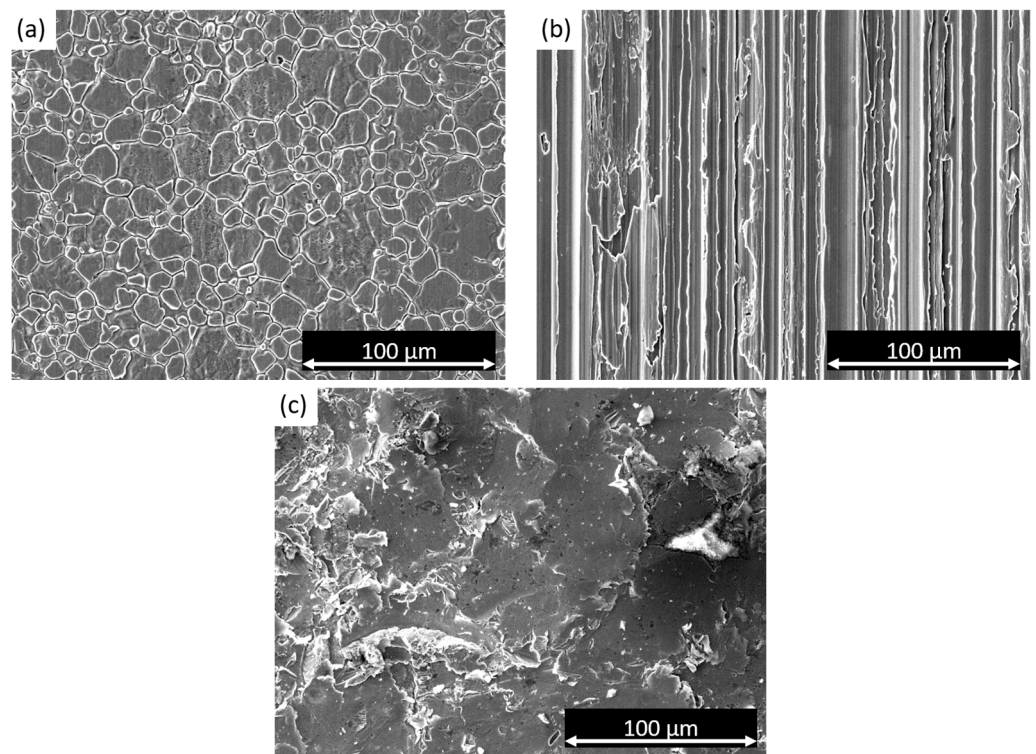
SEM observations were used to examine the surface morphology of the three samples under investigation, as depicted in Figure 1. Figure 1a exhibits the cold-rolled surface, revealing clearly visible and coarse grains. On the other hand, the satin finish specimen, depicted in Figure 1b, displays a distinct directional pattern resulting from the specific brushing technique used for this surface treatment. It is important to note that satin finish is a superficial treatment that does not induce anisotropic behavior in the sample. Figure 1c presents the sandblasted sample, showing a highly damaged surface indicative of the intensive surface treatment.

**Figure 1.** SEM micrographs of (a) cold-rolled sample, (b) satin finish sample, and (c) sandblasted sample.

The average mean value roughness of the sandblasting treatment is ten times higher than the other treatments, and the R<sub>z</sub> value is exceptionally elevated. In the case of the satin finish, the process leads to a horizontal roughness that is twice as high as the vertical roughness. However, the cold-rolled finish stands out as the only treatment with a significantly low roughness value.

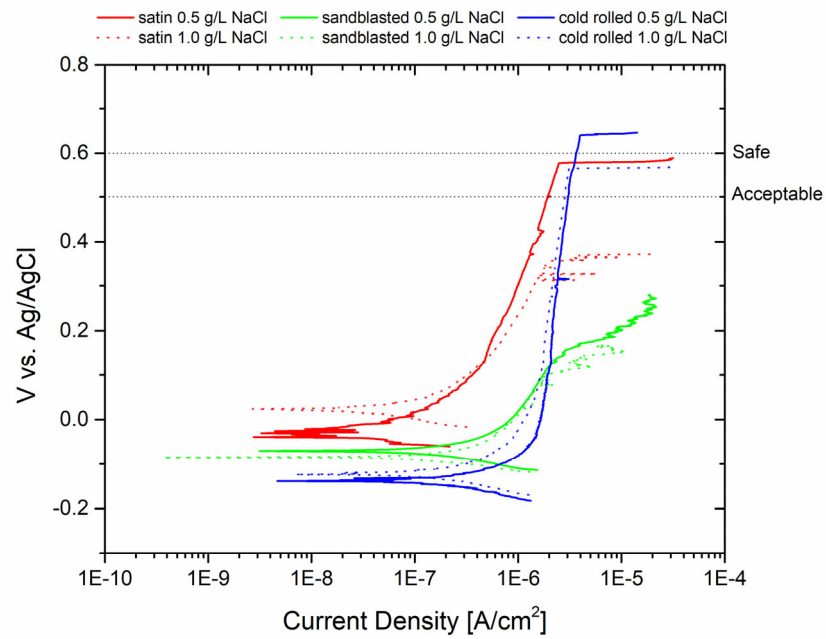
Potentiodynamic analyses were carried out in two different test solutions correlating the pitting potential  $E_{pit}$  values to the surface roughness of the samples. The results are depicted in Figure 2. The pitting potential values of the samples were as follows: for the sandblasted specimen, it was 0.182 V (0.5 g/L NaCl) and 0.138 V (1 g/L NaCl); for the satin specimen, it was 0.574 V (0.5 g/L NaCl) and 0.343 V (1 g/L NaCl); and for the cold-rolled specimen, it was 0.804 V (0.5 g/L NaCl) and 0.51 V (1 g/L NaCl). In order to assess the suitability of the surface treatments for machinery applications, the figure includes an acceptable and safe pitting potential value. According to the literature [28,29], 0.5 V vs. Ag/AgCl can be considered an acceptable pitting potential value, while 0.6 V vs. Ag/AgCl represents a safe value. As a concentration of 1 g/L of NaCl is considered very high if the plant water is potable (even after biocide addition), it is possible to conclude that the cold-rolled and satin finishes can be considered safe. However, the sandblasted sample is highly susceptible to pitting corrosion.

**Figure 2.** Polarization curves of AISI 304L with different surface treatments in contact with two different aggressive solutions.

The potentiodynamic test evaluation indicates that sandblasting can be detrimental to corrosion resistance, which can be attributed to the extensively damaged surface of the specimen with a less resistant passive layer. As mentioned earlier, higher roughness reduces corrosion resistance. Roughness measurements were conducted and compared with the pitting potential, as shown in Figure 3, to establish a proper correlation.

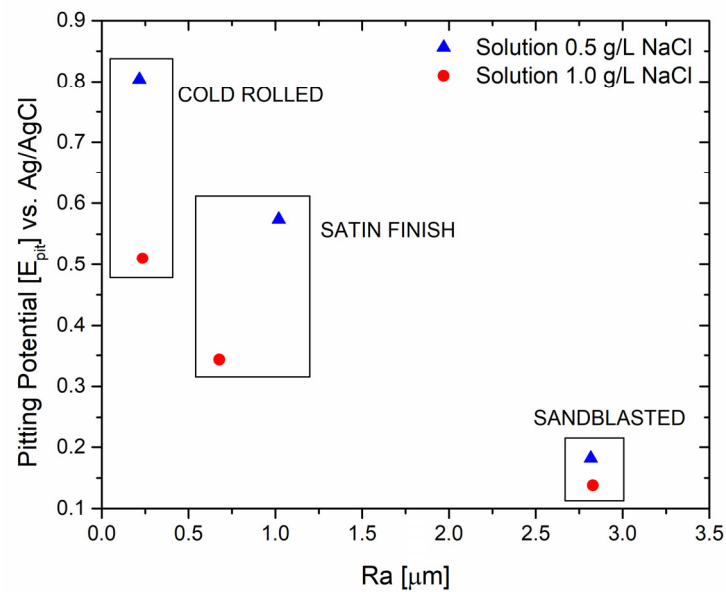
**Figure 3.** Correlation between average roughness and pitting potential values.

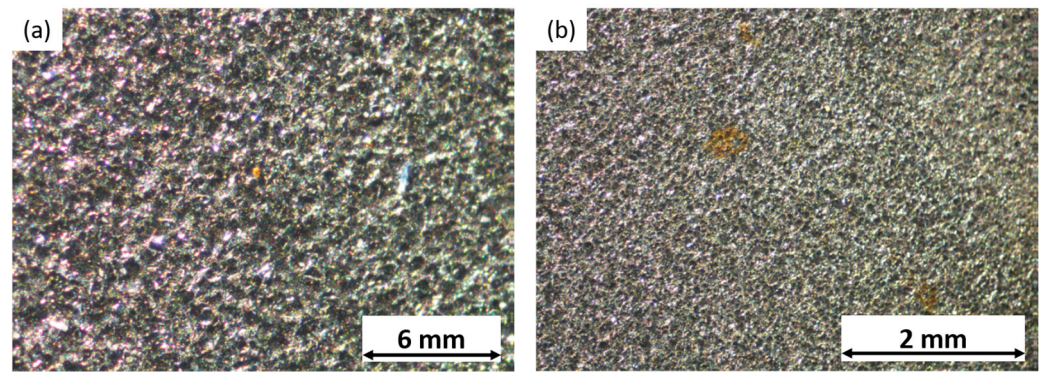
Following the testing, the samples were examined under an optical microscope, to observe the pitting corrosion phenomena induced on their surfaces. The resulting pictures confirmed the occurrence of pitting. However, while pitting was present in the cold-rolled and satin finish samples, it was challenging to observe it distinctly using the optical microscope. Thus, Figure 4 represents this phenomenon appreciated in the sandblasted samples.

**Figure 4.** Pitting phenomena observed on sandblasted samples in contact with (a) 0.5 g/L NaCl and (b) 1.0 g/L NaCl solutions.

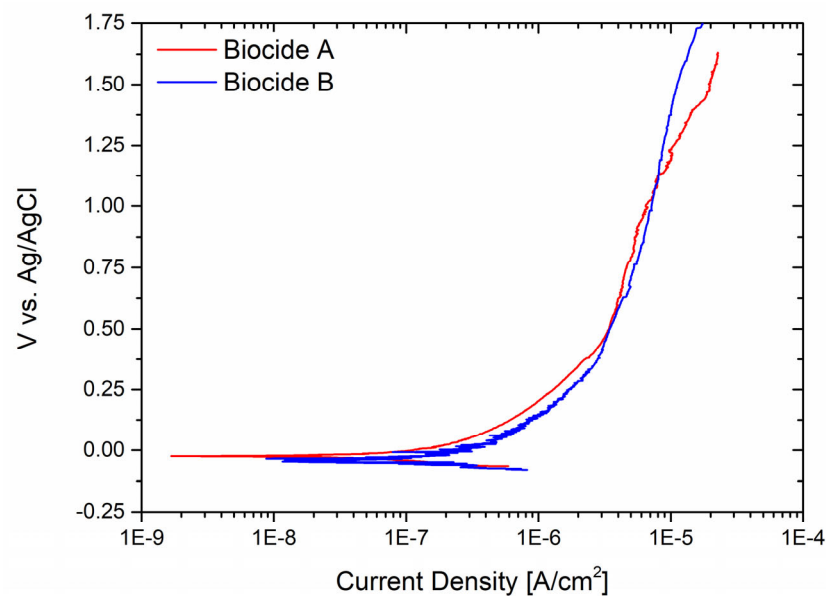
Because the sample that underwent the sandblasting procedure exhibited the highest level of vulnerability to corrosion, its performance was examined when exposed to both oxidant biocides at a concentration of 2 mg/L. This concentration was deemed the minimum requirement for the biocides to be effective, as recommended by the suppliers. Figure 5 shows the potentiodynamic curves of the sample in the two different testing solutions. Both experiments revealed the absence of pitting initiation, suggesting that the two biocides are not corrosive to the metal in such limited concentrations.

**Figure 5.** Sandblasted stainless steel corrosion resistance tested using Biocide A and Biocide B with minimum concentration to kill bacteria.

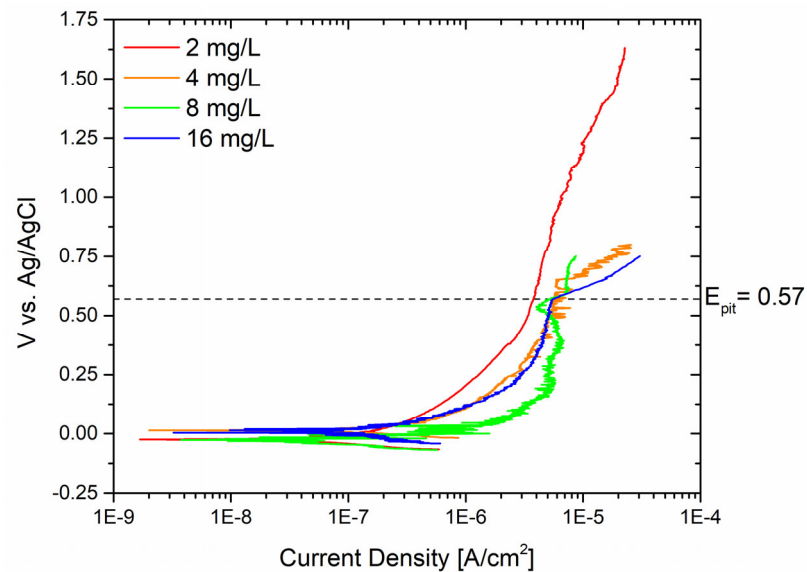
Thus, Biocide A was examined at various concentrations to investigate the initiation of pitting on the sandblasted sample and to determine the maximum concentration that could effectively prevent pitting phenomena. Indeed, in industrial settings, when it is challenging to precisely control the dosage of biocides, they are often over-applied. This approach ensures that the biocide remains effective throughout the operational lifespan of the plant, reaching its effectiveness threshold. Figure 6 illustrates the results obtained for free bromine concentrations of 2 mg/L, 4 mg/L, 8 mg/L, and 16 mg/L.

**Figure 6.** Potentiodynamic curves of sandblasted surfaces with different concentrations of Biocide A.

Pitting corrosion was not observed at free bromine concentrations of 2 mg/L, as evidenced by the absence of pitting throughout the test until it was stopped at 1.75 V vs. Ag/AgCl. Yet, elevating the concentration of free bromine to 4 mg/L led to the loss of passivity at around 0.62 V vs. Ag/AgCl. A comparable occurrence was noted when employing solutions with concentrations of 8 mg/L and 16 mg/L, resulting in the onset of pitting at 0.52 V and 0.57 V vs. Ag/AgCl, respectively. Hence, it can be affirmed that a free bromine concentration exceeding 2 mg/L proves especially pivotal for the passivity layer of the component. This biocide concentration should thus be regarded as a critical threshold that should not be surpassed to prevent the formation of substantial defects in the metal alloy.

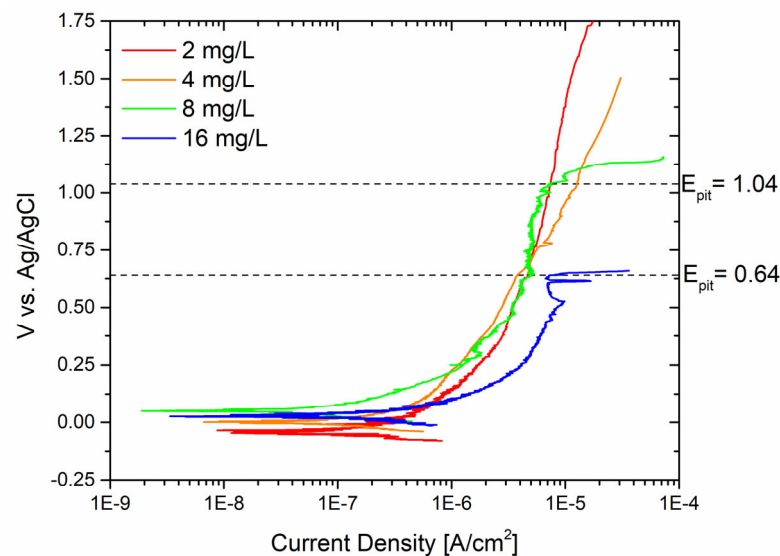
Similarly, the behavior of the sandblasted sample was evaluated in contact with different amounts of Biocide B, as shown in Figure 7.

**Figure 7.** Potentiodynamic curves of sandblasted surfaces with different concentrations of Biocide B.

Pitting corrosion was observed even at high potentials when the free chlorine concentration exceeded 8 mg/L. The pitting potential  $E_{pit}$  was determined to be 1.038 V vs.

Ag/AgCl, which is considered a “high” potential value. The threshold for pitting potential in contact with a 16 mg/L free chlorine solution was determined to be 0.64 V vs. Ag/AgCl.

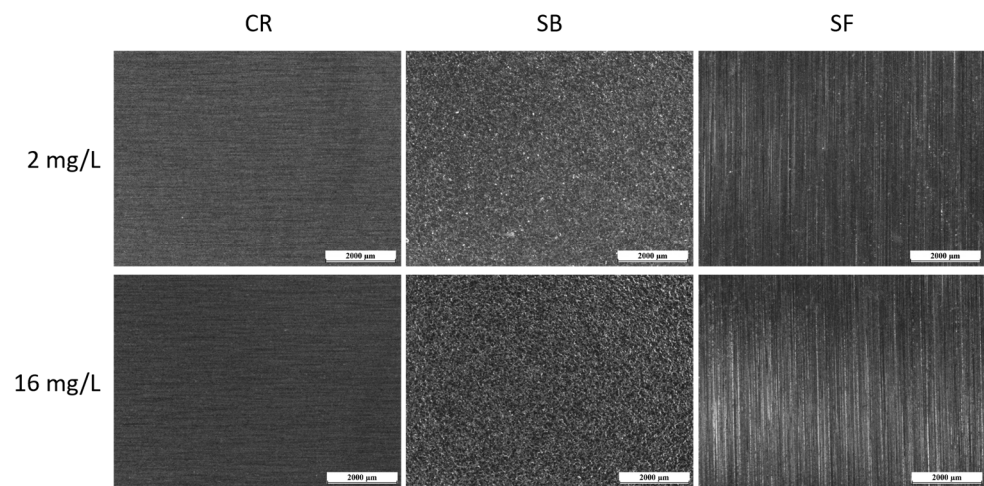
Figure 8 illustrates the appearance of samples after conducting a test with Biocide A, where CR stands for ‘cold rolled’, SB ‘sandblasted’ and SF ‘satin finish’. The depicted images represent both tested conditions: the ‘safe’ condition with a free bromine concentration of 2 mg/L and the notably critical condition at 16 mg/L. While the potentiodynamic measurements shown in Figure 6 demonstrated the heightened aggressiveness of Biocide A when applied beyond 2 mg/L of free bromine concentration, the biocide vapor exposure test did not reveal any significant issues for the three surfaces. These surfaces were free from pitting and morphological defects, and, even under particularly high biocide concentrations (16 mg/L), the integrity of the three sample types remained unaffected.

**Figure 8.** Optical micrographs of the surface of the samples after the test with Biocide A.

The test results indicate that distinguishing the impact of the various surface processing methods on the steel is challenging, since all three sets of samples remained intact and defect-free. In contrast to immersion in the aggressive biocide solution, exposing the samples to simple steam—mimicking the wet and dry fluctuations typical of external components on the pasteurizer—did not seem to significantly affect the metallic component.

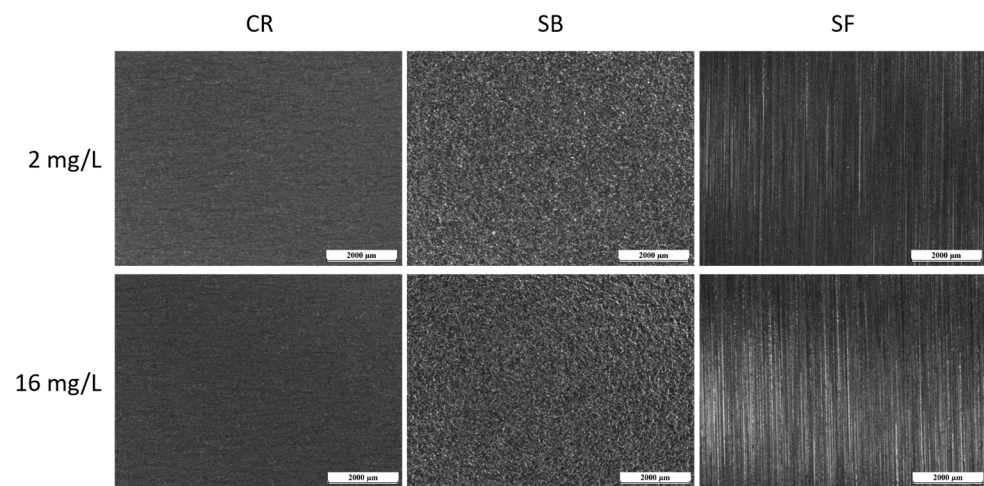
Similar findings were observed with Biocide B, as depicted in Figure 9. The images display surfaces that remained intact, without evidence of localized corrosion processes, as anticipated based on the potentiodynamic measurements in Figure 7. Once more, the test conditions proved inadequate for inducing corrosion in the samples, even under Biocide concentrations deemed notably critical. From this standpoint, the surface treatment of the steel, which yields varying morphologies and levels of roughness, does not appear to significantly impact the durability characteristics of the metal component under wet/dry conditions.

**Figure 9.** Optical micrographs of the surface of the samples after the test with Biocide B.

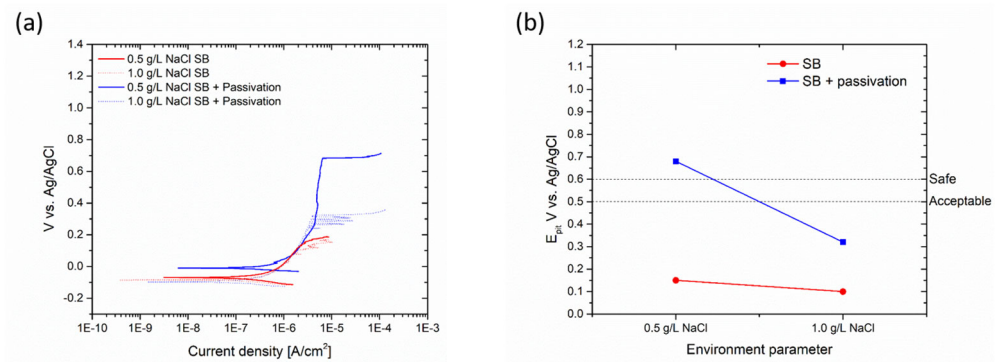
Thus, polarization curves were obtained for each surface finish of AISI 304L, and subsequent pickling and passivation treatments were carried out to assess any changes in the pitting potential. Figure 10a displays the polarization curves of the sandblasted AISI 304L sample before and after the chemical passivation process, carried out in two solutions with different concentrations of sodium chloride: 0.5 and 1.0 g/L, respectively. Figure 10b illustrates the change in pitting potential due to the passivation chemical treatment. For a 0.5 g/L NaCl solution, the pitting potential can be considered safe for usage. After passivation, the material can be deemed protective when exposed to low to medium concentrations of corrosive elements. Due to the passivation treatment, the pitting potential of sandblasted AISI 304L increased from 0.182 V (0.5 g/L NaCl) to 0.685 V, and from 0.138 V (1 g/L NaCl) to 0.32 V. The passivation treatment elevates the pitting potential, thus providing good protection even to sandblasted specimens when encountering a medium to high concentration of corrosive elements.

**Figure 10.** Polarization curves (a) and change in pitting potential (b) of sandblasted sample due to passivation process.

Following the passivation treatment, there was a notable increase in the pitting potential across all surface treatments when immersed in environments containing 0.5 and

1 g/L NaCl. Passivation proved to be particularly effective for the satin and sandblasted surfaces. However, for the cold-rolled surfaces, the pitting potential remained relatively unchanged. This can be attributed to the fact that these kinds of samples undergo minimal manipulation and possess inherent protective properties. The summarized increases in pitting potential are provided in Table 4.

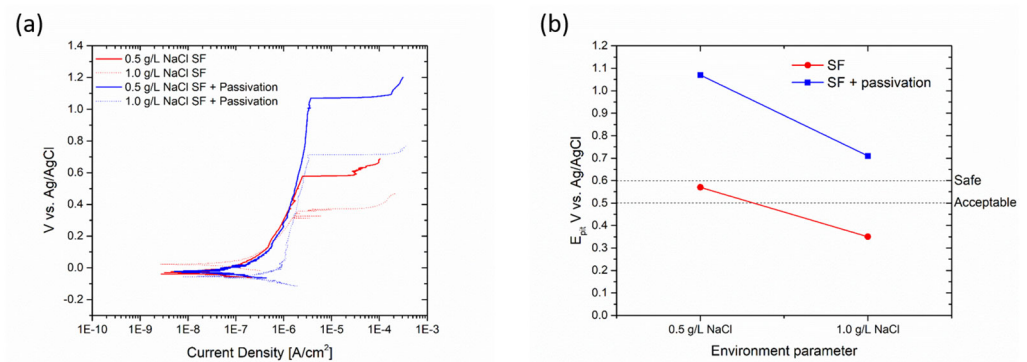
The satin finish sample demonstrated excellent corrosion resistance up to a concentration of 0.5 g/L NaCl, but its performance decreased significantly as the concentration increased. At 1 g/L NaCl, the pitting potential was measured at 0.343 V vs. Ag/AgCl. However, after undergoing passivation treatment, the pitting potential increased to values higher than 0.7 V for both concentrations. The specific changes are depicted in Figure 11.

**Figure 11.** Polarization curves (a) and change in pitting potential (b) of satin finish sample due to passivation process.

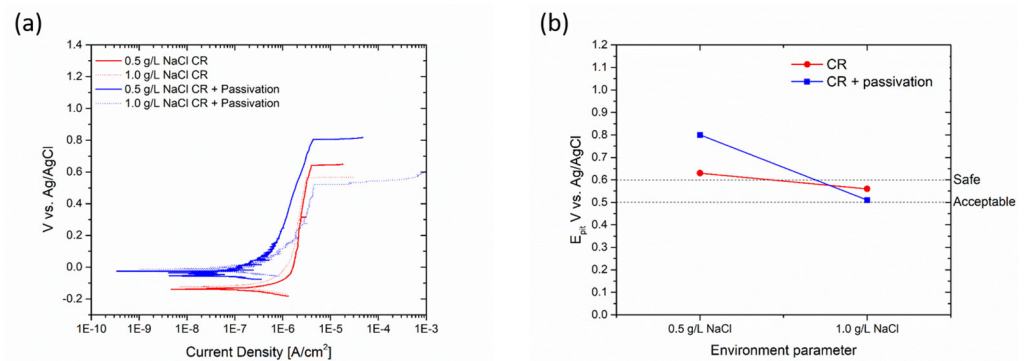
The cold-rolled samples consistently exhibited favorable corrosion resistance properties, even under high chloride concentrations. Passivation treatment is not deemed necessary due to the protective nature of the passive layer, as indicated by the pitting potential values of the untreated samples (Figure 12b).

**Figure 12.** Polarization curves (a) and change in pitting potential (b) of cold-rolled sample due to passivation process.
