# Sliding Behavior of Friction Material Against Cermet Coatings: Pin-on-Disc Study of the Running-in Stage

**Abstract** Running-in is the initial stage during which a tribological system reaches a steady state condition. In this study, the running-in behavior of a commercial brake friction material, pin-on-disc tested under dry sliding conditions has been investigated to understand the role of different surface finishing of hard coatings. These coatings were deposited onto the cast iron counterface disc and then mechanically polished to achieve set values of average roughness,  $R_a$ , and roughness skewness,  $R_{sk}$ . The tribological data were modeled using an exponential relation for the wear rate, according to a literature approach. The model parameters were related to the above disc surface roughness parameters. The results were interpreted in terms of the main wear mechanisms, that determine the formation of the friction layers on the pins as well as discs wear tracks. Of particular relevance is the finding that a negatively-skewed surface roughness is fundamental to achieve the best running-in performances. The beneficial effects coming from this surface treatment derive

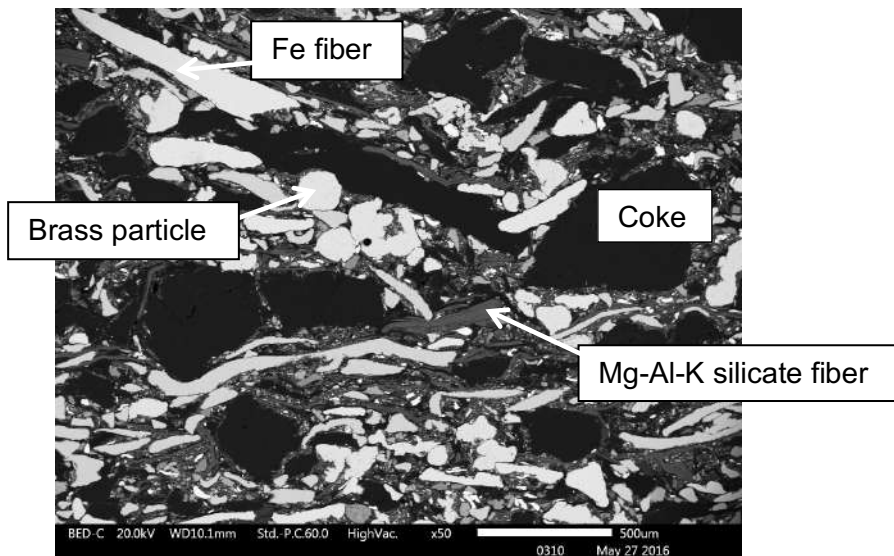
Fig. 1: SEM micrograph of a friction material cross section with the indication of the main constituents.

Fig. 1: SEM micrograph of a friction material cross section with the indication of the main constituents.

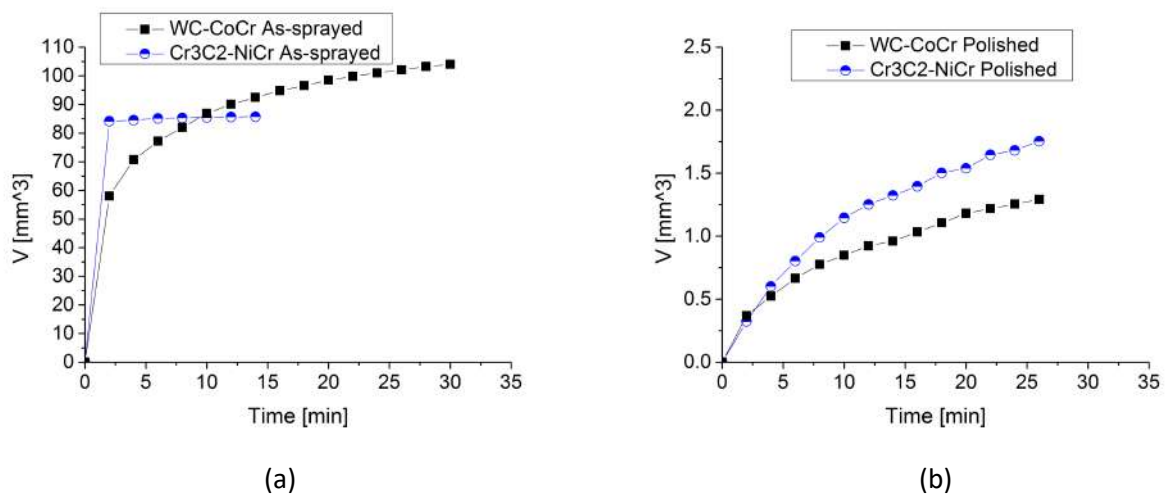
Fig. 2 depicts the recorded evolution of the pin wear volumes as a function of the sliding time, for the discs in the as-sprayed (a) and polished(b) conditions.

Fig. 2: Wear volume of pins as a function of the sliding time for (a) discs in the as-sprayed conditions and (b) discs with an average roughness of 1 $\mu$ m, obtained by surface polishing. Please note the very different range for the y-axes.

Fig. 2a shows that the initial wear volume for the Cr<sub>3</sub>C<sub>2</sub>-NiCr coating is higher than the one of the WC-CoCr coating. This is related to the difference in the surface roughness in the as-sprayed conditions (Table 1), that is larger for the first coating,  $R_a \approx 5 \mu\text{m}$ , with respect to the second one,  $R_a \approx 3 \mu\text{m}$ . Due to the lower microhardness of the Cr<sub>3</sub>C<sub>2</sub>-NiCr coating, however, the wear volume of the pin after 6 minutes of sliding reaches a steady condition. The higher microhardness of the WC-CoCr coating resulted in a continuous increase in the wear volume of the pin, with a prolonged running-in stage lasting for about 34 minutes. Analyzing the curves in Fig. 2b, referring to surface polished coatings, it is possible to note that both the initial wear volume and the increasing trend of the curves are almost the same for the Cr<sub>3</sub>C<sub>2</sub>-NiCr and WC-CoCr coatings.

Fig. 2: Wear volume of pins as a function of the sliding time for (a) discs in the as sprayed conditions and (b) discs with an average roughness of  $1\mu\text{m}$ , obtained by surface polishing. Please note the completely different range for the y-axes.

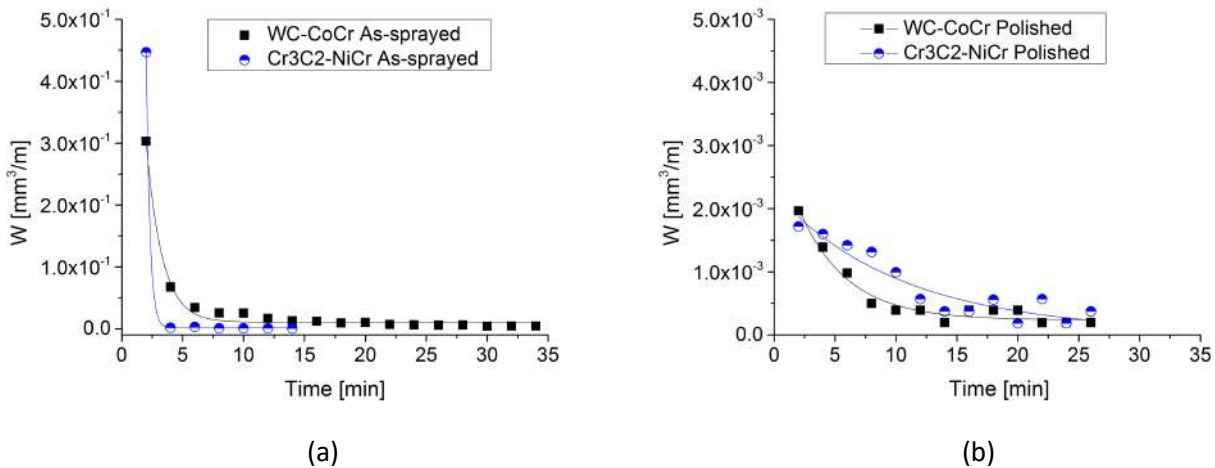
The values of the wear volumes were used to calculate the wear rates,  $W$ , whose values are shown in Fig. 3. The experimental points were then fitted using Eq.1. The relevant model parameters are listed in Table 3. First of all, it can be observed that the experimental fit is very good in case of the as-sprayed samples (with adjusted  $R^2$  values very close to unity), whereas in the case of the polished specimens the quality of the fit was lower. This is due to the scatter of results of Fig, 3b, which is most probably due to the difficulties in the weighting operations when dealing with a very little amount of debris. It can be further noted that the steady-state wear rates ( $W_\infty$ ) are always lower for the  $\text{Cr}_3\text{C}_2\text{-NiCr}$  coatings and decrease by one to two orders of magnitude after the polishing treatment.

Fig.3: Wear rate of pins as a function of the sliding time for (a) discs in the as-sprayed conditions and (b) discs with an average roughness of 1 $\mu\text{m}$ . Data points are fitted by the continuous lines given by Eq.1 (see main text).

Fig.3: Wear rate of pins as a function of the sliding time for (a) discs in the as sprayed conditions and (b) discs with an average roughness of  $1\mu\text{m}$ . Data points are fitted by the continuous lines given by Eq.1 (see main text).

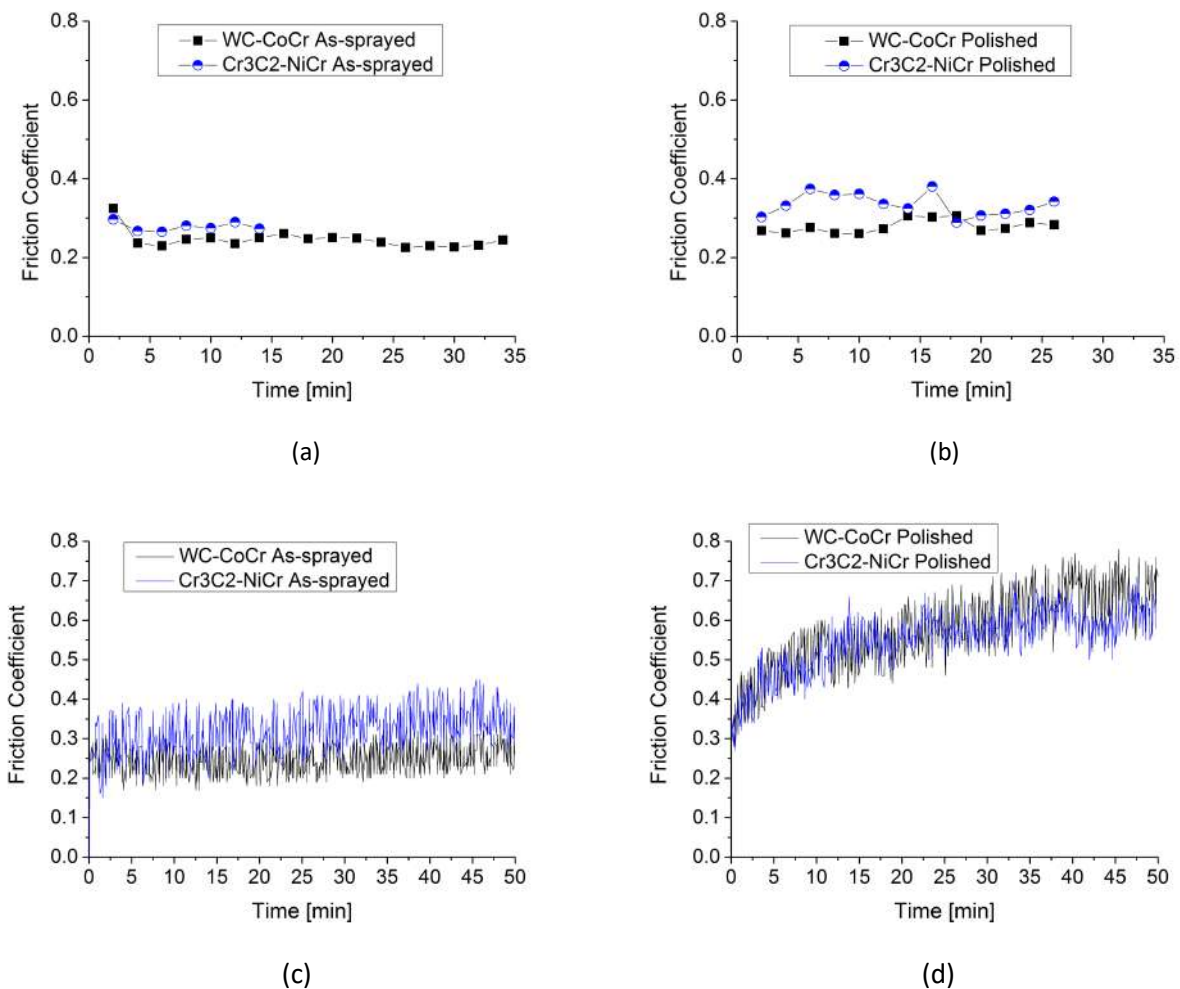
Fig. 4a and 4b show the average friction coefficients, obtained for each time step used for the wear-volume and wear-rate quantifications. For a comparison, Fig. 4c and 4d show the evolution of the friction coefficient in case of the continuous tests.

Fig. 4: (a, b) Average friction coefficient in the case of the *interrupted* tests; (c, d): plots of the friction coefficient evolution during the *continuous* tests.

From Fig. 4a and 4b it is possible to note that the friction coefficient for the as-sprayed coatings is on average lower than that for the polished coatings. This aspect is more evident in the continuous wear tests (Fig. 4c and 4d). In these tests the friction coefficient of the as-sprayed coatings is slightly higher than for the interrupted tests on the same samples. For the polished coatings, the friction coefficient is much higher, and it continuously increases during the tests reaching a value of about 0.6 after 25 minutes. Almost the same value of the steady-state friction coefficient, i.e., 0.6, was found during the PoD tests conducted using with traditional gray cast iron sliding against the same friction material [31].

After reducing the surface roughness ( $R_a$ ) and skewness ( $R_{sk}$ ) by means of a controlled mechanical polishing treatment, the friction coefficient displayed an increasing trend during the continuous tests (Fig. 4(d)). During the interrupted tests the values of the friction coefficient of the polished discs were higher than the values detected for the as-sprayed coatings. However, the increasing trend observed in the continuous tests was no detected any longer (Fig. 4(a)). The general increase in the friction coefficient measured with the polished coatings can be explained by the rise of the adhesive contribution ( $\mu_{ad}$ ) associated with the increase in the load-bearing area. The increase in the adhesive contribution is particularly evident during the continuous tests. Rabinowicz [35] related the strength of the adhesive forces to the degree of contaminants on the sliding surfaces; the interruptions of the sliding tests lead to a higher degree of contamination, due to air humidity and pollutants, whose lubricating action hinders the rise of the friction coefficient to the same value as in the continuous test regime.

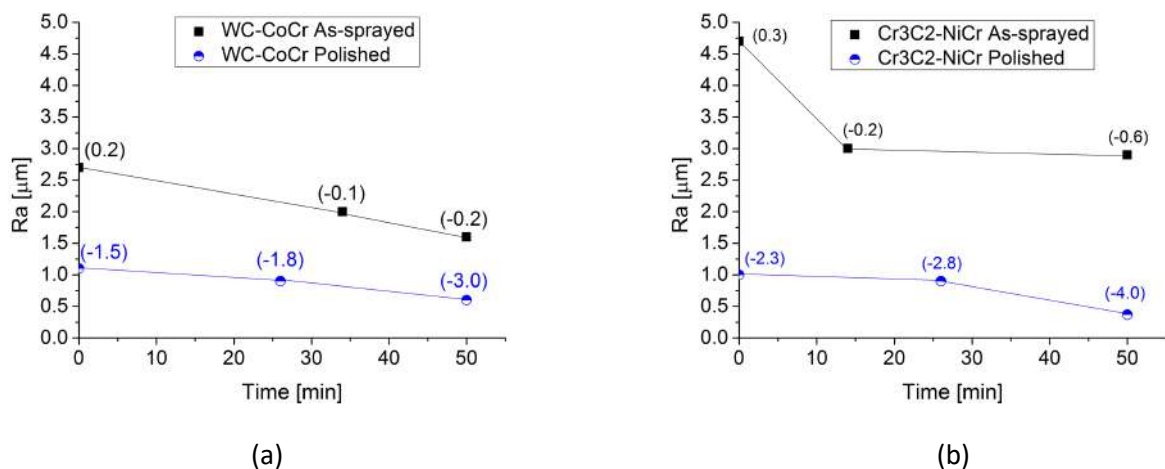
In Table 1, the initial surface roughness,  $R_a$ , and the skewness,  $R_{sk}$ , of the unworn coatings are listed. These parameters were also measured at the end of the interrupted as well as the continuous tests. The results are listed in Table 5, and plotted in Fig. 5.

Fig. 5 Evolution of surface average roughness and, among brackets, roughness skewness parameter during PoD wear tests. Two sets of data are plotted: *interrupted* (a) and *continuous* (b) tests.

Fig. 5 clearly shows the progressive decrease in the average surface roughness and in the skewness as the sliding proceeds, for both the as-sprayed and the polished coatings. The controlled polishing procedure led to lower  $R_a$ -values and, most importantly, to a more negatively skewed surface profile that further decreased during sliding. The lowest skewness values were achieved with the polished discs. This is in agreement with the fact that more negative values of roughness skewness correspond to wider load bearing regions and to a more uniform contact with respect the as-sprayed coatings.

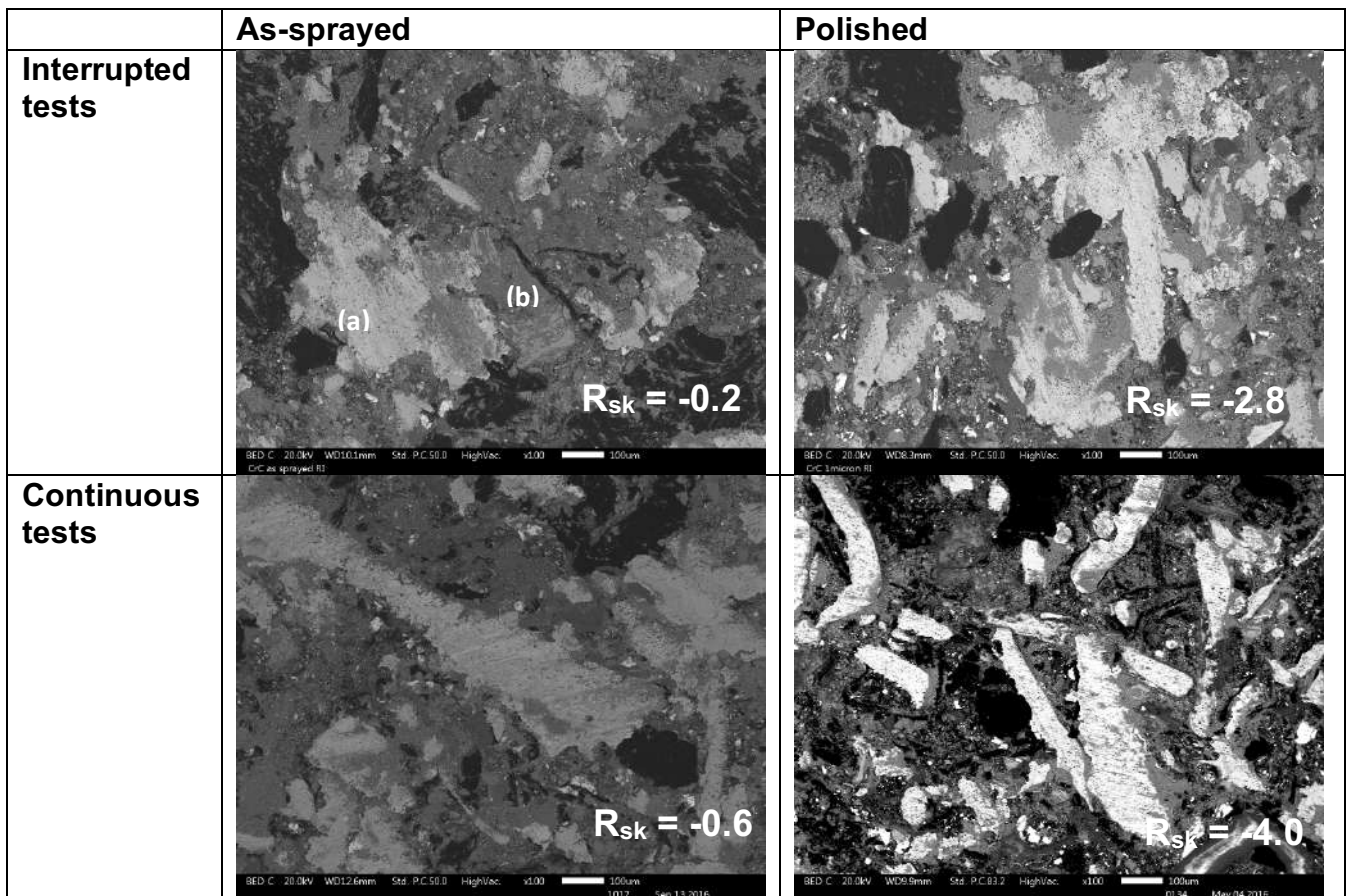
The worn surface of friction materials is typically characterized by the presence of friction layers, made by primary and secondary plateaus [3-9]. Figure 6 shows such plateaus observed on the pin surfaces after sliding against the  $\text{Cr}_3\text{C}_2\text{-NiCr}$  coated discs. The micrographs refer to the pins used both for the interrupted and the continuous tests. The letter (a) indicates a typical primary plateau, whereas with the letter (b) a typical secondary plateau is indicated. The EDXS analysis showed that primary plateaus are constituted by steel fibers, and that the secondary plateaus contain all the main ingredients of the friction material, with only a minor contribution from the disc coating.

Fig. 6: SEM images of the worn surfaces of the pins after sliding against the  $\text{Cr}_3\text{C}_2\text{-NiCr}$  coatings in the as-sprayed and polished conditions, and in the case of the interrupted and continuous tests. The values of the relevant coating skewness,  $R_{sk}$ , are indicated (see also Table 5).

As can be noted from the SEM observations of the pin worn surfaces (Fig. 6), the extension of the friction layer decreases as the surface skewness becomes more negative. This phenomenon is strictly related to the increase in the load-bearing area that induces a lowering in the abrasive contribution of the asperities initially present on the unpolished coating surface. Upon reducing the wearing out of the friction material, the amount of wear debris decreases, leading to the formation of more compacted and adherent secondary plateaus. The same mechanism is valid for the transfer layer built up on the disc surfaces; the wear debris accumulated in the unpolished valleys of the coatings are more compacted in the case of low skewness values. The EDXS elemental maps in Fig. 9 clearly show the accumulation and the compaction of the wear debris inside the unpolished valleys of the coatings. Furthermore, the joint presence of copper and iron within the same areas and in similar ratios for the two coatings (see Table 6) is a further proof that the detected iron comes from the friction material (pin). As a further indication, the EDXS quantitative analysis revealed a comparatively low amount of iron on the wear tracks. This low amount can be ascribed to the transfer from the pin materials rather than to the exposition of the gray cast iron substrate.

Fig. 6: SEM images of the worn surfaces of the pins after sliding against the  $\text{Cr}_3\text{C}_2\text{-NiCr}$  coatings in the as-sprayed and polished conditions, and in the case of the interrupted and continuous tests. The values of the relevant coating skewness,  $R_{sk}$ , are indicated (see also Table 4).

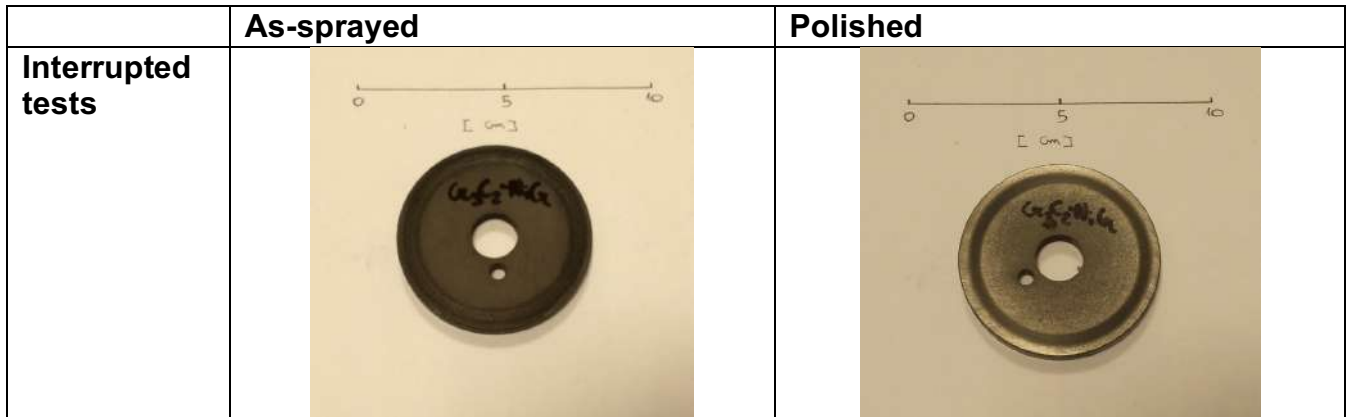
The general view of the wear tracks on the coated disc, tested both in the as-sprayed and polished conditions, are shown in Fig. 7. The wear tracks exhibit a uniform surface topography, indicating the occurrence of a homogeneous wearing out process.

Fig. 7: General view of the wear tracks on the  $\text{Cr}_3\text{C}_2\text{-NiCr}$  coated discs in the as sprayed and polished conditions, after the interrupted tests.

Fig. 7: General view of the wear tracks on the  $\text{Cr}_3\text{C}_2\text{-NiCr}$  coated discs in the as sprayed and polished conditions, after the interrupted tests.

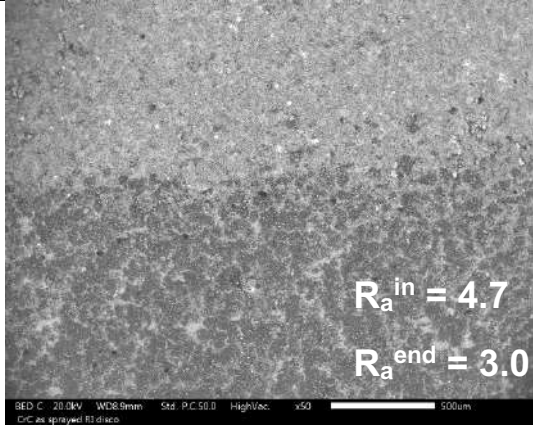
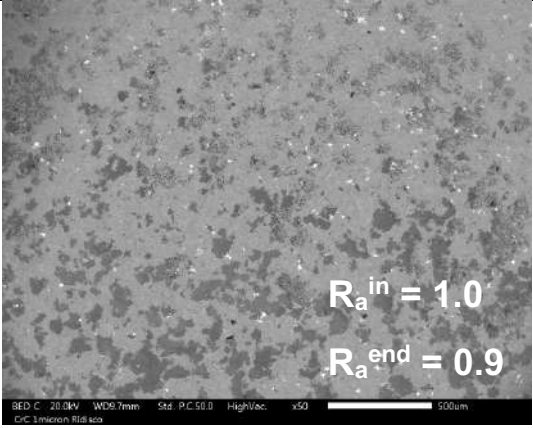
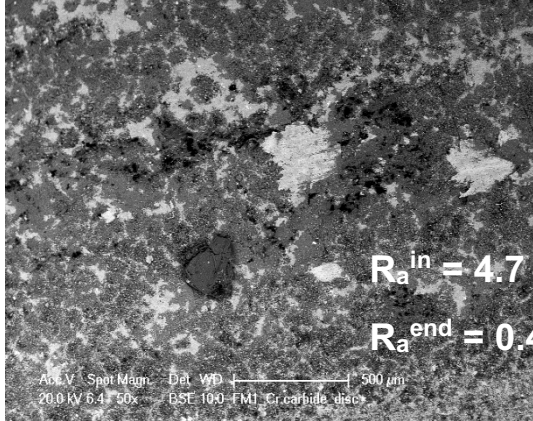
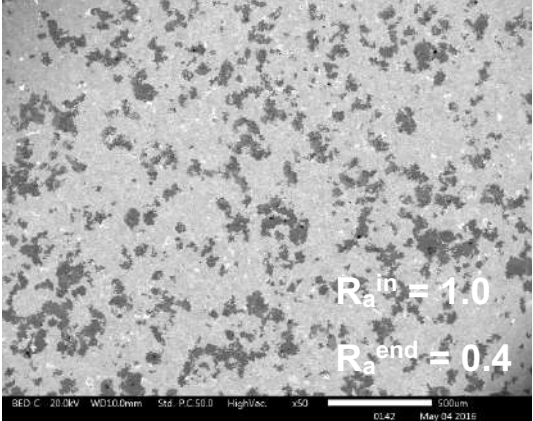
Fig. 8 shows the SEM micrographs of the wear tracks on the coated discs. As already observed [16], the wear debris coming from the wear of the pins accumulated and compacted into the unpolished “valleys” of the polished coatings. The amount of material transferred from the pin onto the disc surface increases with its roughness and the micrographs of as-sprayed coatings clearly show this trend.

<p><math>R_a^{in} = 4.7</math> <math>R_a^{end} = 3.0</math></p> <p>BED C 20.0kV WD8.9mm Std. P.C.50.0 HighVac. x50 500um CrC as sprayed R1 disc</p>

<p><math>R_a^{in} = 1.0</math> <math>R_a^{end} = 0.9</math></p> <p>BED C 20.0kV WD9.7mm Std. P.C.50.0 HighVac. x50 500um CrC 1 micron R18 sco</p>
Continuous tests

<p><math>R_a^{in} = 4.7</math> <math>R_a^{end} = 0.4</math></p> <p>ACL V Spot Magn Det WD 500um 20.0kV 6.4x50x BST 100-FM1 Cr carbide disc</p>

<p><math>R_a^{in} = 1.0</math> <math>R_a^{end} = 0.4</math></p> <p>BED C 20.0kV WD10.0mm Std. P.C.50.0 HighVac. x50 500um 0142 May 04 2011E</p>

Fig.8: SEM images of the wear tracks on the disc surfaces after run-in the  $Cr_3C_2-NiCr$  coating in the as-sprayed and polished condition, after the interrupted and continuous test. The roughnesses refer to the average surface roughness,  $R_a$ , detected before and after the PoD tests.

As shown by Figure 8, in the as-sprayed coatings the high initial roughness induces a significant transfer phenomenon that occurs from the beginning of the tests. This explains the high initial wear rates of the as-sprayed coatings, as shown by Figure 1a, and evidenced by the  $A_1$ -values listed in Table 4. In Figure 10 the almost linear relationship between the  $A_1$ -values and the initial roughness, expressed by the  $R_a$ -values, is highlighted. As already mentioned,  $A_1$  is an indicator of the wear rate during the first minutes of sliding contact; higher values of  $A_1$  are related to higher initial wear rates of the friction material.

Fig. 8: SEM images of the wear tracks on the disc surfaces after run-in the  $\text{Cr}_3\text{C}_2\text{-NiCr}$  coating in the as-sprayed and polished condition, after the interrupted and continuous test.

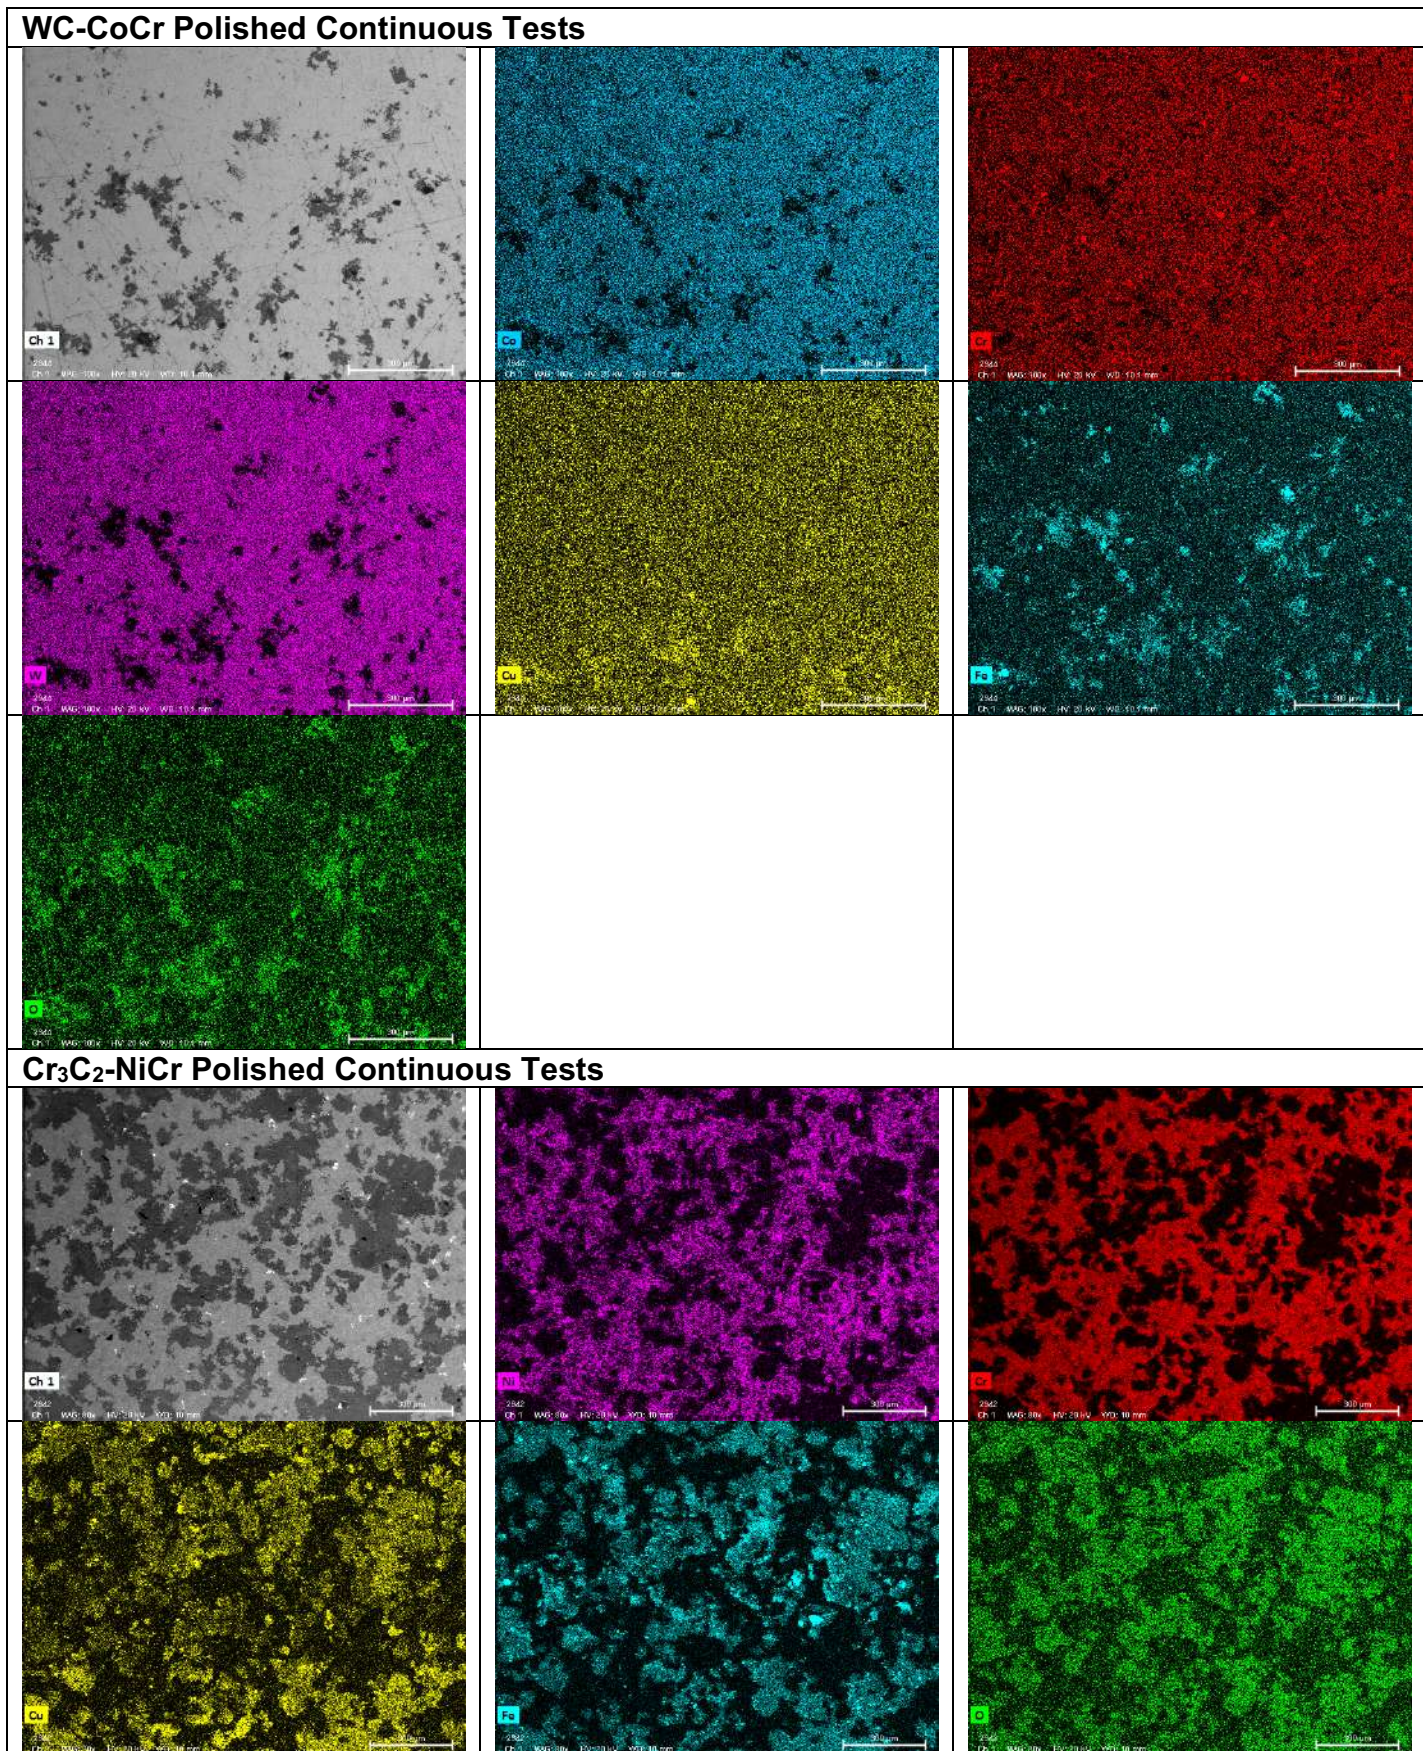
In order to confirm that during the sliding contact the coatings did not wear, EDXS elemental analyses and maps were acquired on the wear tracks of the polished coatings continuously tested. Since the polishing procedure leads to a decrease in the coating thicknesses only the polished coatings were analyzed. The results of these analyses are shown in Fig. 9 and Table 6.

Fig. 9: EDXS elemental maps for the polished coatings continuously tested.

The results of the EDXS quantitative analysis are listed in Table 6.

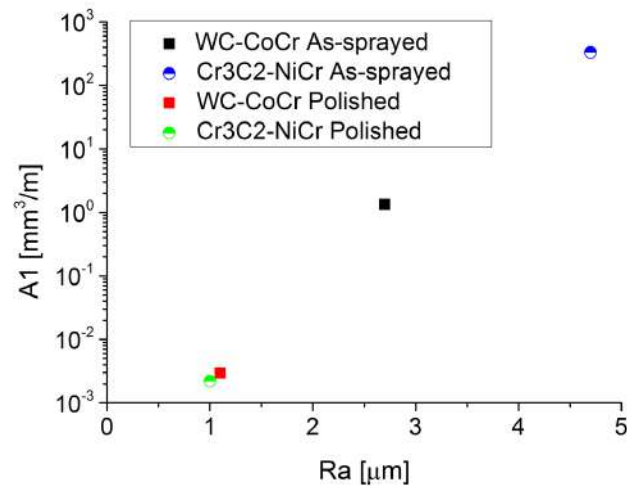
Fig. 10:  $A_1$  as a function of the initial roughness ( $R_a$ ) of the discs.

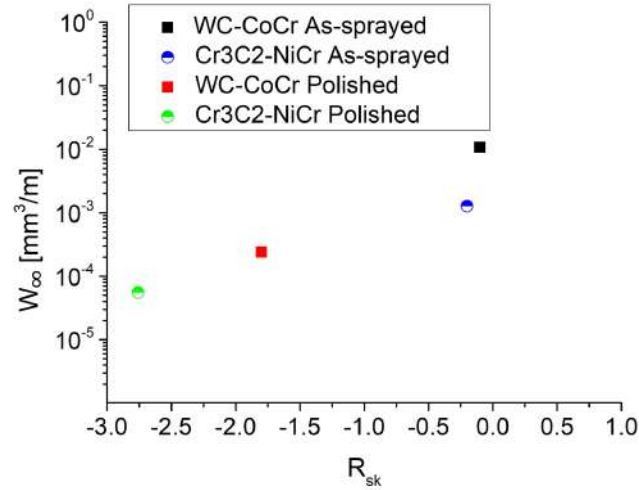
Fig. 11 shows the relationship between the steady-state wear rate of the pins ( $W_\infty$ ) and the skewness at the end of the interrupted running-in tests. Coherently with the above results, the increase of the load-bearing area, due to the decrease in the skewness, leads to a more efficient compaction of the wear debris inside the unpolished valleys of the coatings and thereby to lower wear rates.

Fig. 11: Steady state wear rate of the pin ( $W_{\infty}$ ) as a function of the skewness at the end of the interrupted tests.

Fig. 11: Steady state wear rate of the pin ( $W_\infty$ ) as a function of the skewness at the end of the interrupted tests.
