Crevice Corrosion Study of Materials for Propulsion Applications in the Marine Environment

F. Deflorian^{1†}, S. Rossi¹, M. Fedel¹, C. Zanella^{1,2}, D. Ambrosi¹, and E. Hledé³

Keywords: head gasket, crevice corrosion, galvanic corrosion

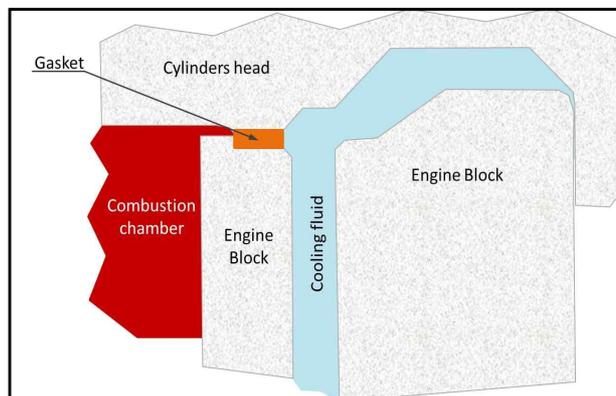
Fig. 1. Schematic representation of the Cylinder liner / engine block / cylinder gasket head / cylinders head system.

Medium speed four-stroke diesel engines are commonly used to power marine propulsion systems. Similar to the engines equipping ground vehicles, “medium-speed engines” consists in a cylinder liner-connected to the cylinder head by means of an head gasket interposed between the two components. The presence head gasket prevents the release of pressure gasses from the combustion chamber, thus improving the engine efficiency, and accommodates the thermal expansion of the cylinders head and cylinder liner due to the heat generated during fuel combustion. Moreover, the gasket material is subjected to wear and fretting due to the relative sliding of the different component during thermal expansion and/or shrinkage. Owing to the heat generated during combustion, the engine components, as well as the head gasket, are cooled using a water based refrigerant. Fig. 1 depicts a schematic representation of a common strategy to control the engine temperature by cooling, at the same time, cylinders head,

head gasket and cylinder liner. Observe that the gasket is affected by the combustion by-products, heat and pressurized gas on the inner side, while the outer side is directly in contact with the cooling fluid. In addition, notice that the cooling circuit is closed and is therefore expected not to be rich in oxygen.

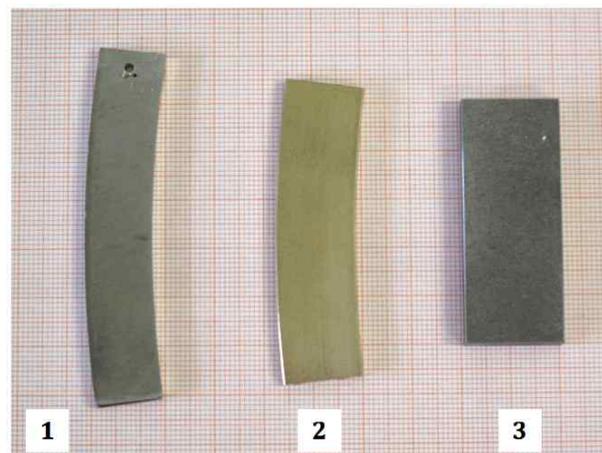
Fig. 2. Appearance of the metal samples: austenitic stainless steel without Mo (1), Nickel bronze (2) and lamellar cast iron (3).

50 x 20 x 5 mm lamellar and spheroidal cast iron samples were cut from real engine components using a CNC cutter. Fig. 2 shows an example of the appearance of the samples.

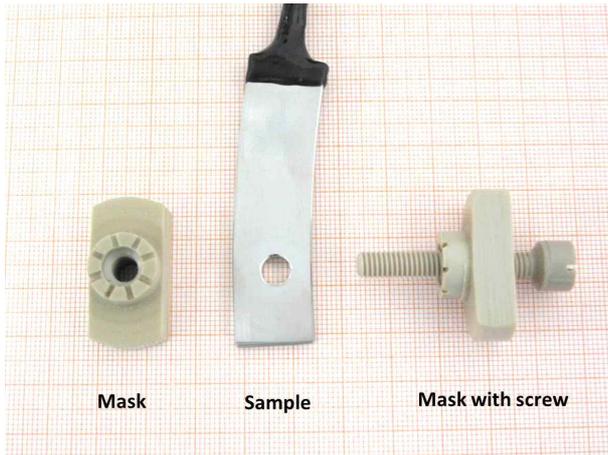
Fig. 3. Two-part PEEK mask.

(THE) test method”⁴). The test was carried out exploiting the experimental set-up proposed in ASTM G192–08 standard, which was successfully exploited by other authors^{5,6}). A PEEK mask (Fig. 3) was used to produce the geometrical conditions to promote the occurrence of crevice corrosion. The two-part mask consists of two PEEK circular crown with small gorges which are forced against the metal sample by means of a screw (Figure 4). The two parts are connected by means of the screw which is loaded with a 0,20 N/m torque.

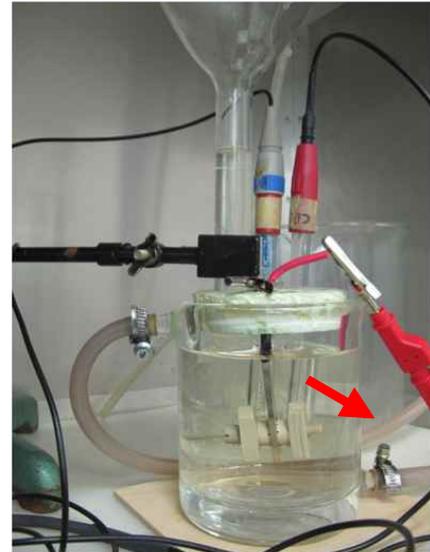
Fig. 4. Experimental set-up: the arrow indicates the PEEK mask exploited to promote crevice corrosion.

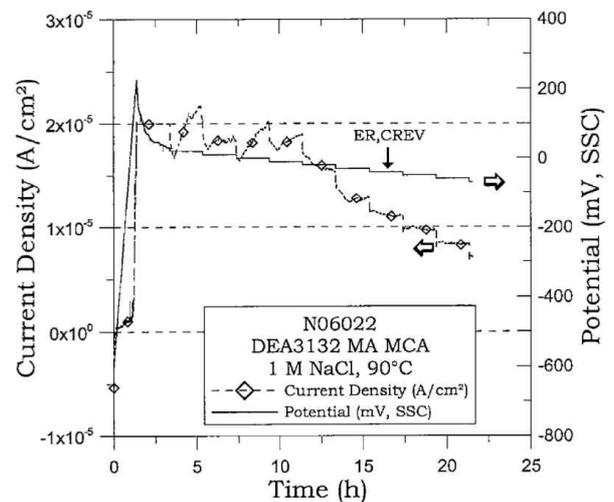
Fig. 5. Example of “Tsuji-kawa-Hisamatsu Electrochemical (THE) test method”, from⁴).

1. Polarization measurement starting 100 mV below OCP and progressing anodically (0,0167 mV/s) until a pre-specified current density is reached;
2. Galvanostatic conditioning at the end current in the previous step for 2 h (to grow the crevice corroded area) monitoring the potential output;
3. Potentiostatic conditioning at the end potential in the previous step minus 10 mV for 2 h monitoring the current density output;
4. If the current increases with time during the step 3. another potentiostatic period of 2 h was applied subtracting another 10 mV to the previously applied potential: decreasing steps of 10 mV were repeated until the output current density decreased with time in the 2 h period;

Fig. 5 depicts the example reported in⁴) to explain the “THE” method: potential and current density are collected/imposed during the different steps of the electrochemical test method.

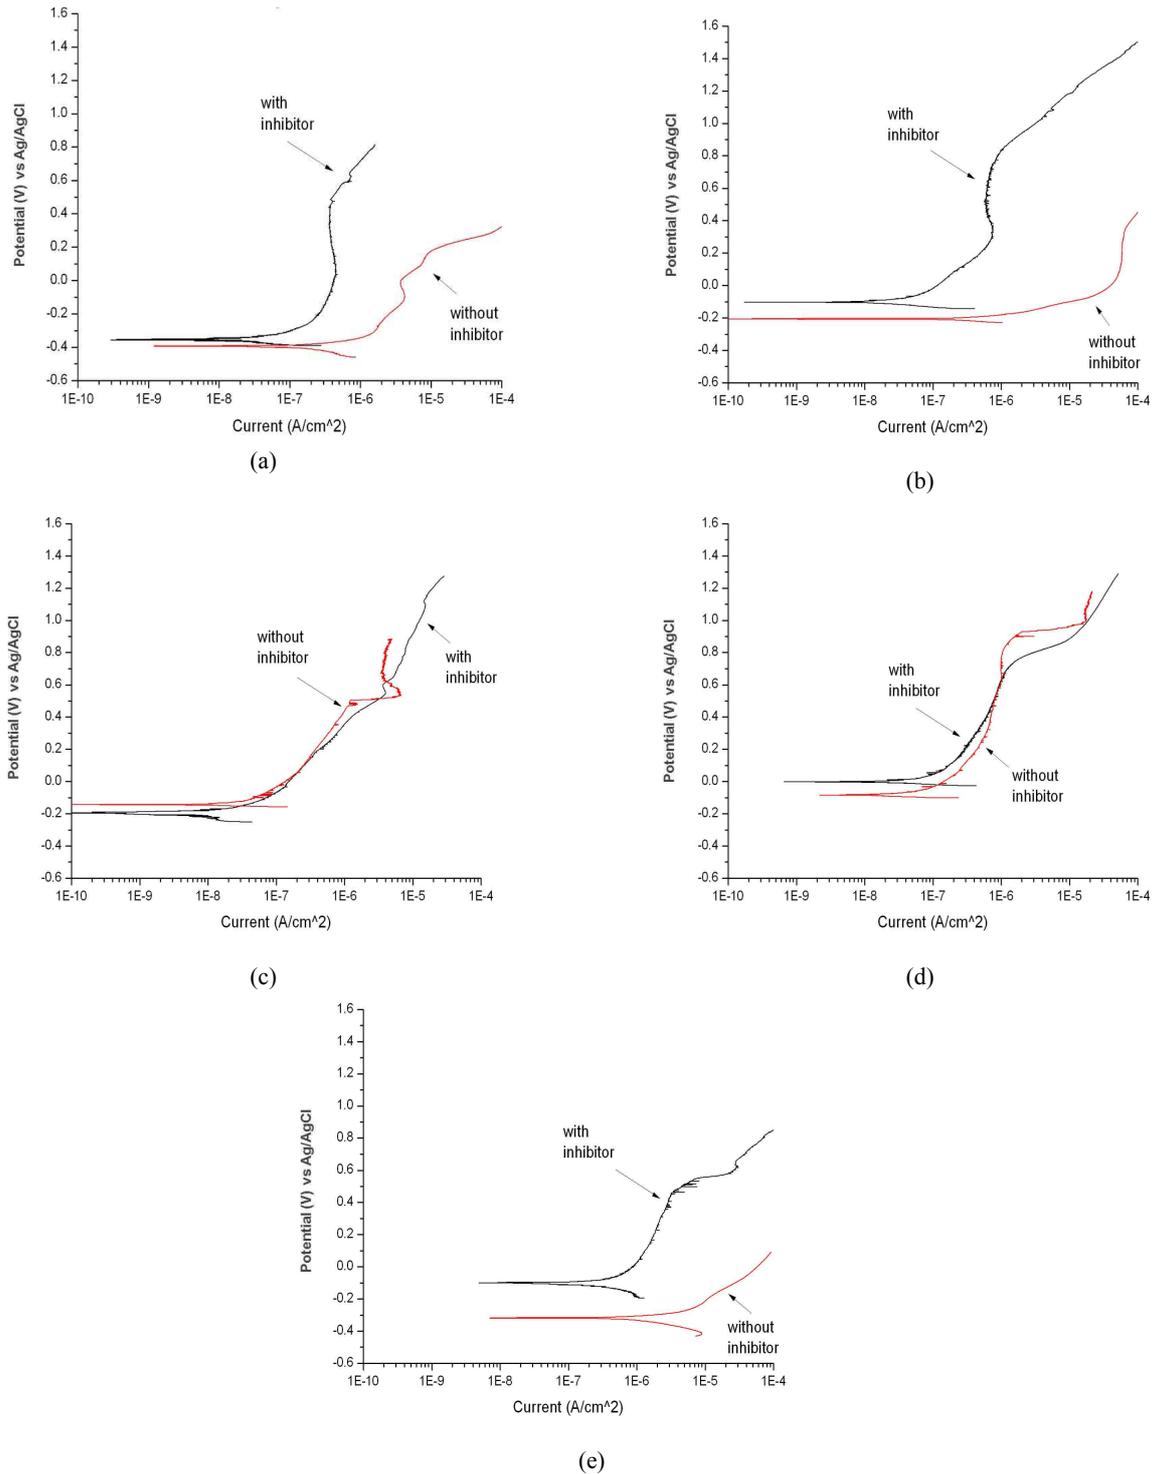
Fig. 6. Polarization curves: (a) Aluminium bronze, (b) Nickel Bronze, (c) S.S., (d) S.S.-Mo and (e) mild steel.

sion inhibitor on the different metals. Fig. 6 (a-d) shows the experimental results for the head gaskets materials. From Fig. 6 it is possible to observe that the corrosion inhibitor seems efficient in decreasing anodic corrosion current for the Cu-Al alloy, Cu-Ni alloy and mild steel samples. The presence of the corrosion inhibitor shifts the anodic currents of the Cu-Al, Cu-Ni and mild steel samples to lower values, around 10^{-6} A/cm². On the other hand, stainless steel substrates are not influenced by the presence of the corrosion inhibitor. However, it should be noted that the anodic currents measured on S.S. and S.S.-Mo samples are relatively low ($10^{-6} \div 10^{-7}$ A/cm²) and, therefore, the corrosion inhibitor is not able to further reduce the corrosion rate. Since the cooling fluid is in contact with engine component (different from the head gasket) such as cylinder liner and cylinder head, the effect of the electrolyte with and without the corrosion inhibitor was tested also on grey cast iron and ductile cast iron samples. Fig. 7 shows the polarization curves for the cast iron samples.

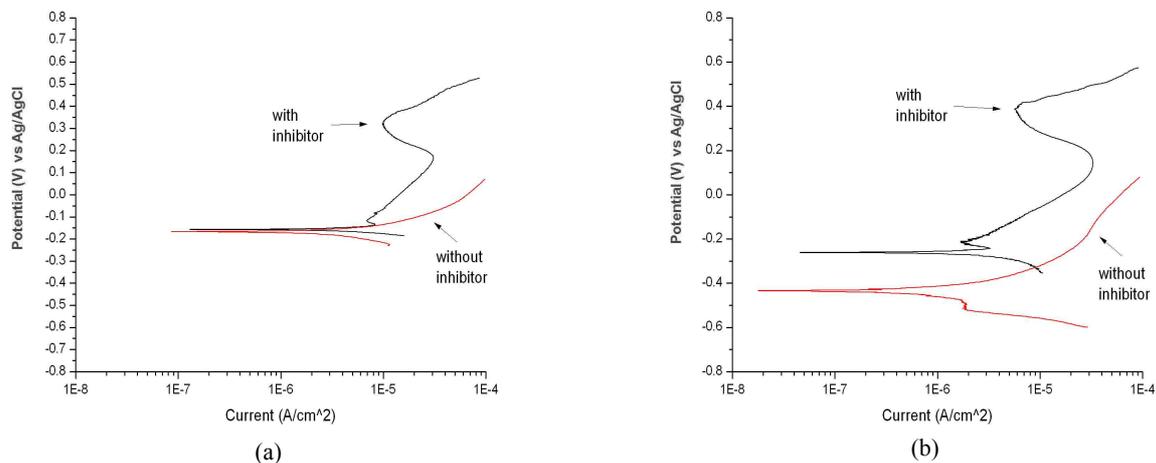
Fig. 7. Polarization curves for the engine components materials: (a) grey cast iron and (b) Ductile cast iron.

Considering Fig. 7, one can notice that the inhibitor promotes a certain reduction of the anodic current on both samples. However the beneficial effect (in terms of current reduction) is not as remarkable as for Cu-Al, Cu-Ni and mild steel samples.

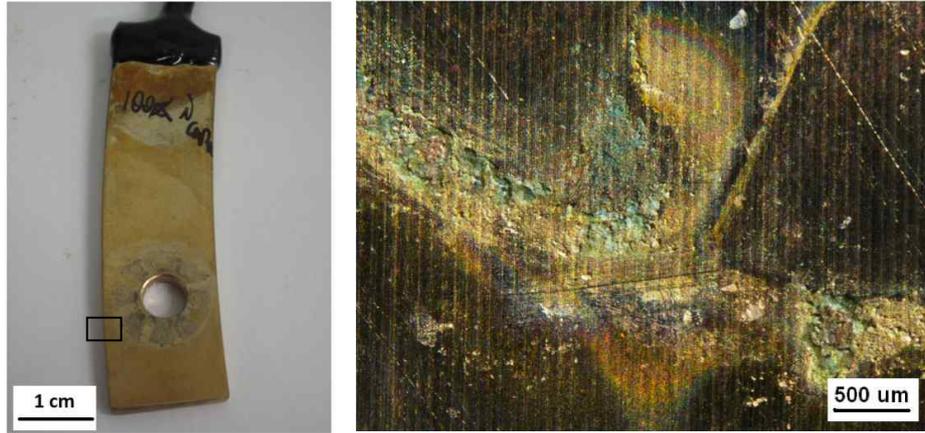
Fig. 8. Appearance of the Cu-Al samples after “THE” crevice corrosion test.

Crevice repassivation potential determination test was carried out on the different metals both in aerated and de-aerated conditions. All the “THE” tests were carried out in the electrolyte containing 5v/v% of corrosion inhibitor. Fig. 8 depicts the appearance of a metal sample after the crevice repassivation potential determination test (in particular, the Cu-Al sample is reported). Notice that a crevice corrosion process took place in correspondence of the area which was partially covered by the PEEK mask in order to promote the formation of differential aeration cells.

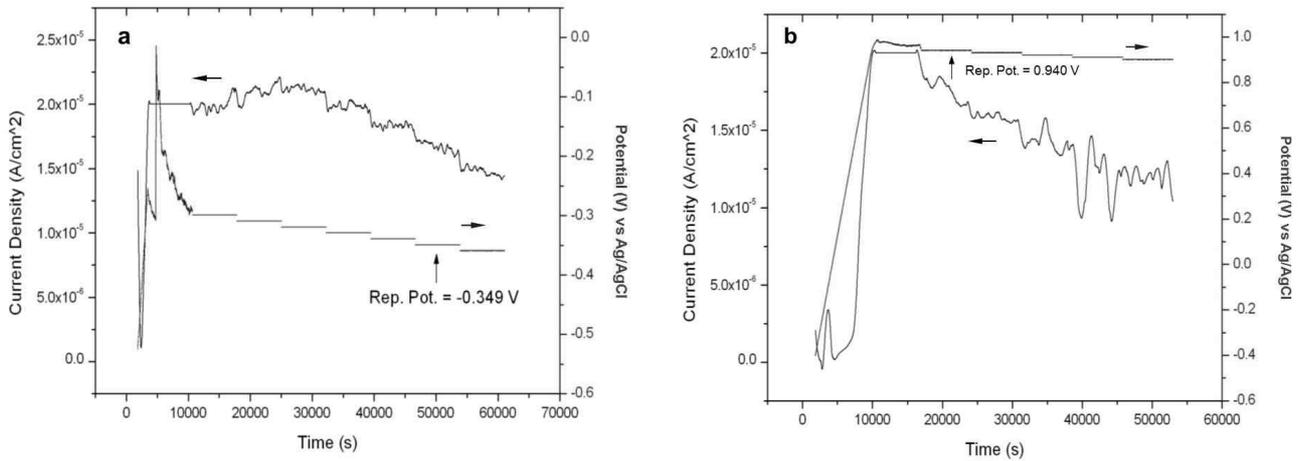
Fig. 9. Crevice corrosion repassivation potential and corresponding currents for (a) mild steel sample and for (b) S.S.-Mo sample.

As an example, Fig. 9 (a,b) shows the crevice repassivation potential determination for mild steel (a) and S.S.-Mo (b) samples in de-aerated conditions. For mild steel in de-aerated conditions (Fig. 9a) it was possible to determine a crevice corrosion repassivation potential at -0.349 V, obtained after six decreasing step (10 mV each) of the potential conditioning. Considering S.S.-Mo sample (Fig. 9b), repassivation occurred immediately after the switch off of the galvanostatic conditioning at the constant current density. This behaviour is clearly related to a very high crevice corrosion resistance of S.S.-Mo substrate under the conditions considered in the present study.

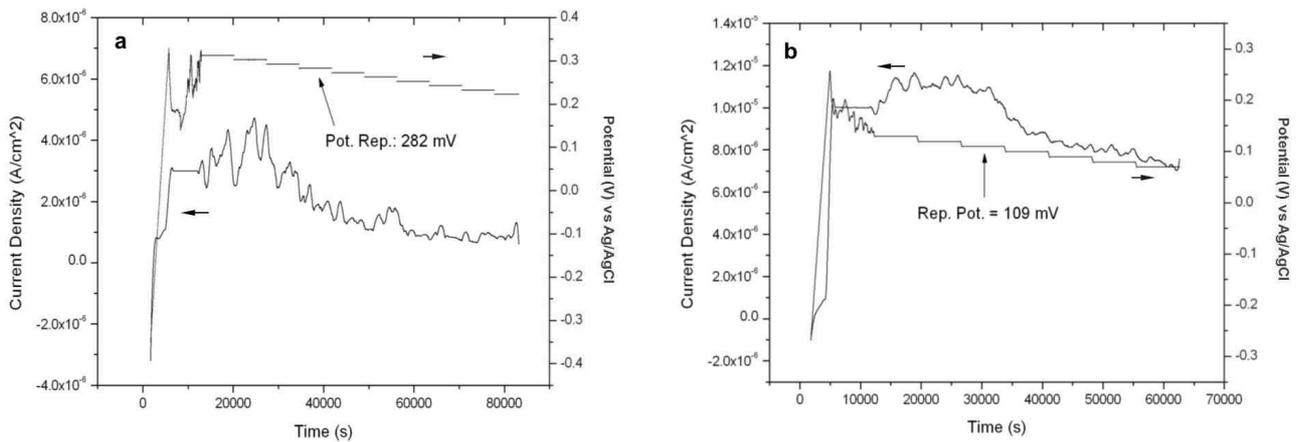
Fig. 10. Crevice corrosion repassivation potential and corresponding currents for (a) Cu-Ni and for (b) Cu-Al.

(aerated conditions), it is possible to observe that differently from the previous case, Cu-Ni and Cu-Al samples need a certain number of 10 mV decreasing steps to reach a crevice corrosion repassivation potential after the galvanostatic conditioning (Fig. 10). In fact, in aerated conditions, only stainless steels samples are able to repassivate immediately after the switch off of the galvanostatic current superimposition.
